# MAS Home Care Solutions

## Property Inspection Report

### Advanced Inspection

Report ID	ABC
Owner Name	DEF
Property Address	GHI
BHK Type	3 BHK
Date of Inspection	DD-MM-YYYY
Inspection Type	Advanced Inspection
Inspected By	Manoj Kumar

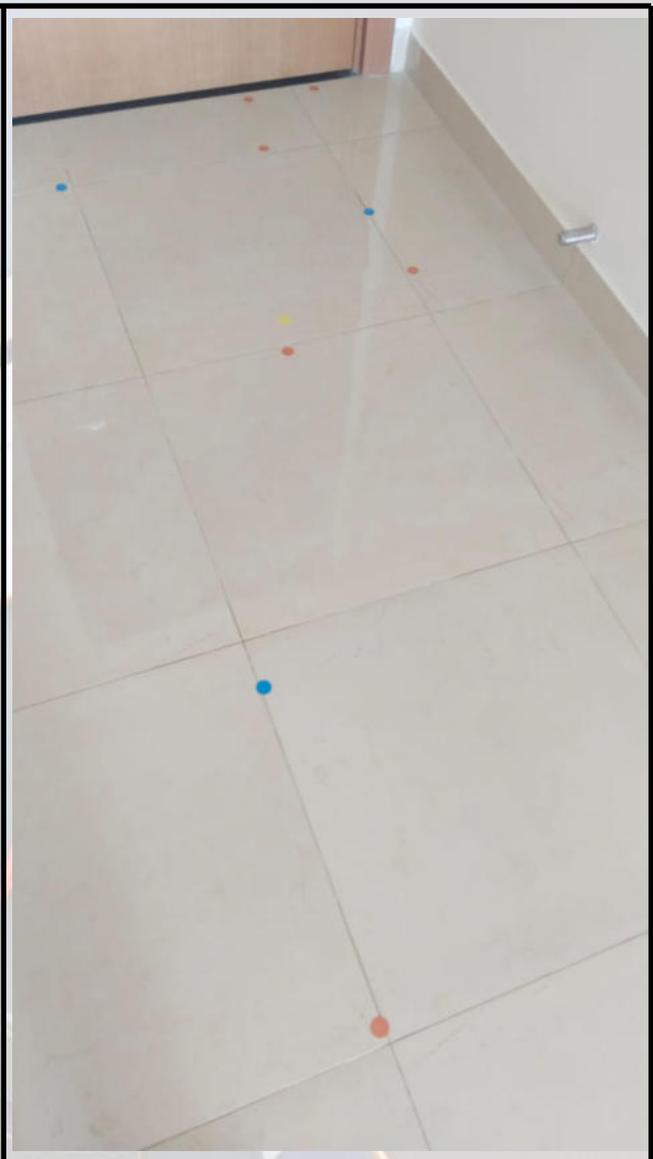
6 floor floor tiles minor chipped off

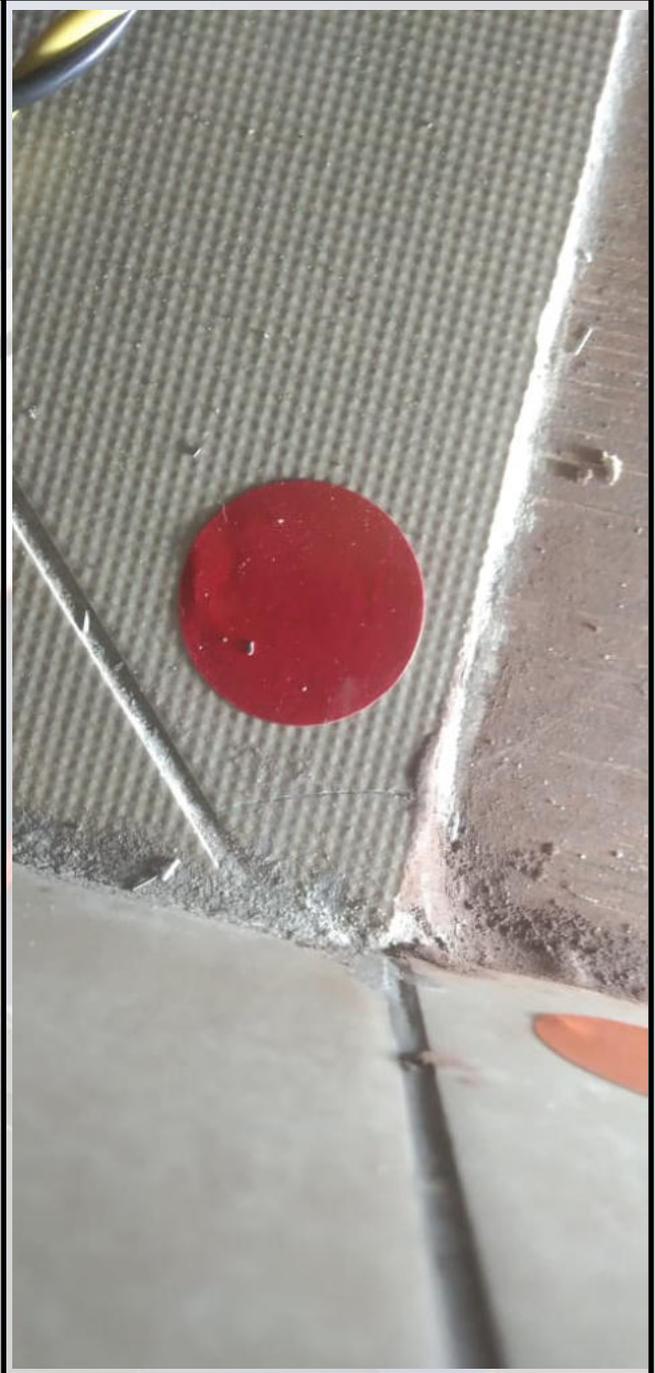
Floor tiles unevenness found - 19

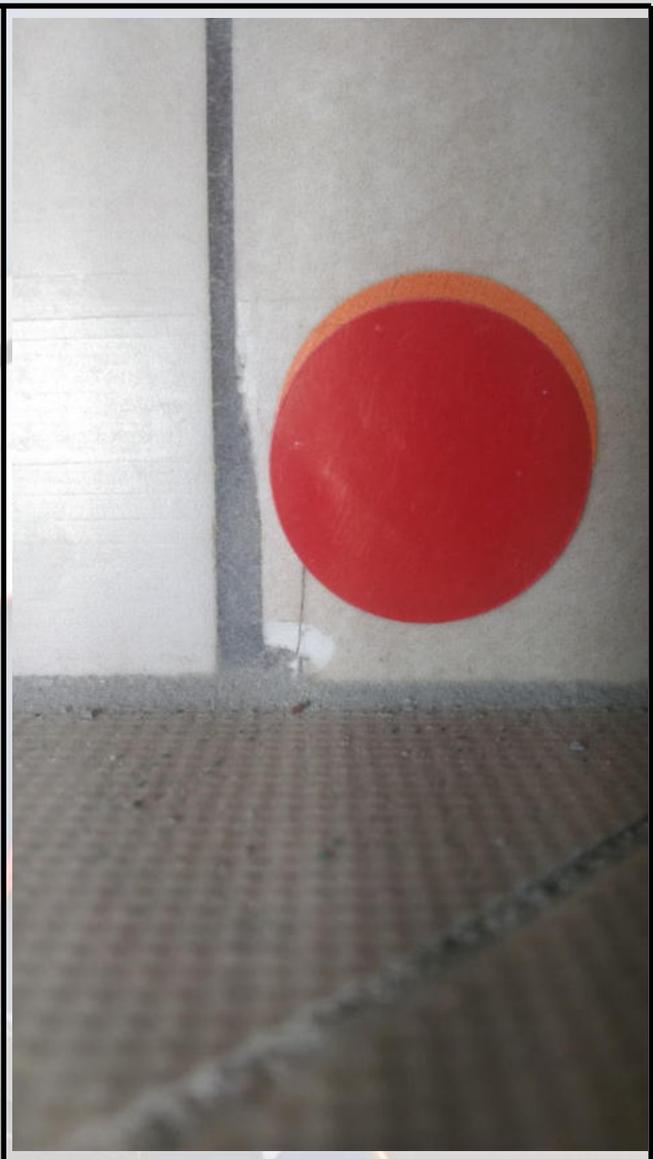
Floor tiles minor chipped off -14
