# MAS Home Care Solutions

## Property Inspection Report

### Advanced Inspection

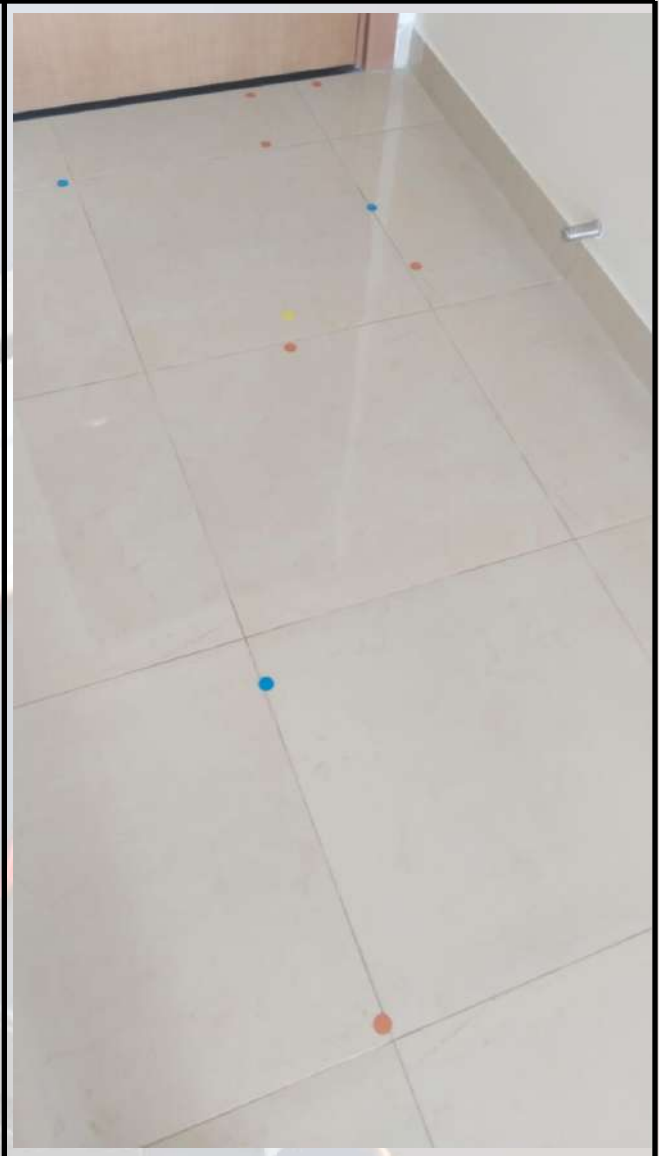
6 floor floor tiles minor chipped off

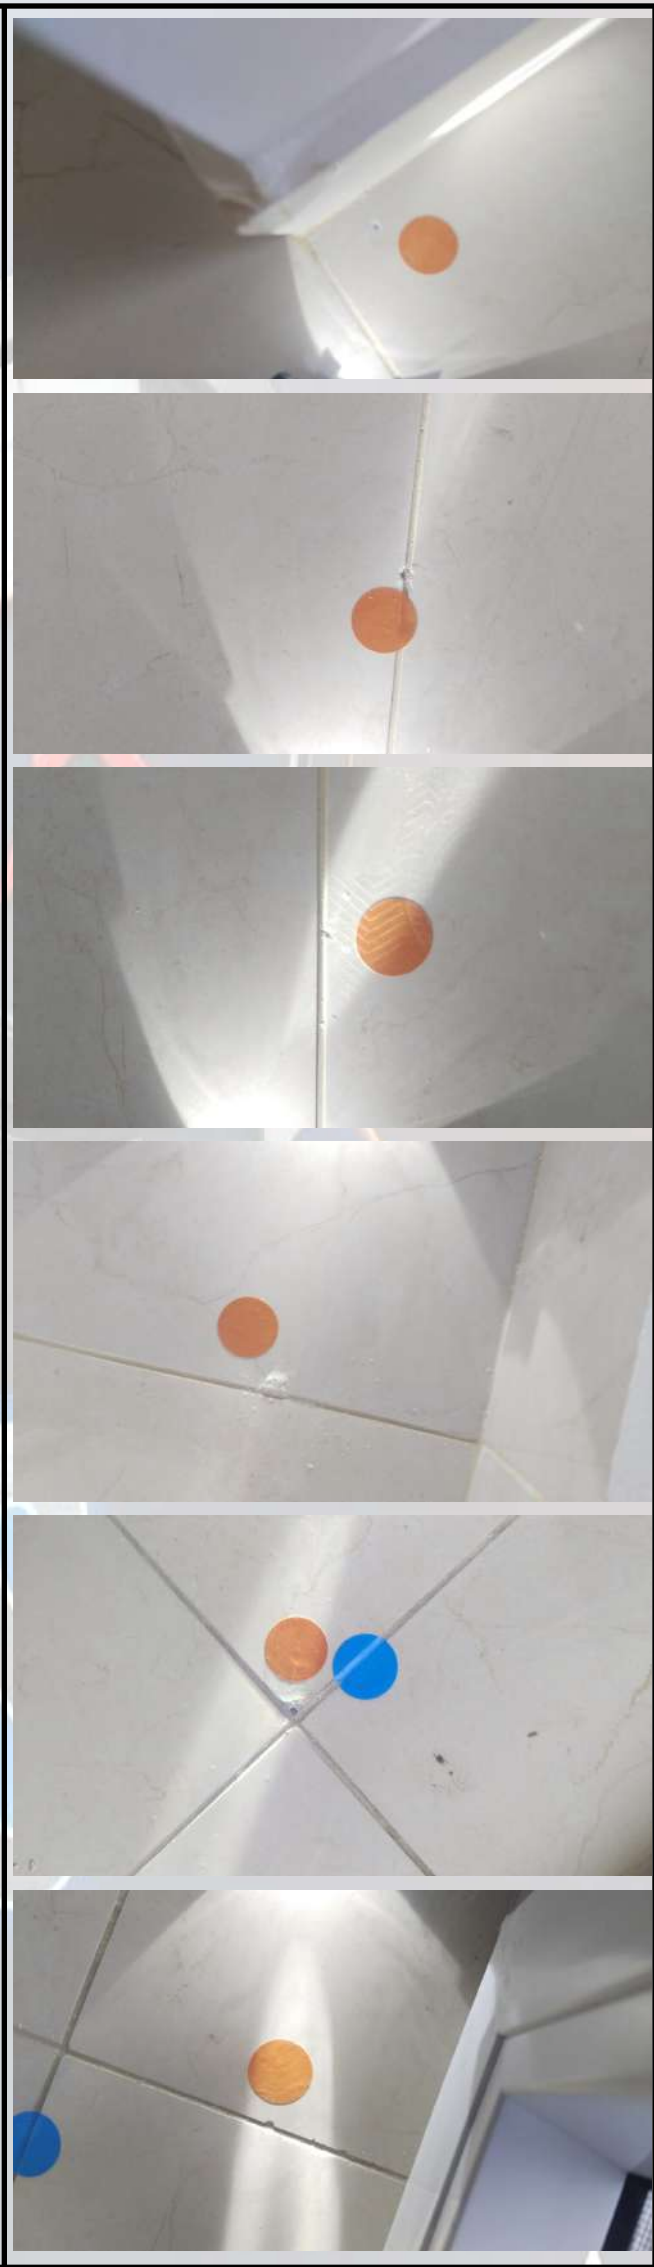
19 floor tiles unevenness found

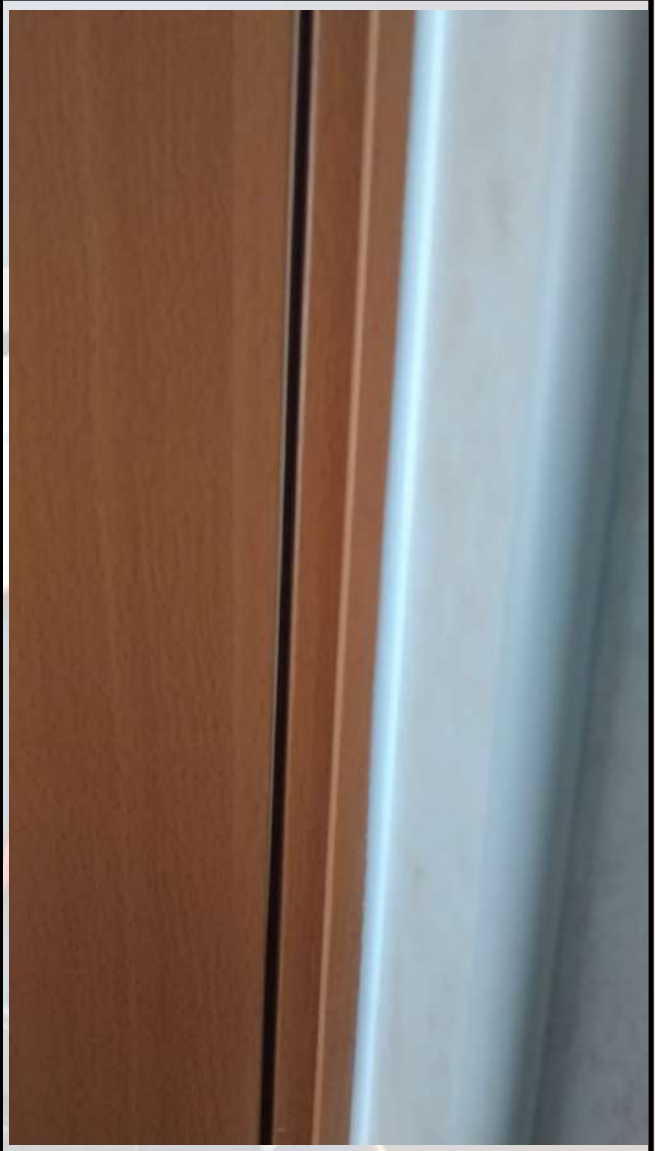
Left side Door frame near lock plate lamination minor damaged
