# MAS Home Care Solutions

## Property Inspection Report

### Advanced Inspection

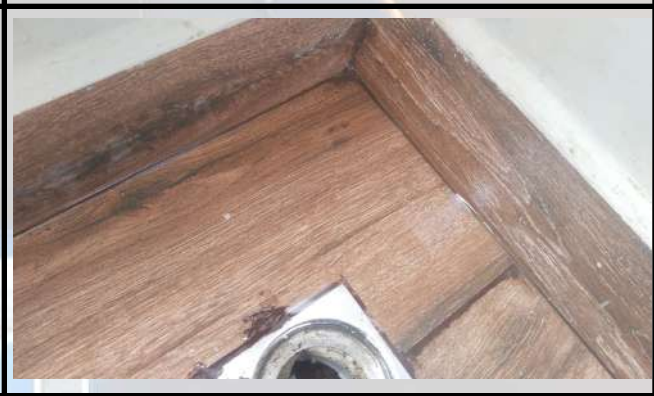
Water accumulates near the drainage pipe left corner .

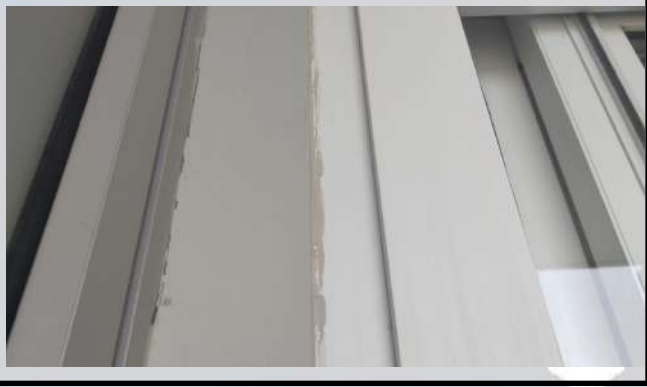
Sliding door frame and switch board packing and cleaning the border area to get proper finishing .

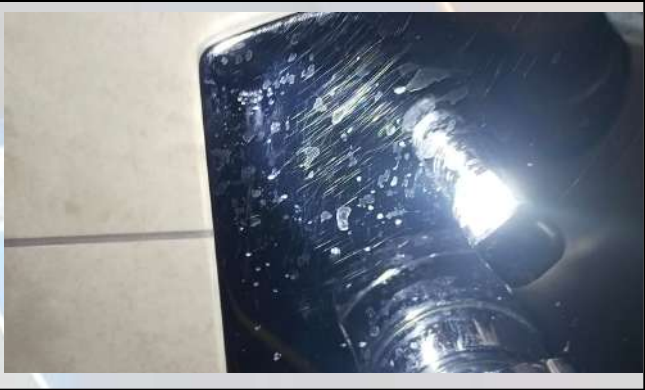
Scratch marks found on wall mixer tap

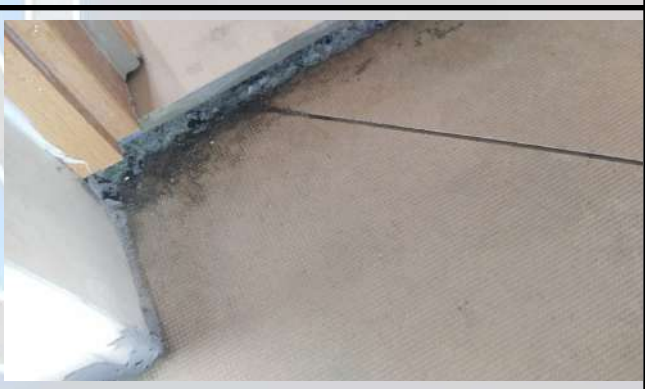
Door entrance tile grouting not done from the  
passage side
