# MAS Home Care Solutions

## Property Inspection Report

### Advanced Inspection

Report ID	ABC
Owner Name	DEF
Property Address	GHI
BHK Type	3 BHK
Date of Inspection	DD-MM-YYYY
Inspection Type	Advanced Inspection
Inspected By	Manoj Kumar

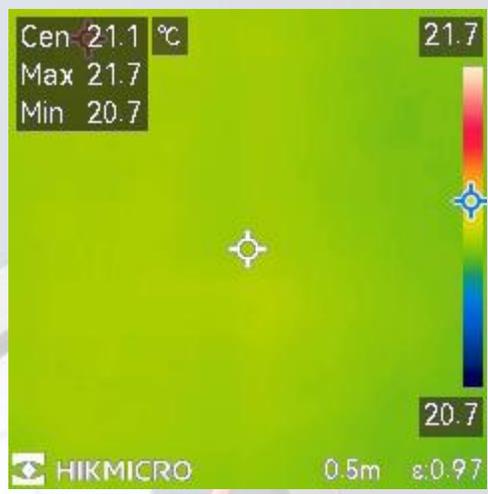
**Dining / Passage area**

No Seepage Observed

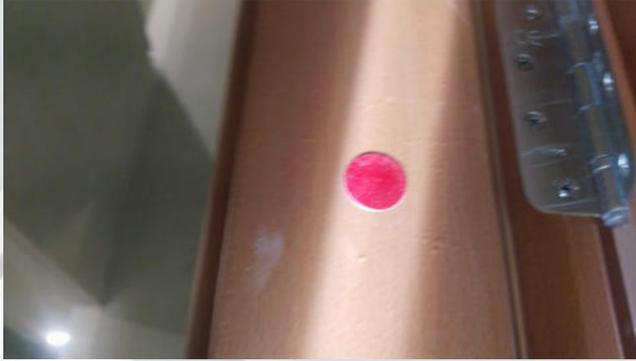
Exterior	Image Reference
<p>Door frame beading got bulged in multiple places .</p>

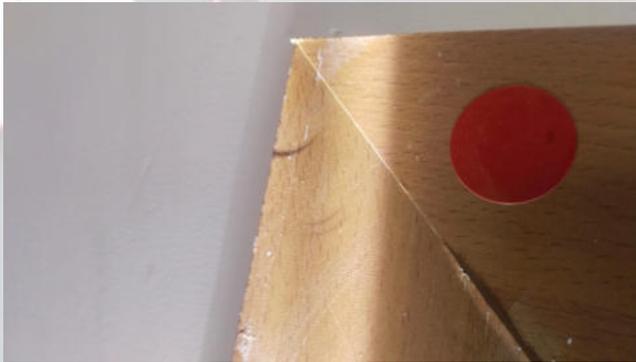
<p>Door frame beading top portion minor dent mark found .</p>

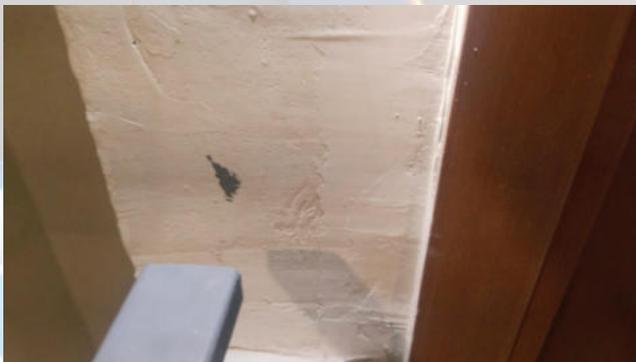
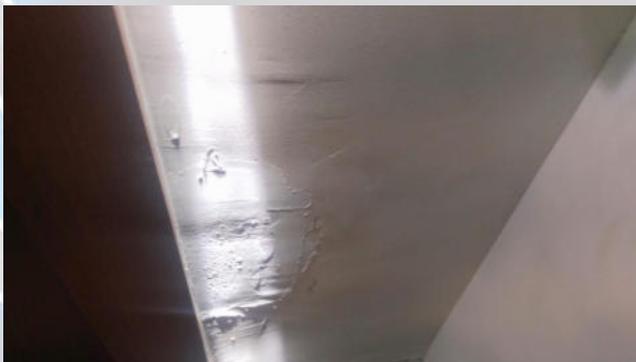
<p>Wall putty finishing is not proper on both sides of the door .</p>

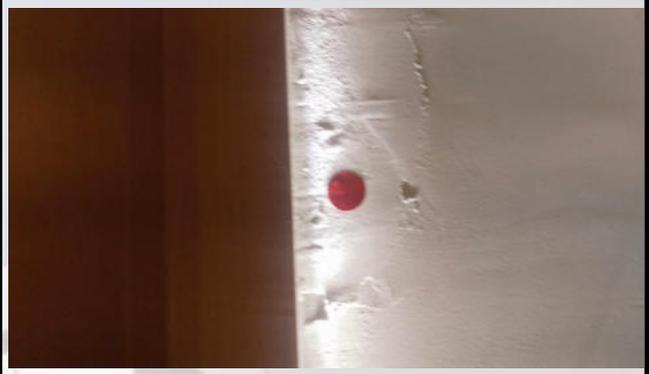
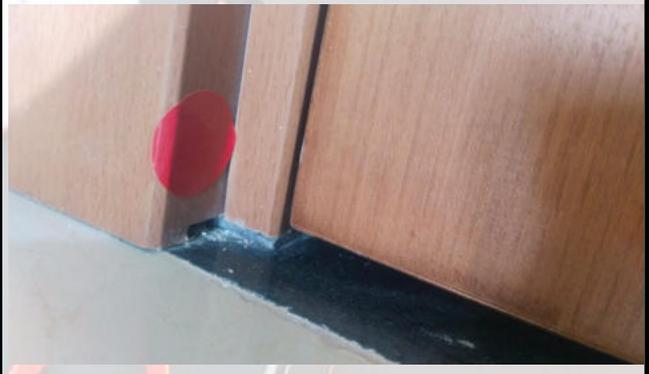
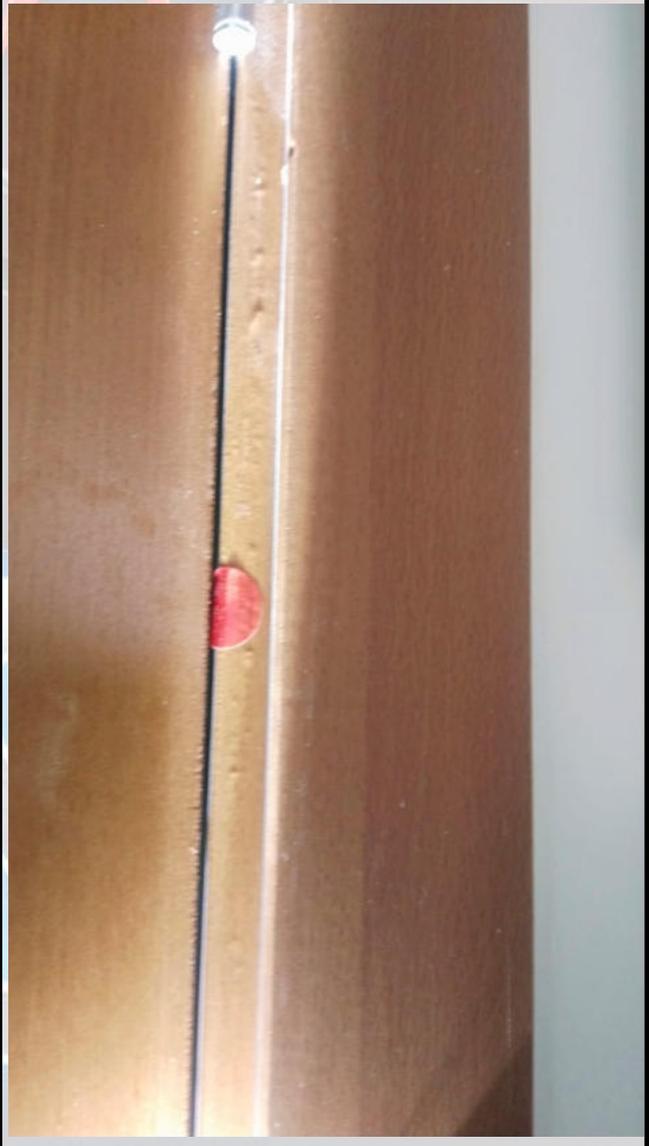
The door is rattling .

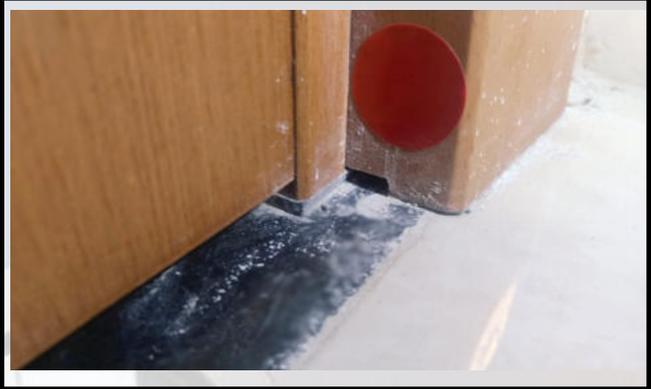
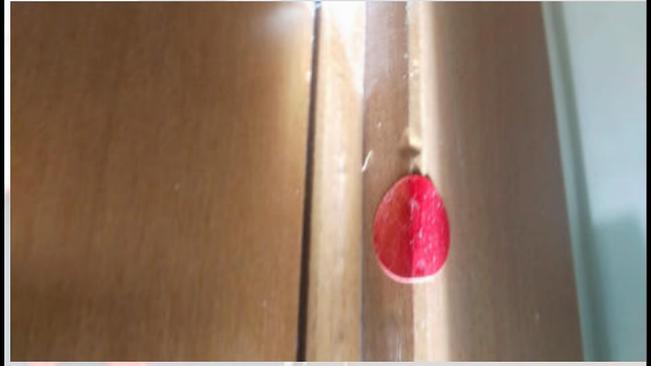
left internal side frame beading and both frame bottom packing required .

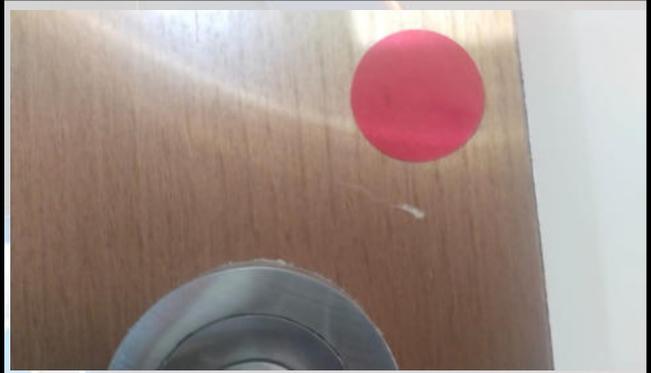
Scratch marks found on door lock

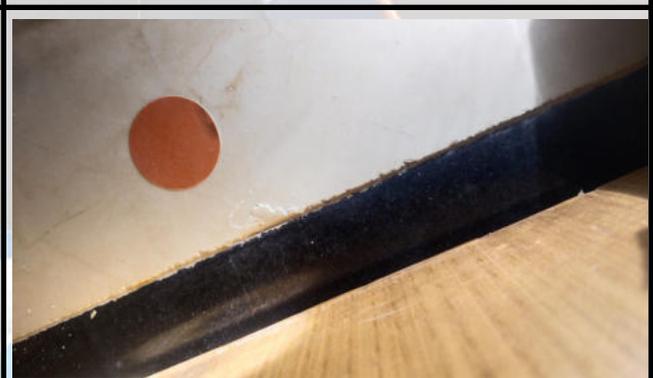
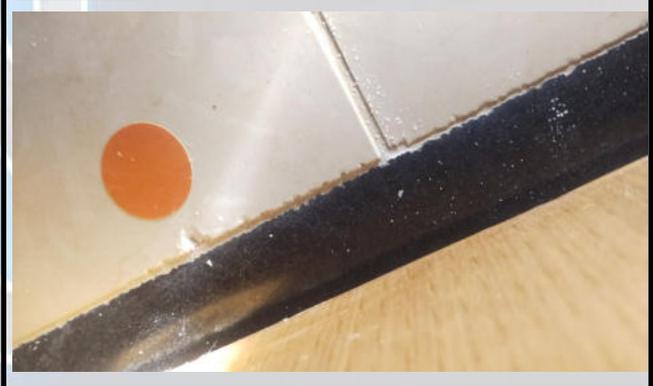
6 floor floor tiles minor chipped off

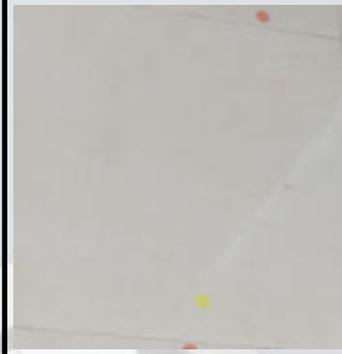
1 floor tile scratch mark found .

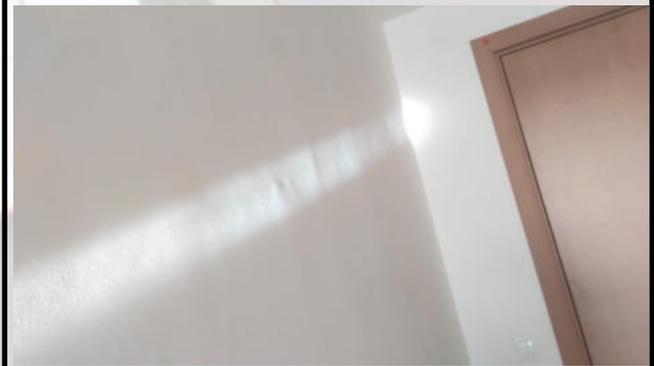
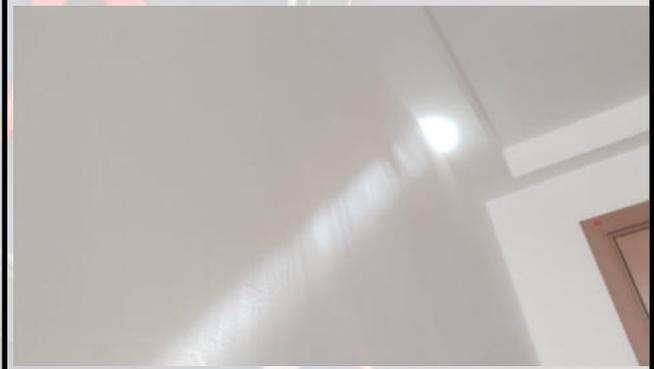
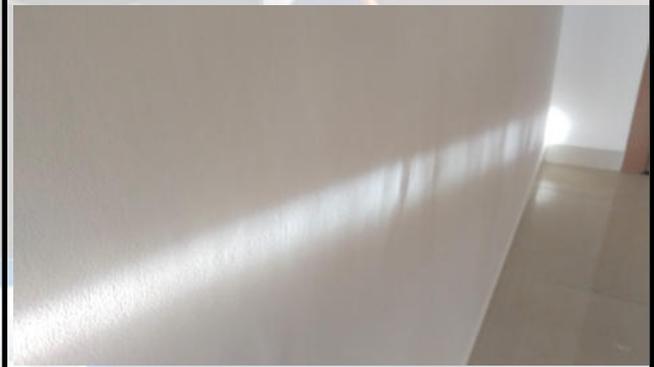
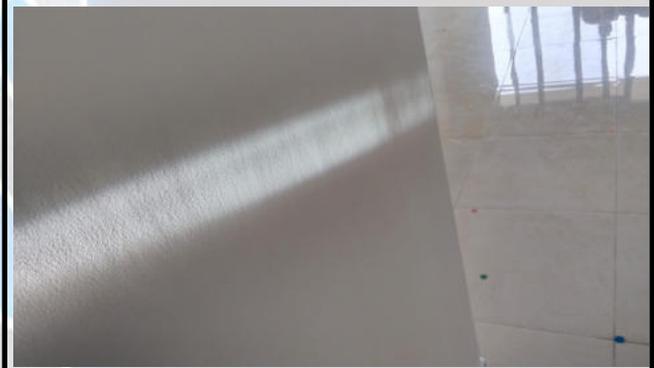
All wall undulations found .

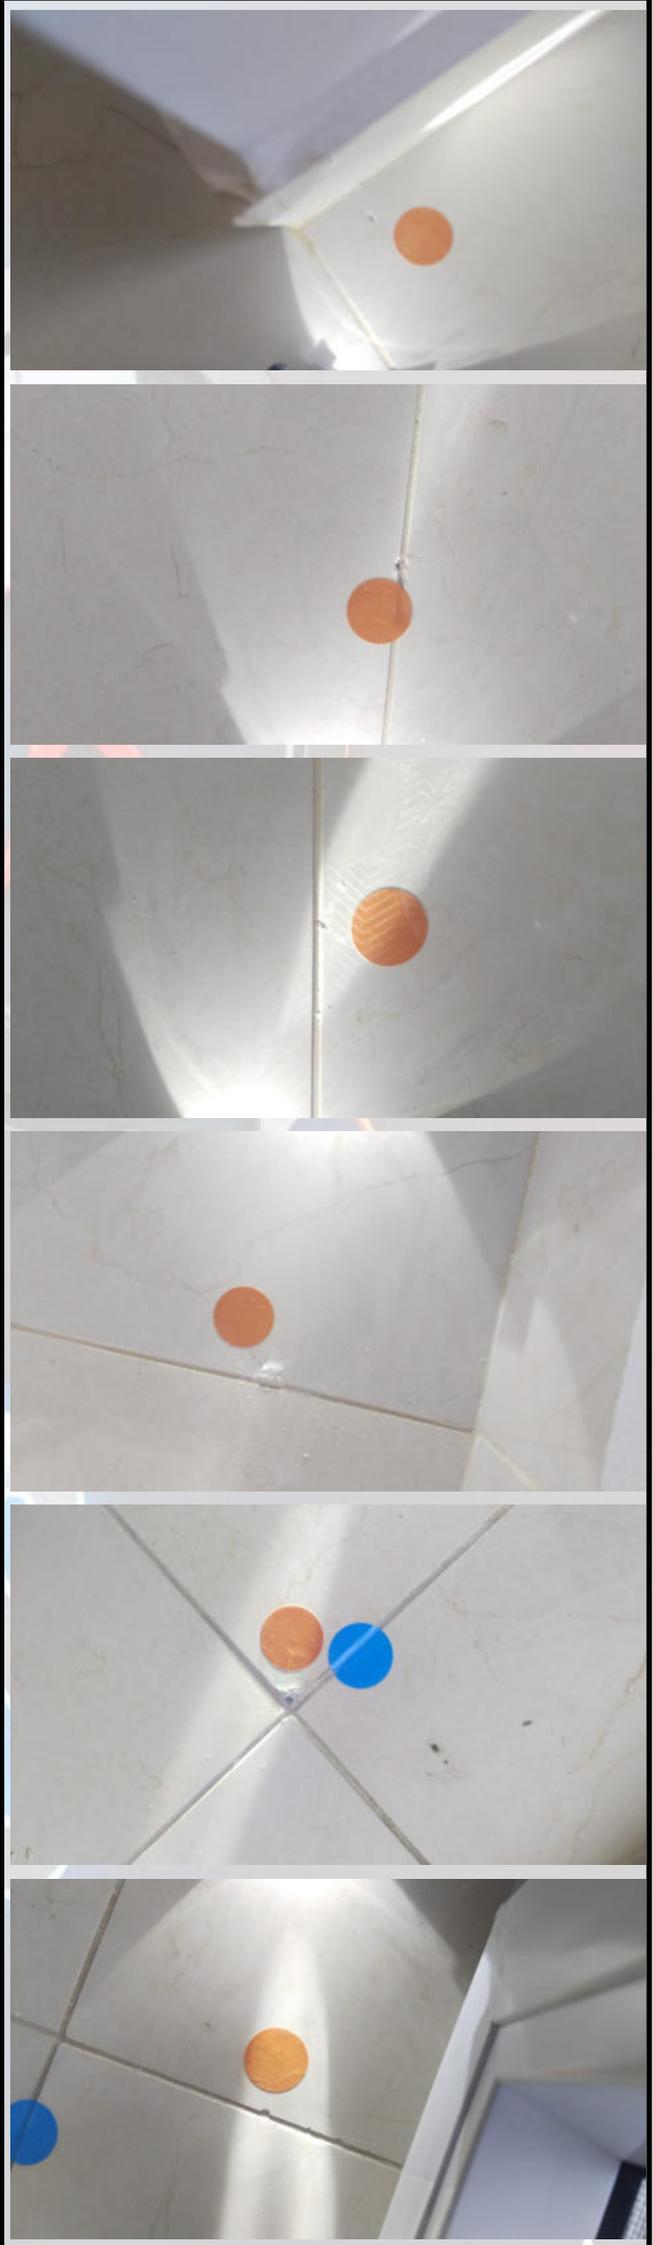
9 floor tiles chipped out.

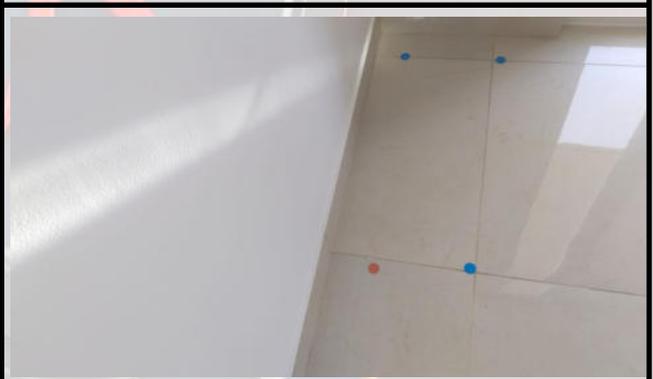
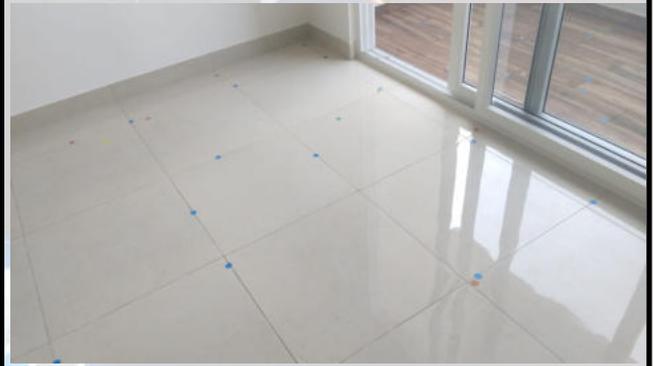
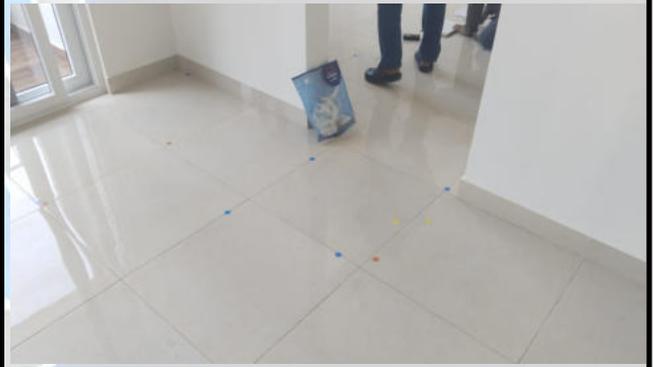
19 floor tiles unevenness found

3 floor tiles scratch marks found

1 floor tile hollowness found

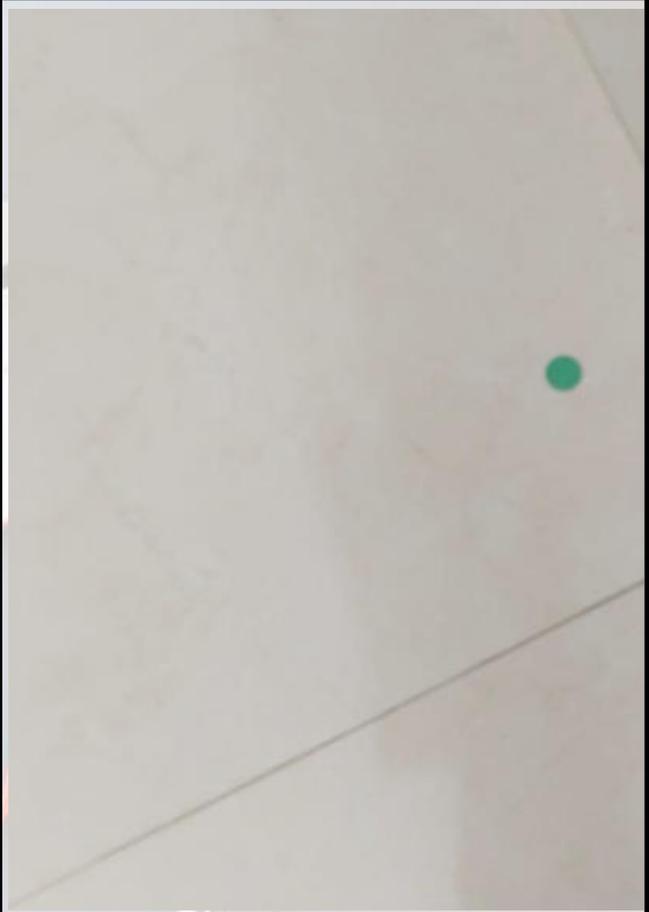
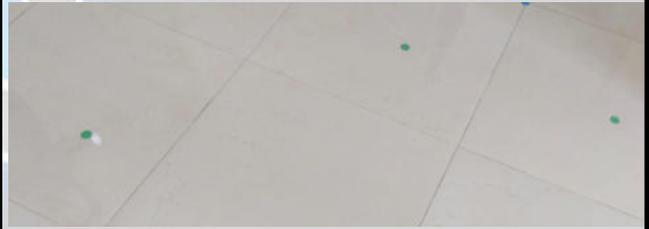
Dining area

8 floor tiles hollowness found

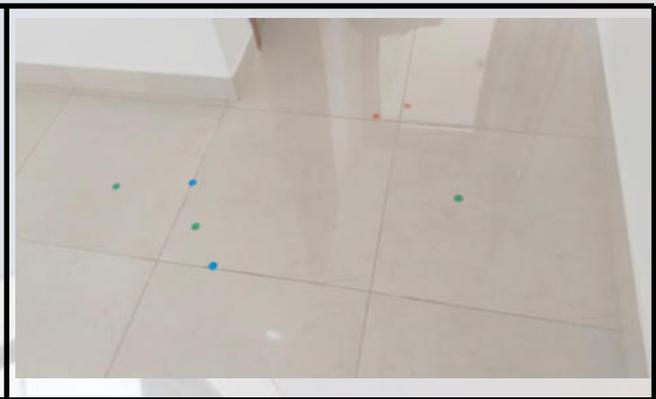
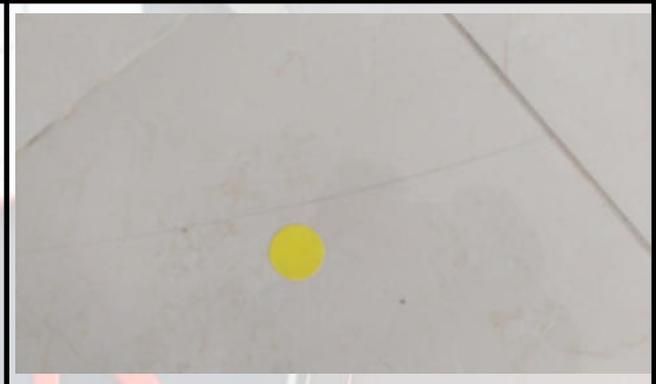
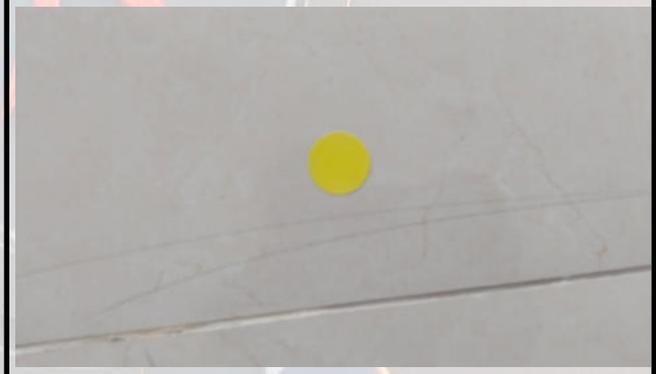
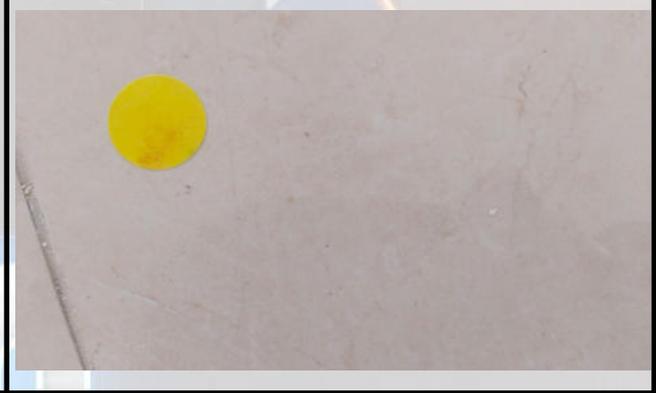
6 floor tiles scratch marks found

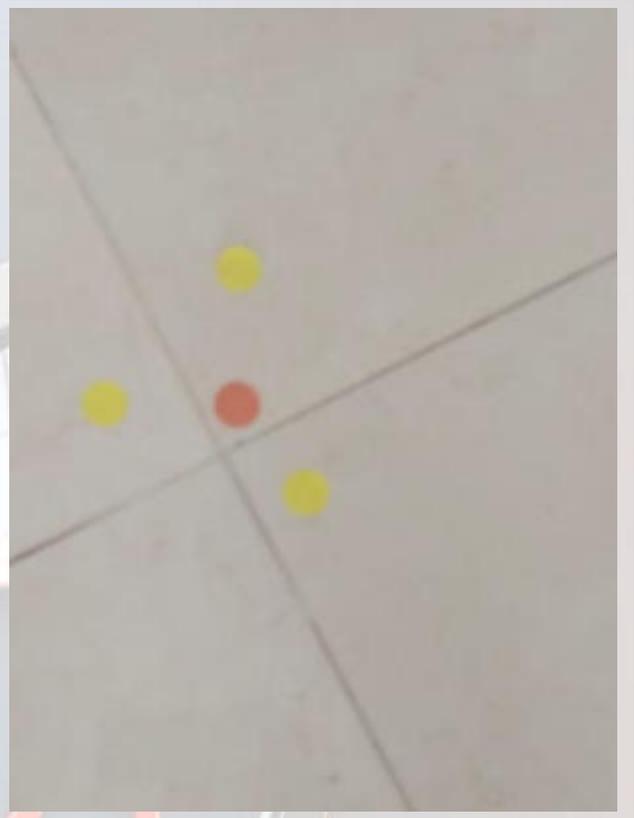
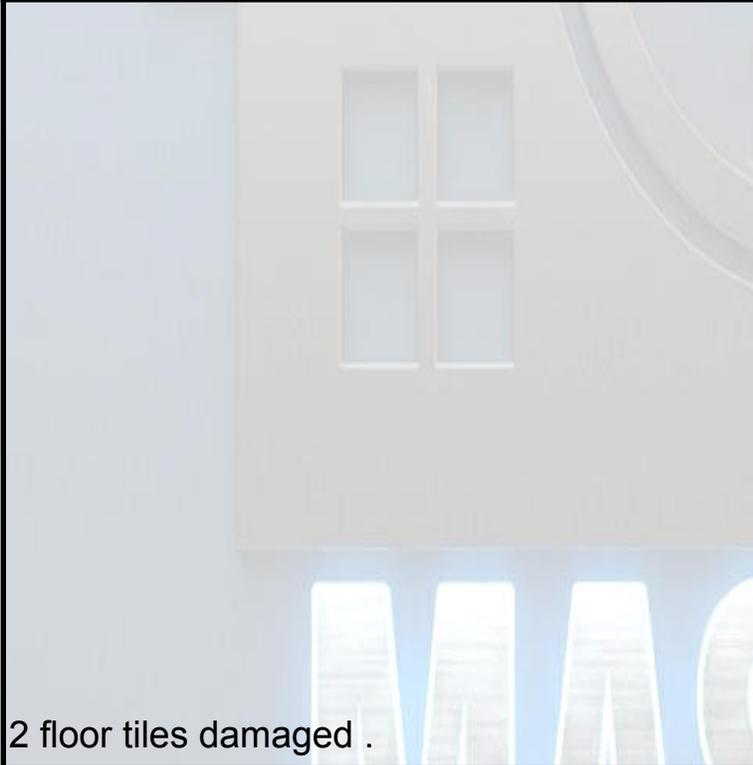
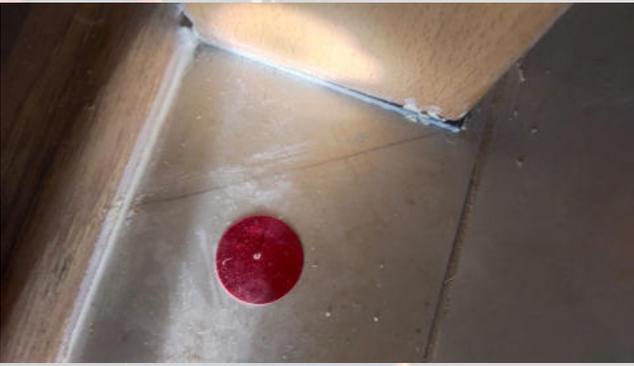
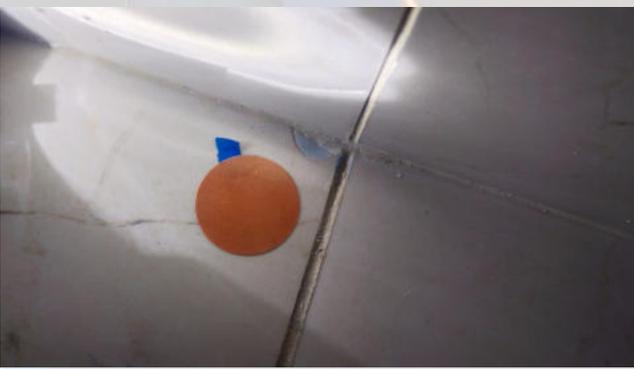
2 floor tiles damaged .

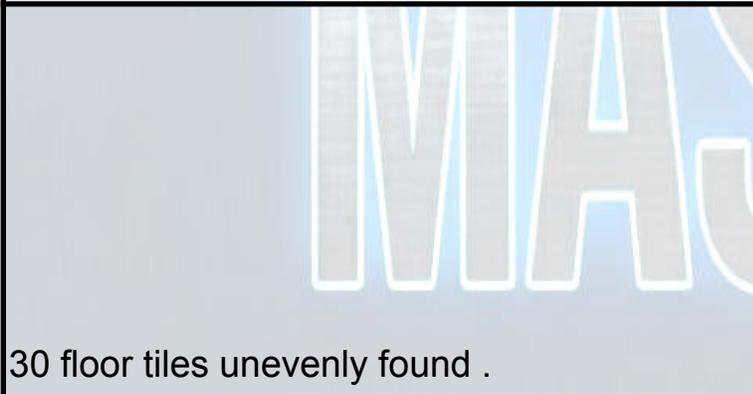
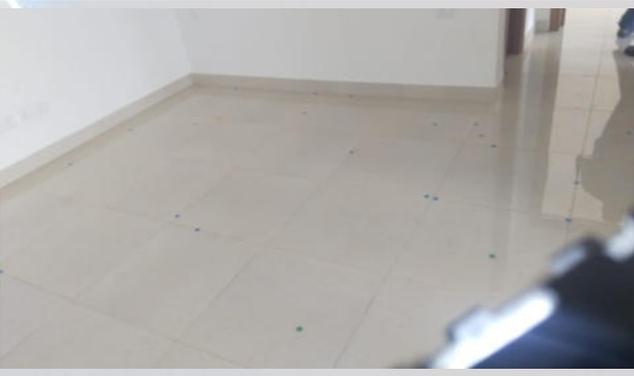
30 floor tiles unevenly found .

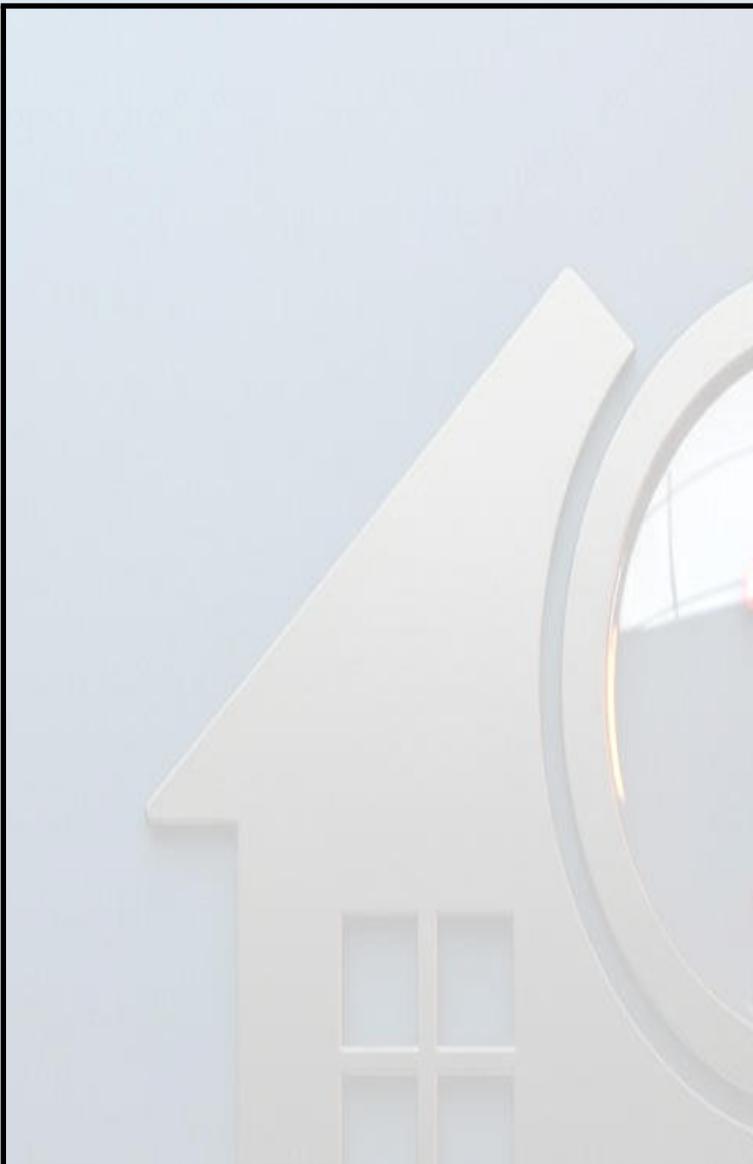
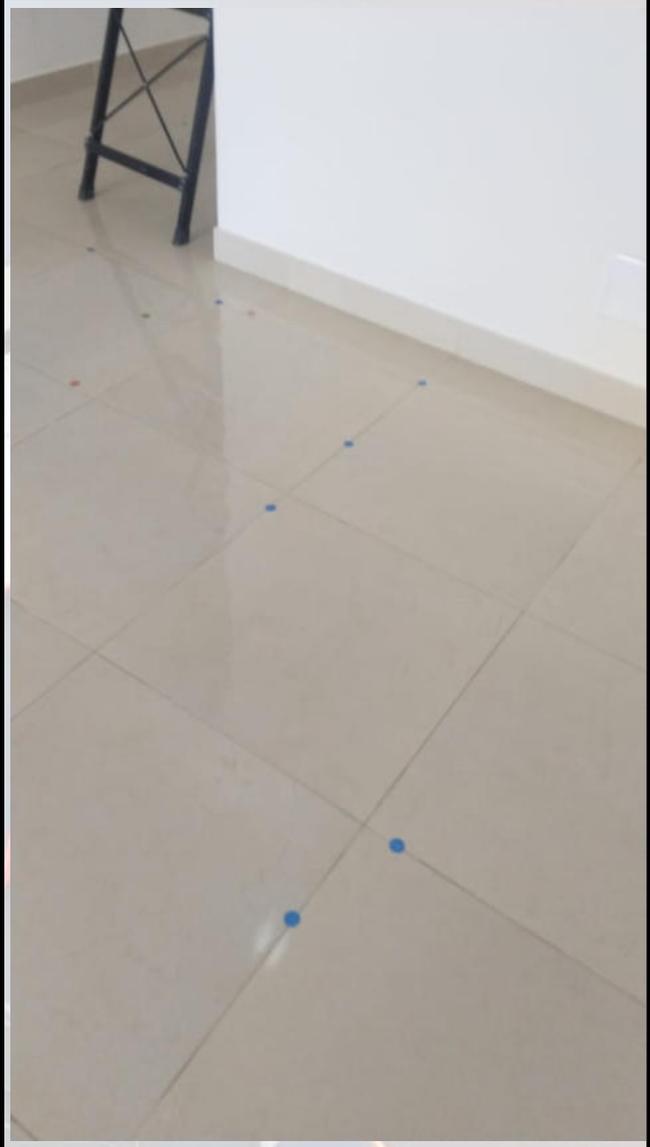
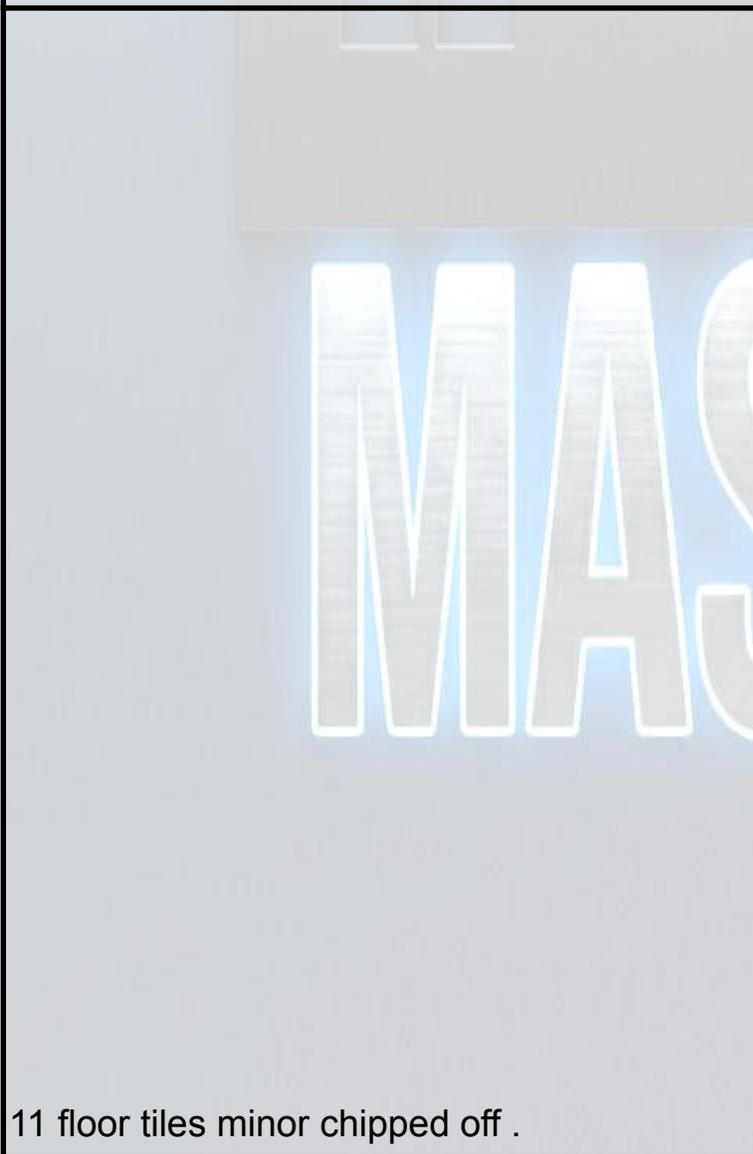
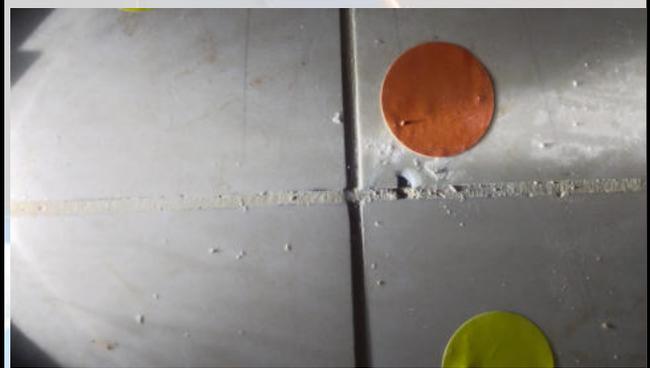
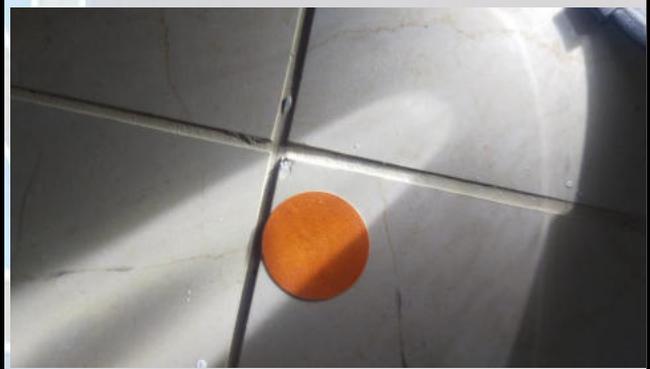
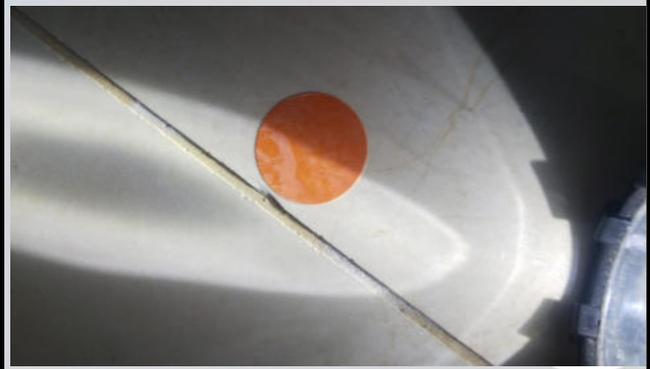
11 floor tiles minor chipped off .

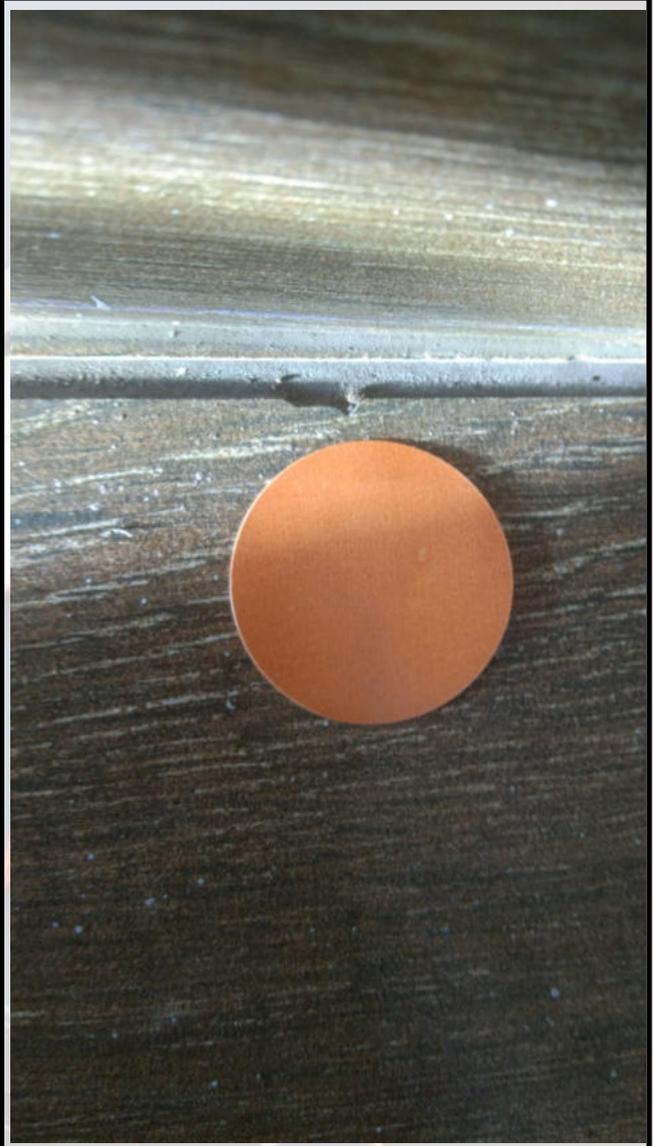
Floor tiles minor chipped off -19

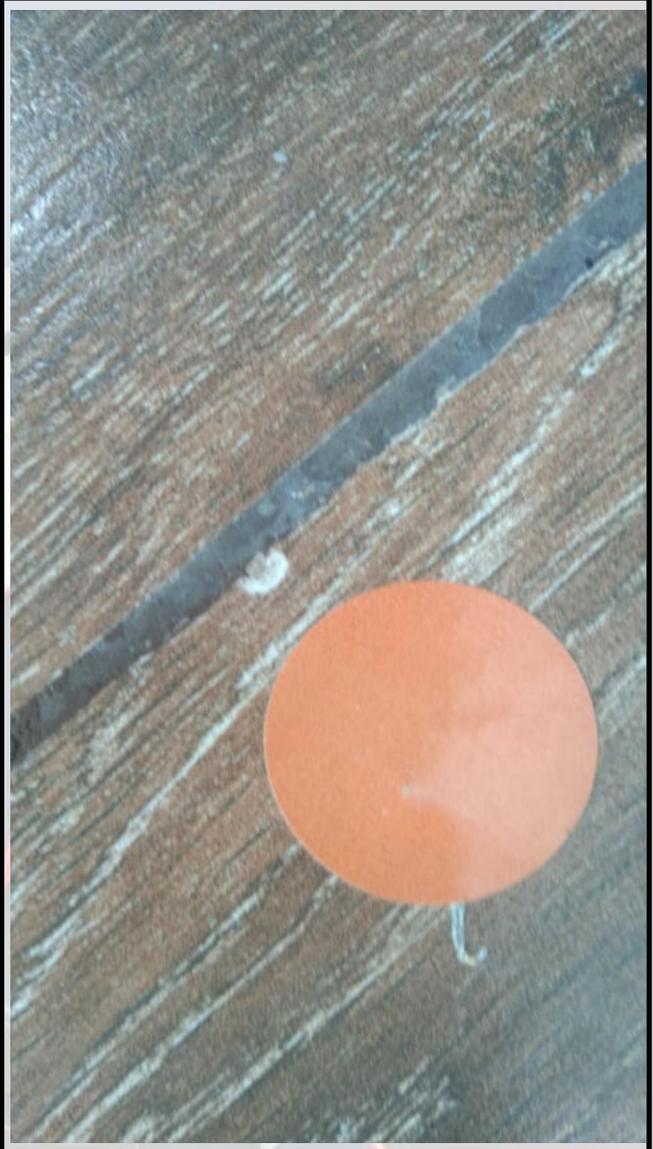
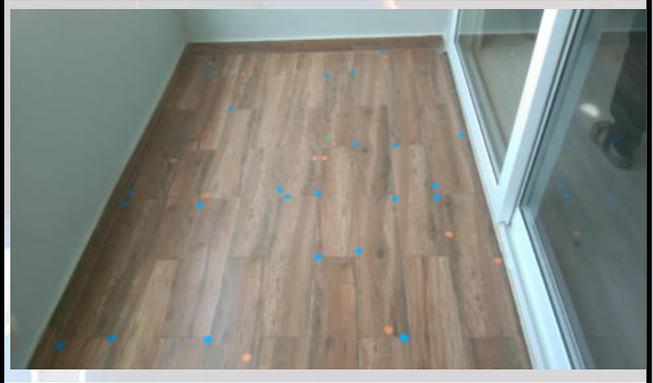
Floor tiles unevenness found - 33.

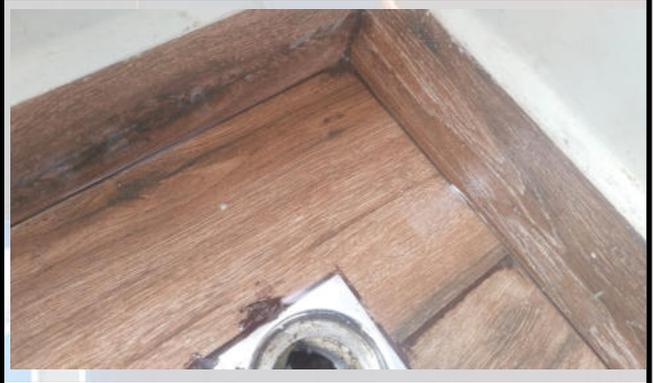
Water accumulates near the drainage pipe left corner .

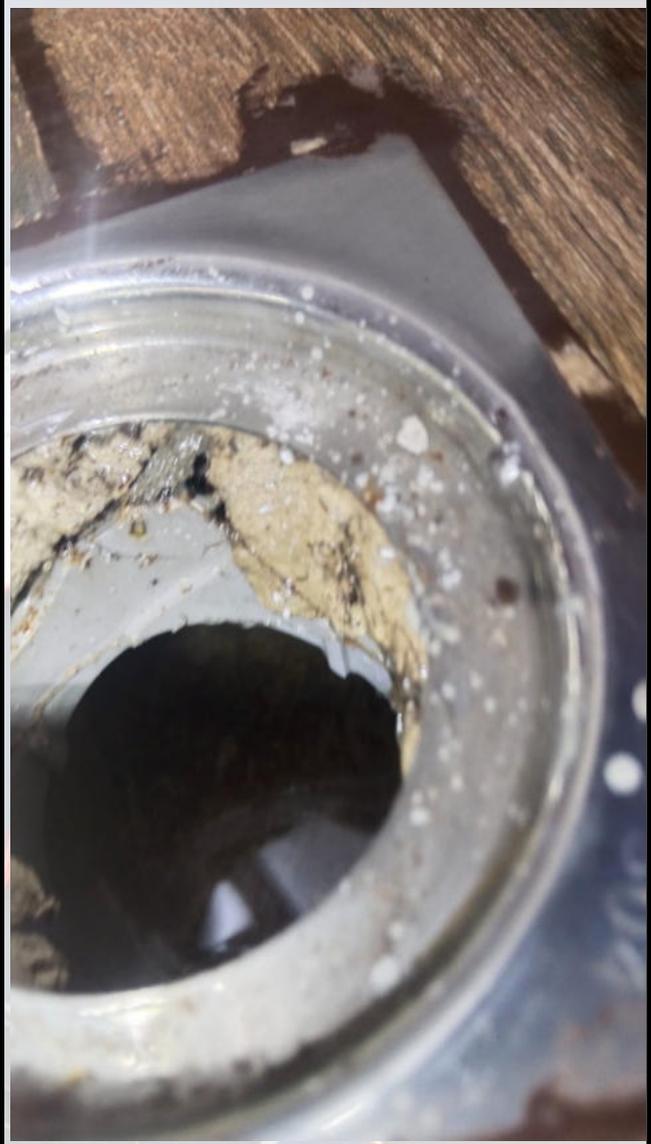
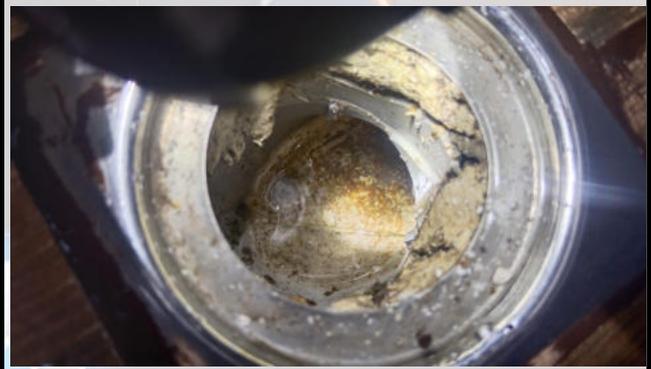
Drainage pipe inside proper packing finishing required as well as cleaning .

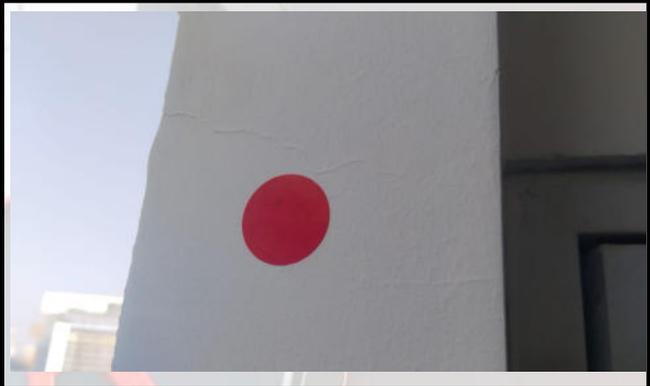
Multiple cracks found on the right side of the wall .

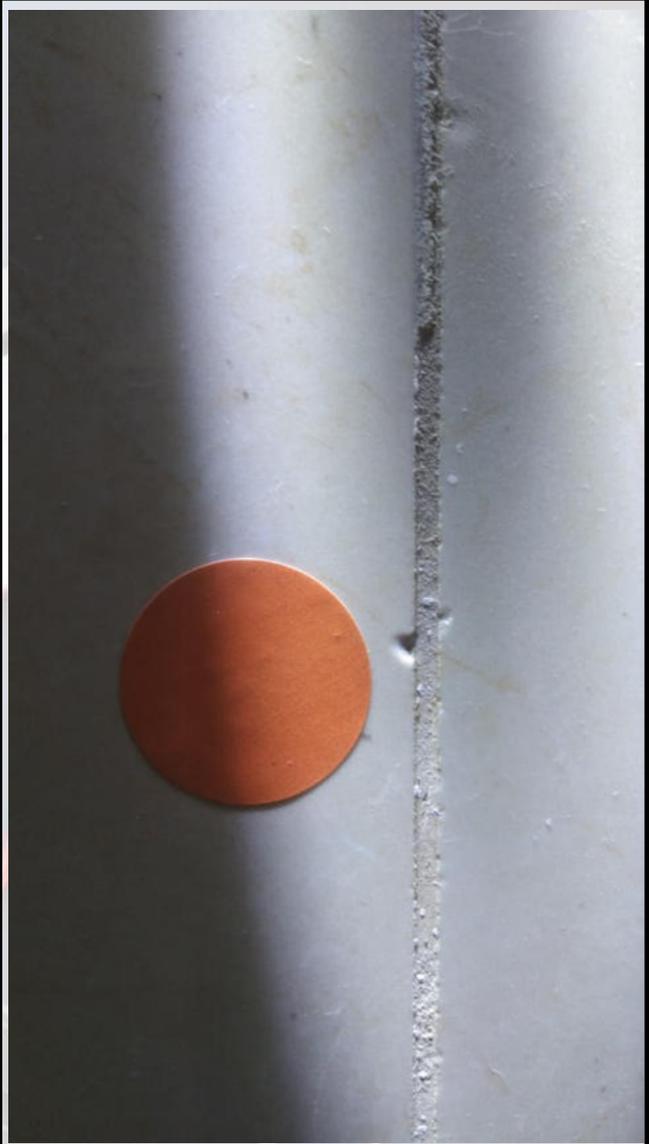
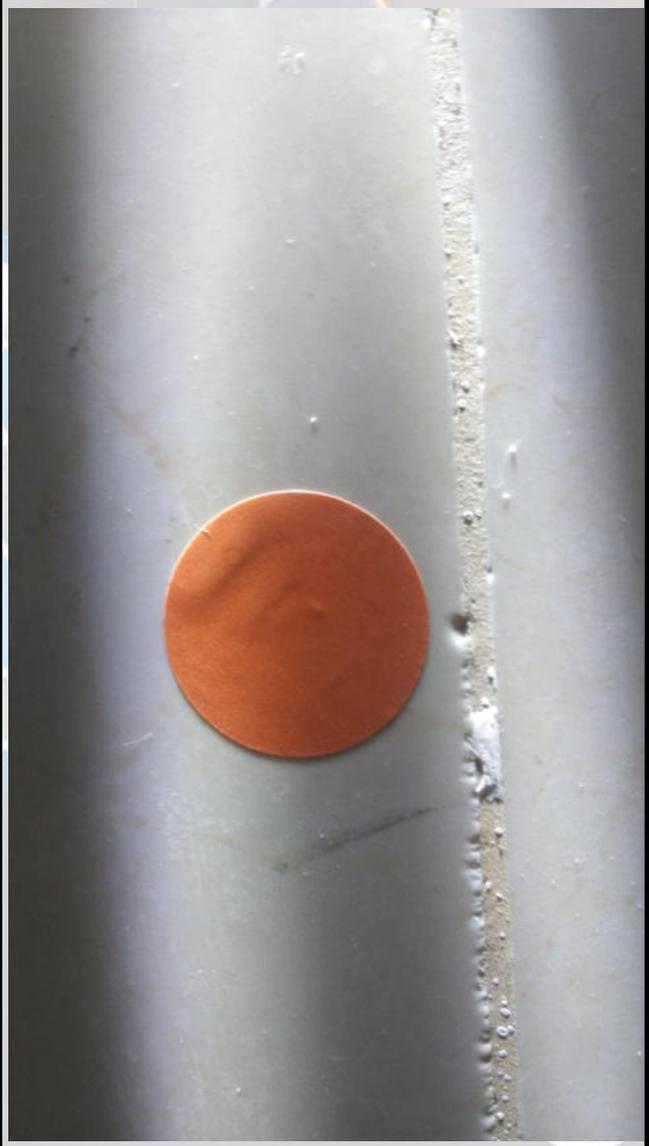
Floor tiles minor chipped off -4

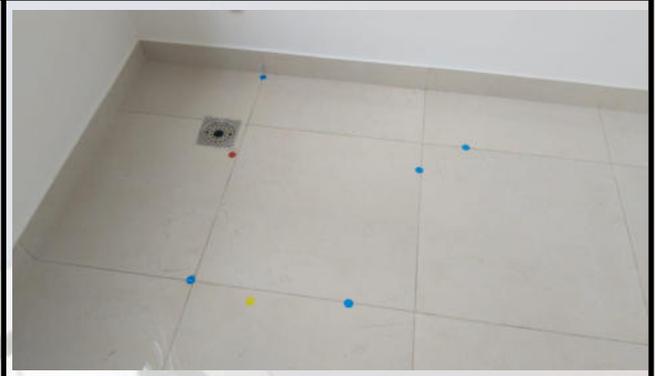
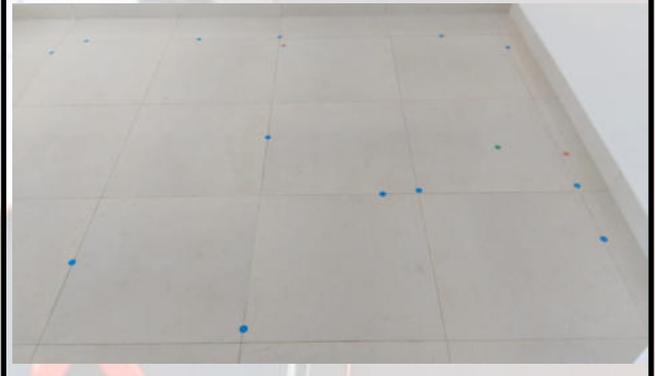
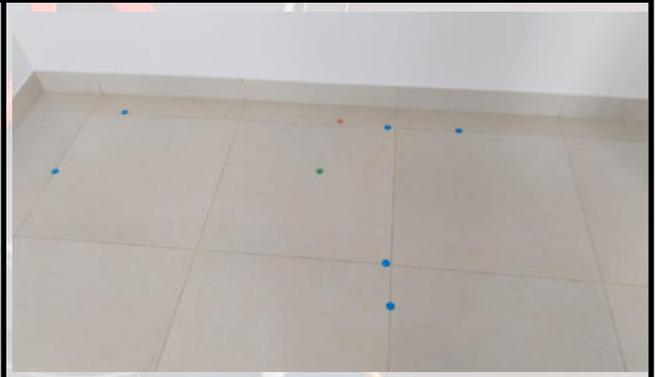
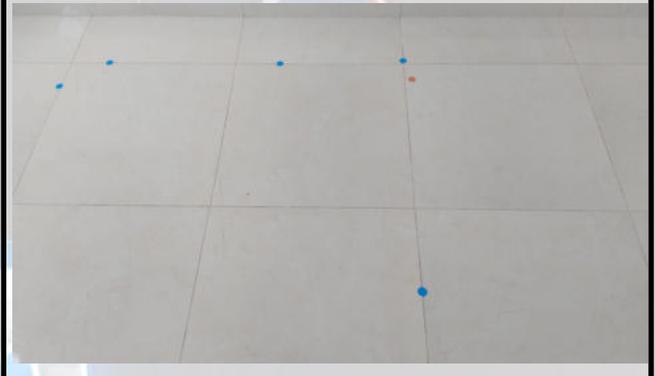
Floor tiles unevenness found - 17

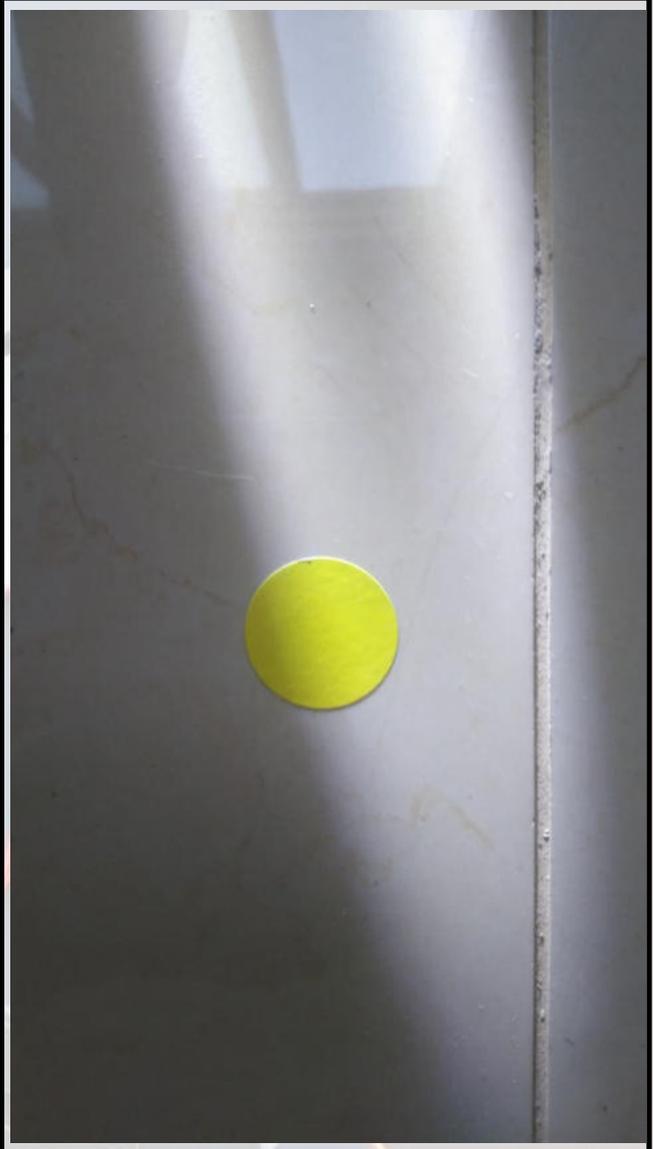
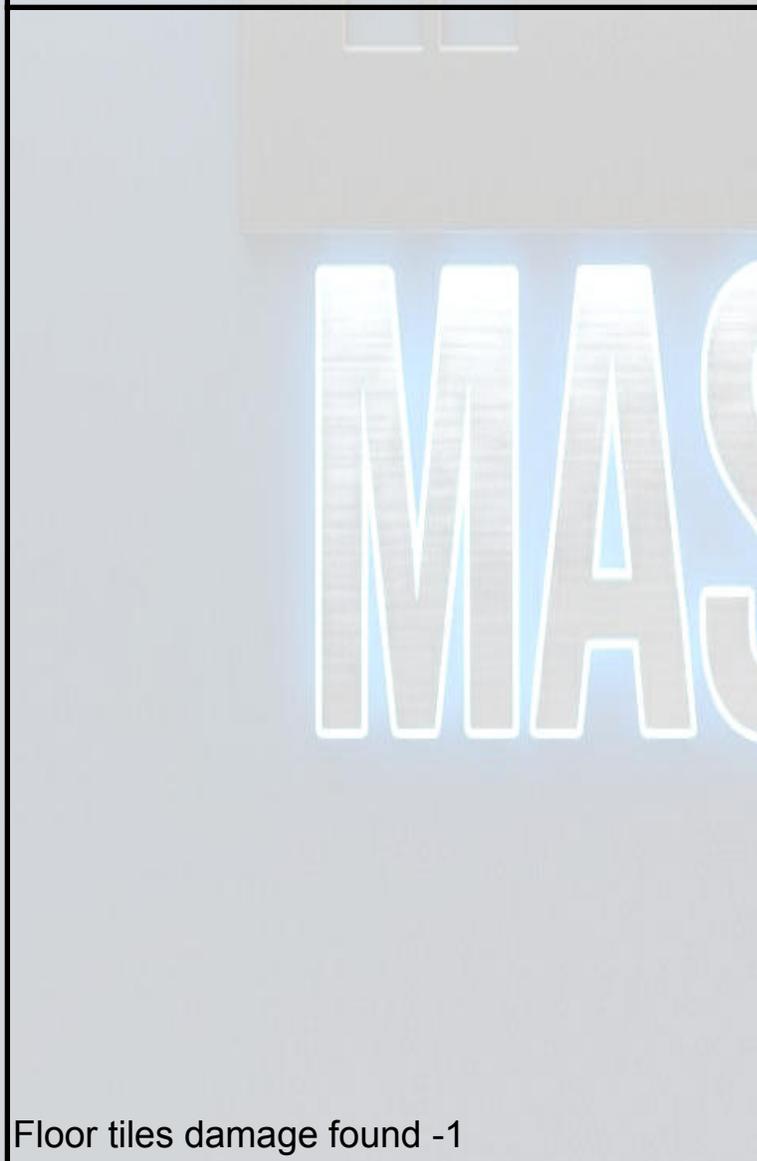
Floor tiles scratch Mark's found -1

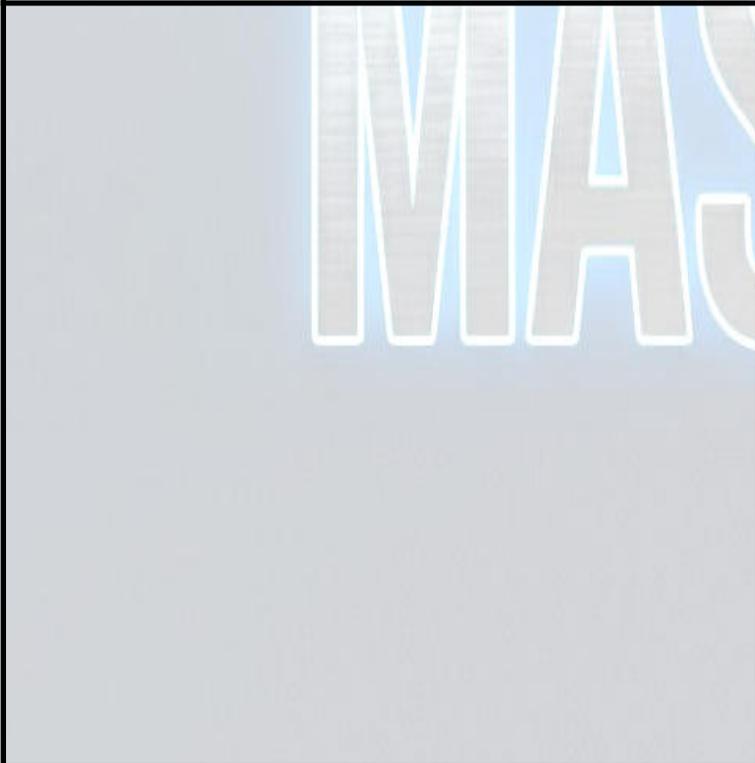
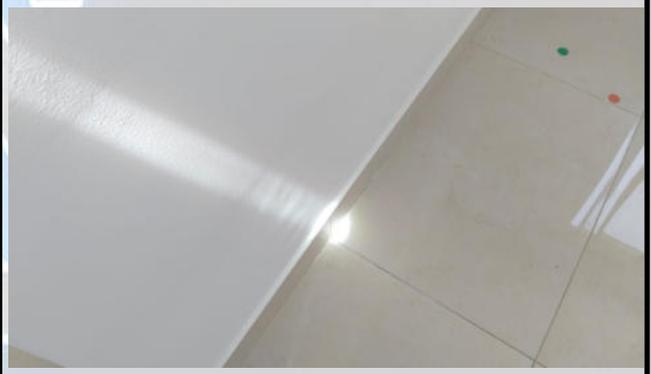
Wall undulations found .

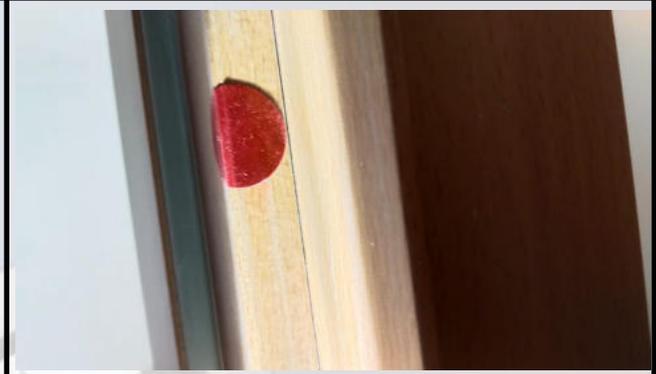
Door frame beading internal side packing required .

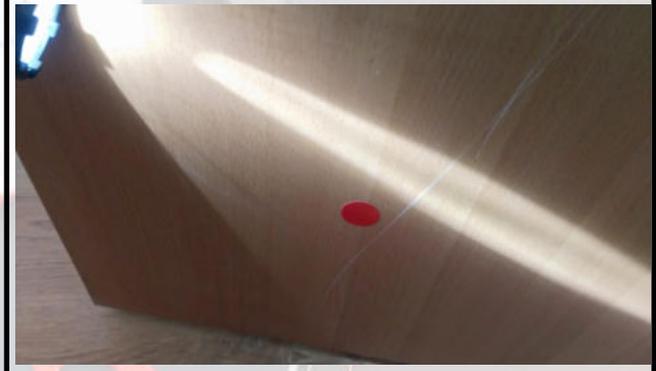
Major scratch mark found on door front bottom side .
