# MAS Home Care Solutions

## Property Inspection Report

### Advanced Inspection

Report ID	ABC
Owner Name	DEF
Property Address	GHI
BHK Type	3 BHK
Date of Inspection	DD-MM-YYYY
Inspection Type	Advanced Inspection
Inspected By	Manoj Kumar

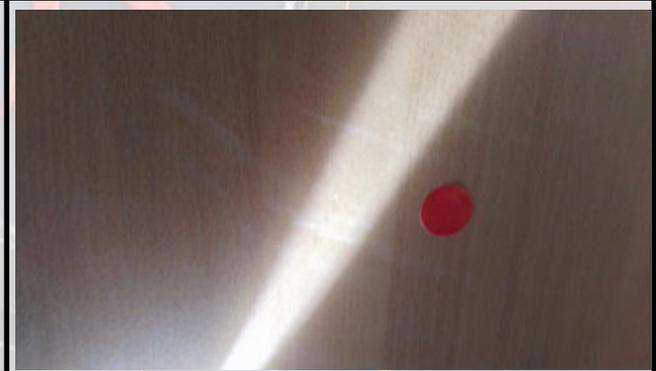
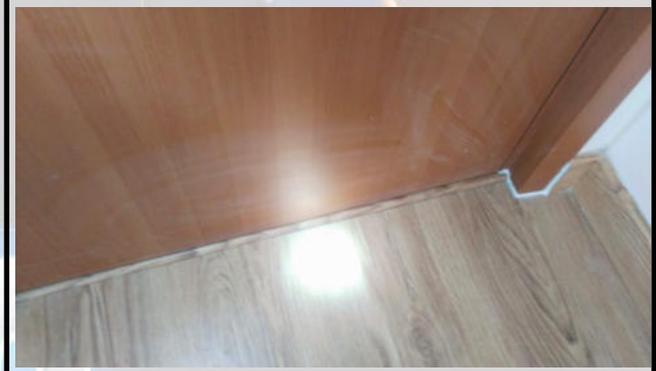
Paint stains makes found on door front and back portion

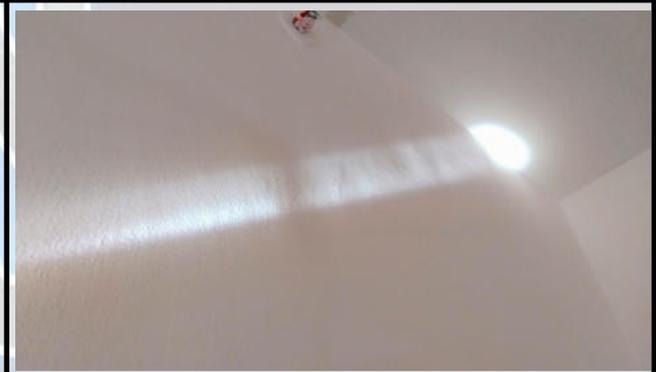
Wall undulations found

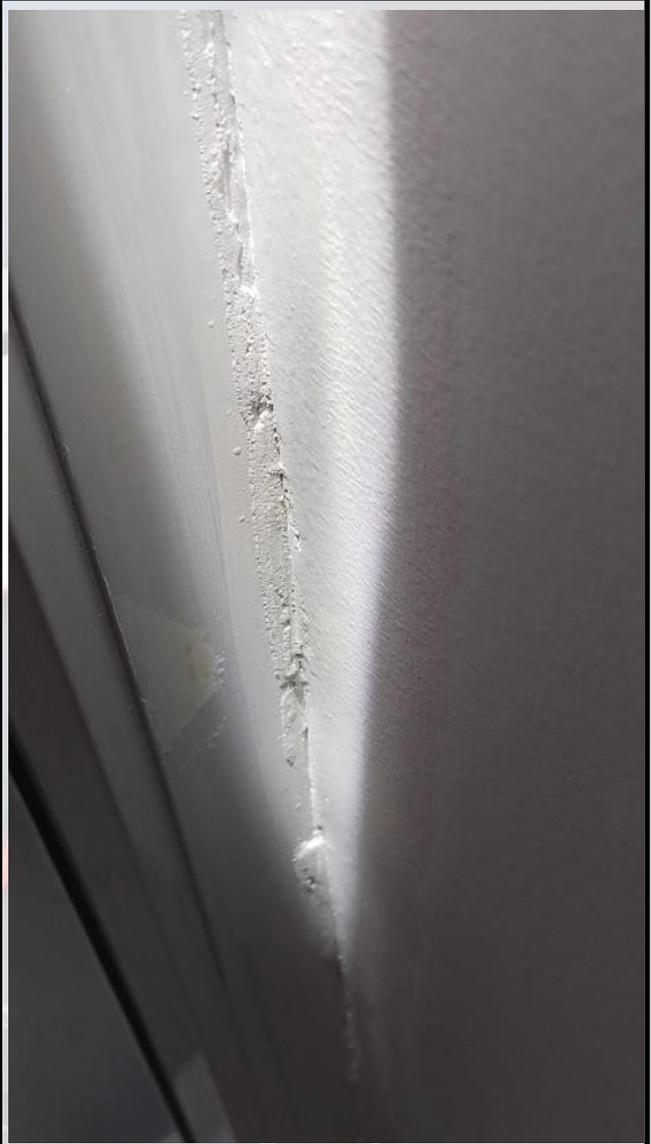
Window frame packing finishing not proper ,proper finishing required .

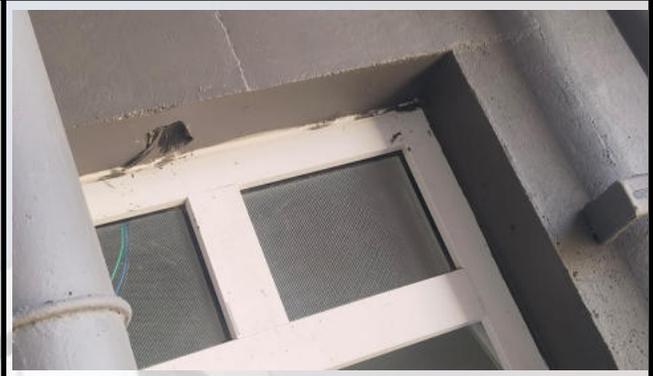
Bathroom exhaust fan connection junction cover not provided .

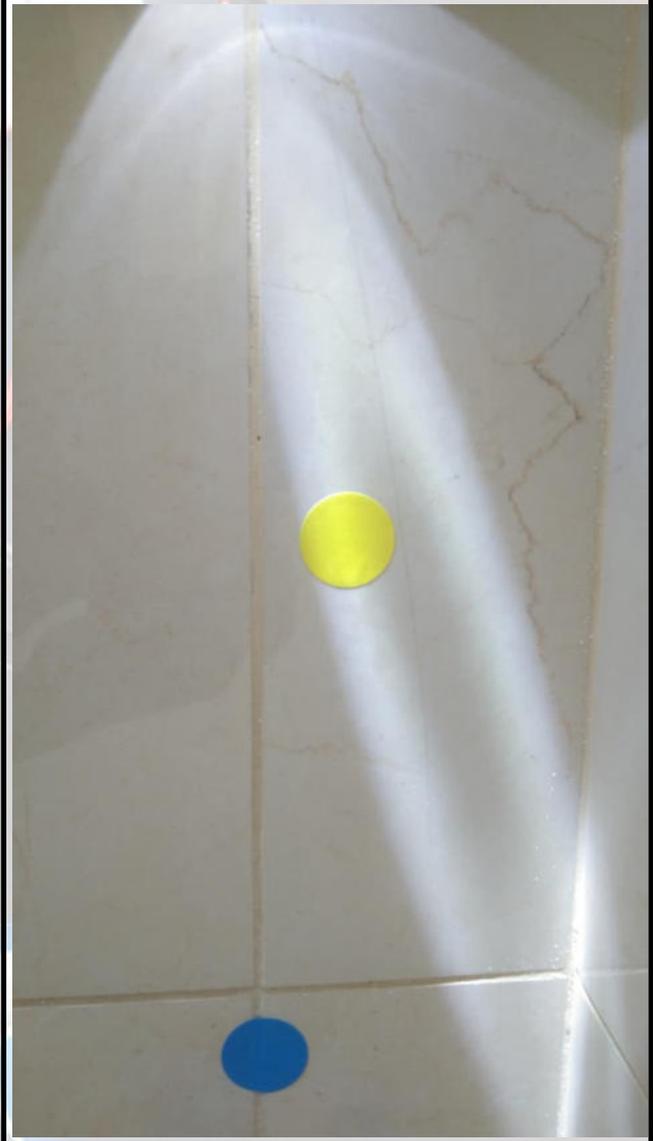
Floor tiles scratch Mark's -2

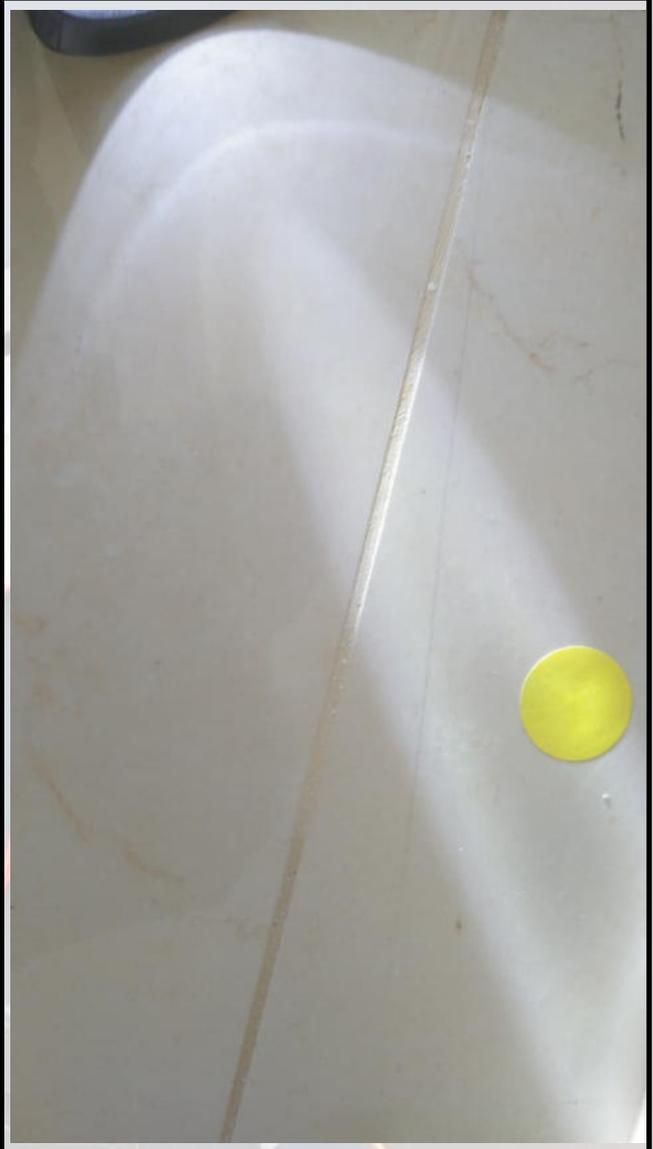
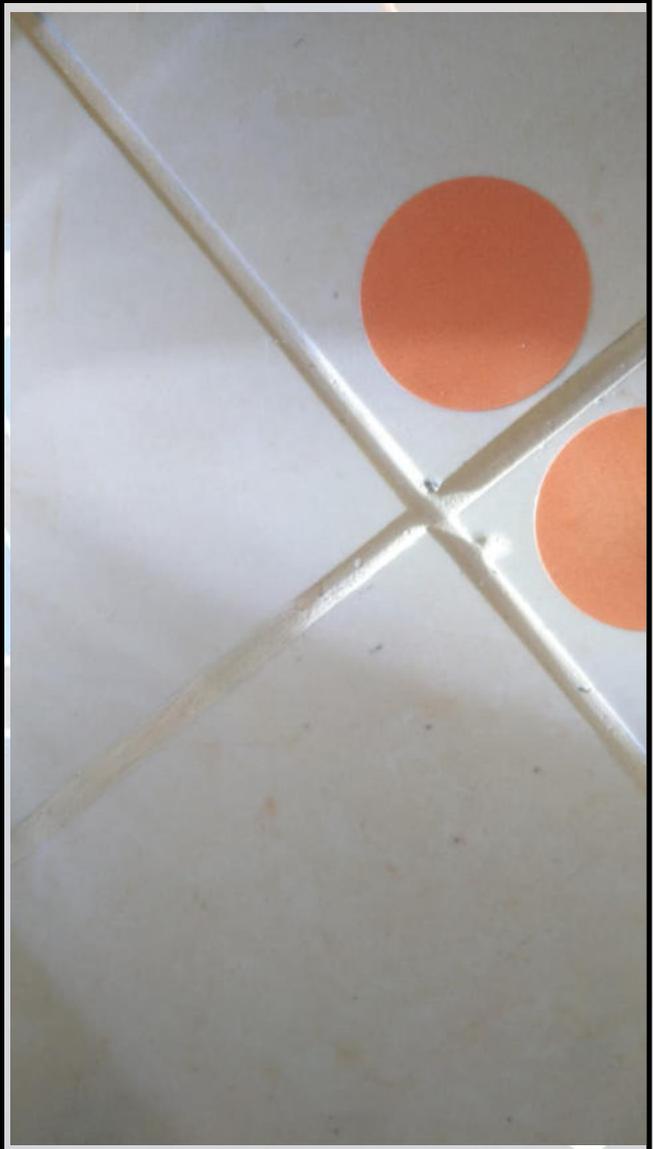
Floor tiles minor chipped off -9

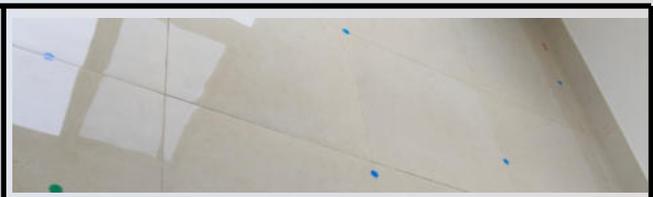
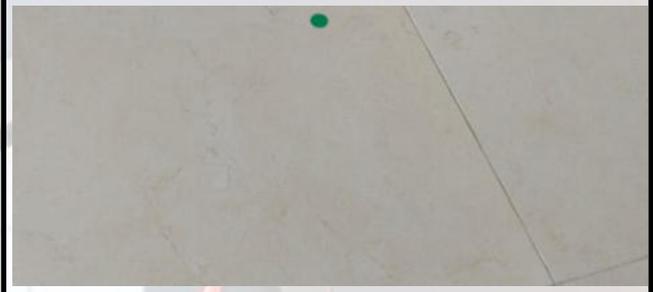
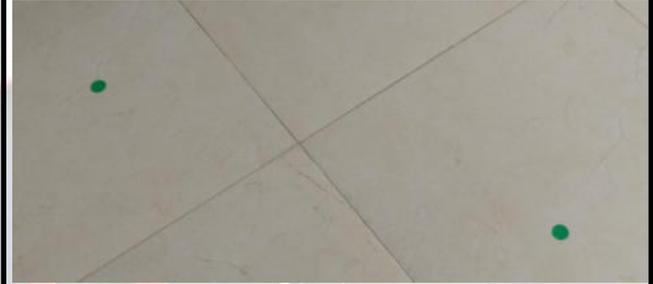
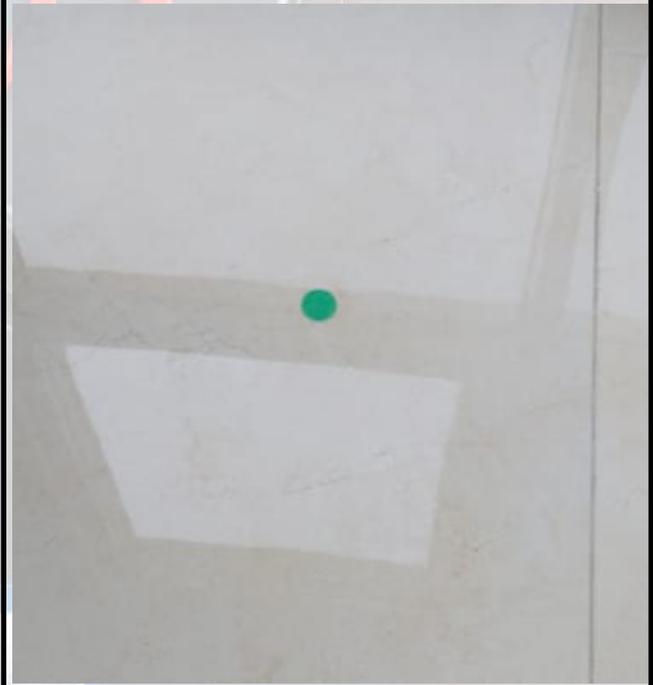
Floor tiles hollow found -7

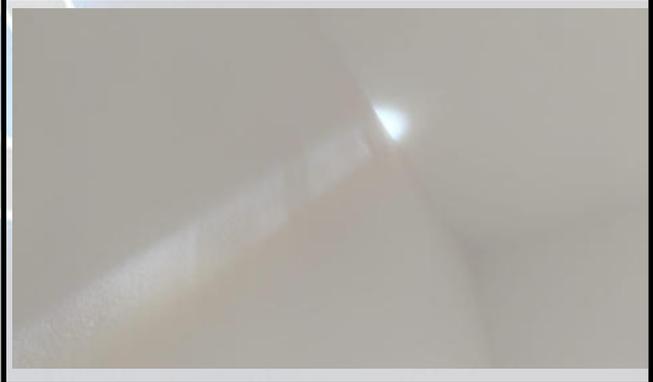
Wall undulation found

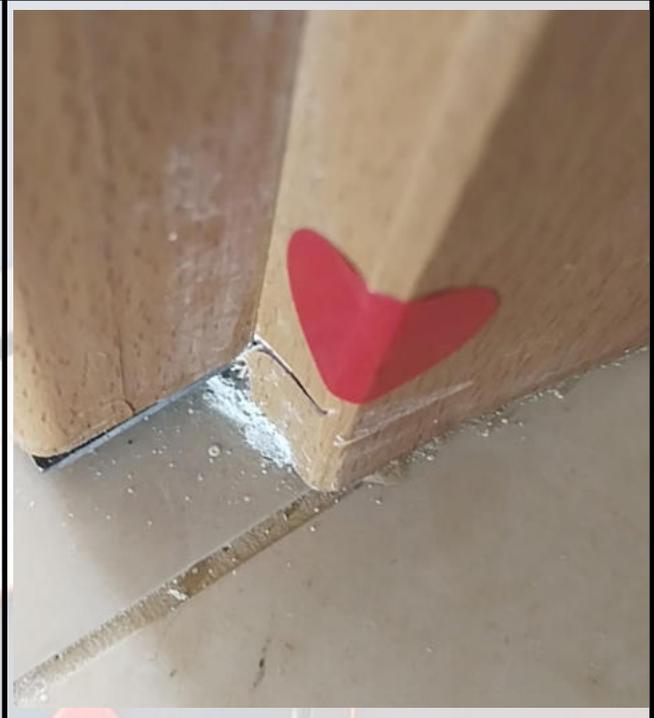
Right side door frame beading lamination  
bottom side minor damage .

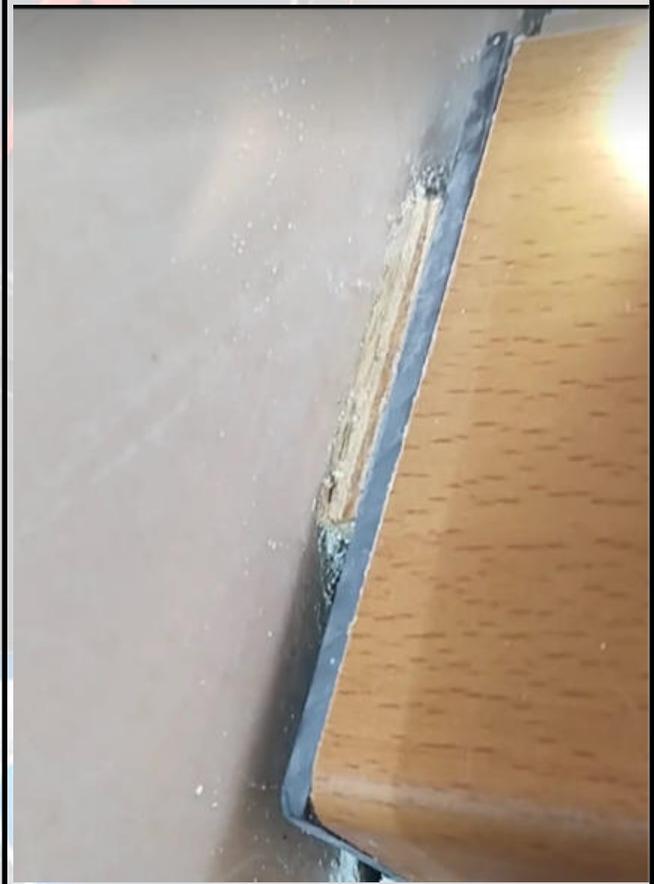
Door Frame bottom packing required

The door is rattling .

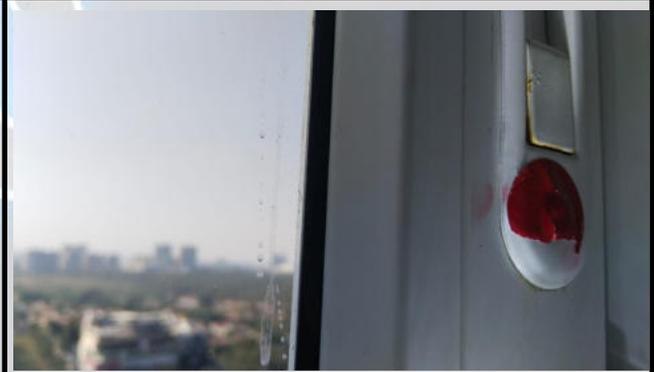
The right side window lock started getting  
rusty .

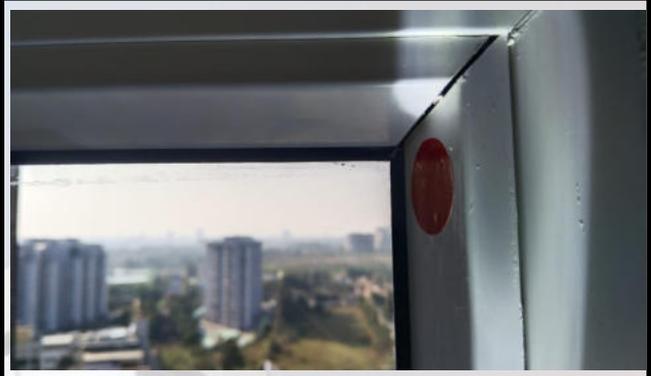
Right side Glass frame centre portion finishing not proper , gap visible .

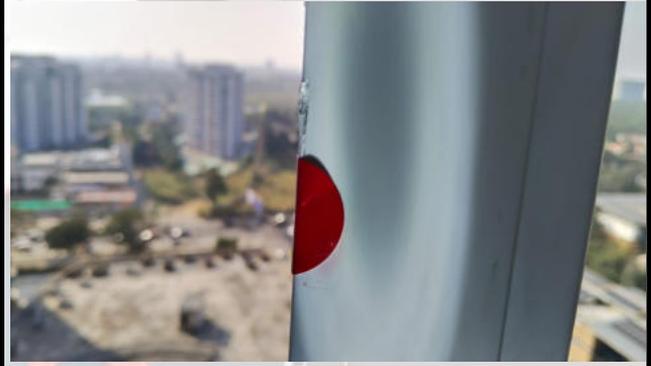
Left side glass frame minor chipped off .

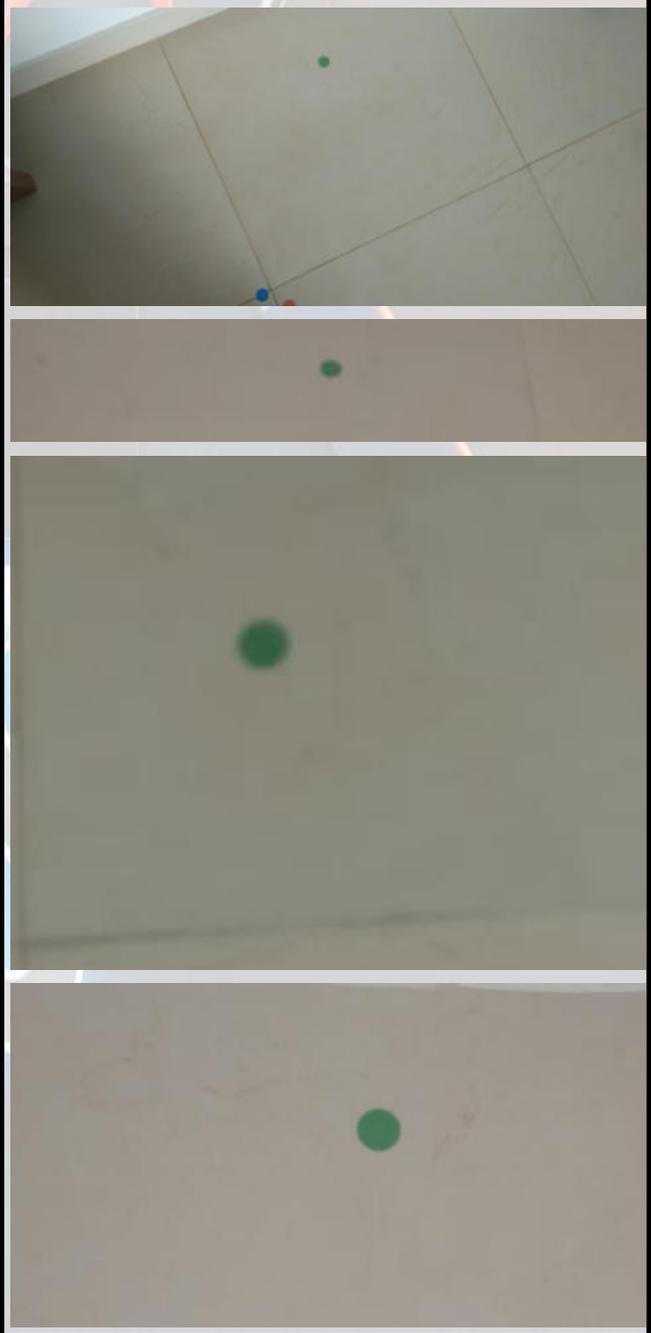
Floor tiles hollowness -6

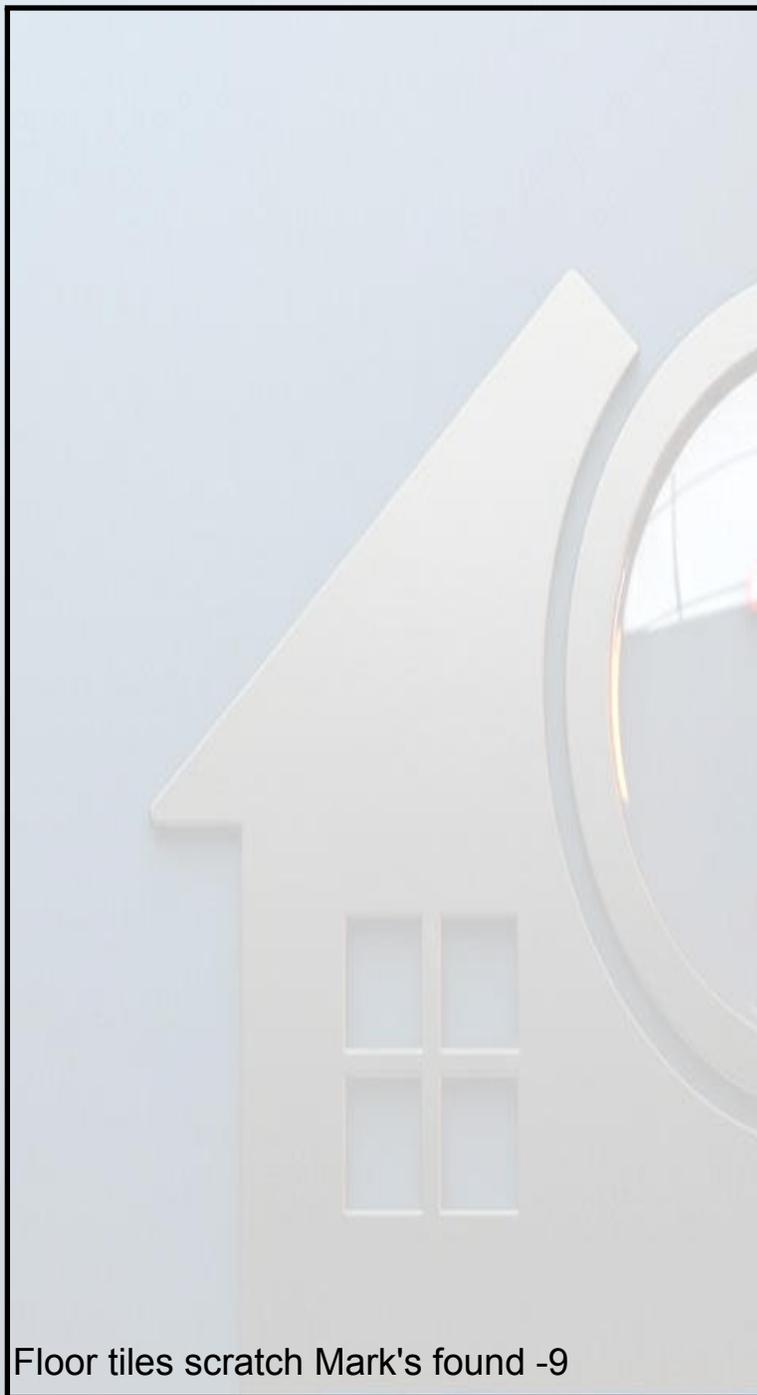
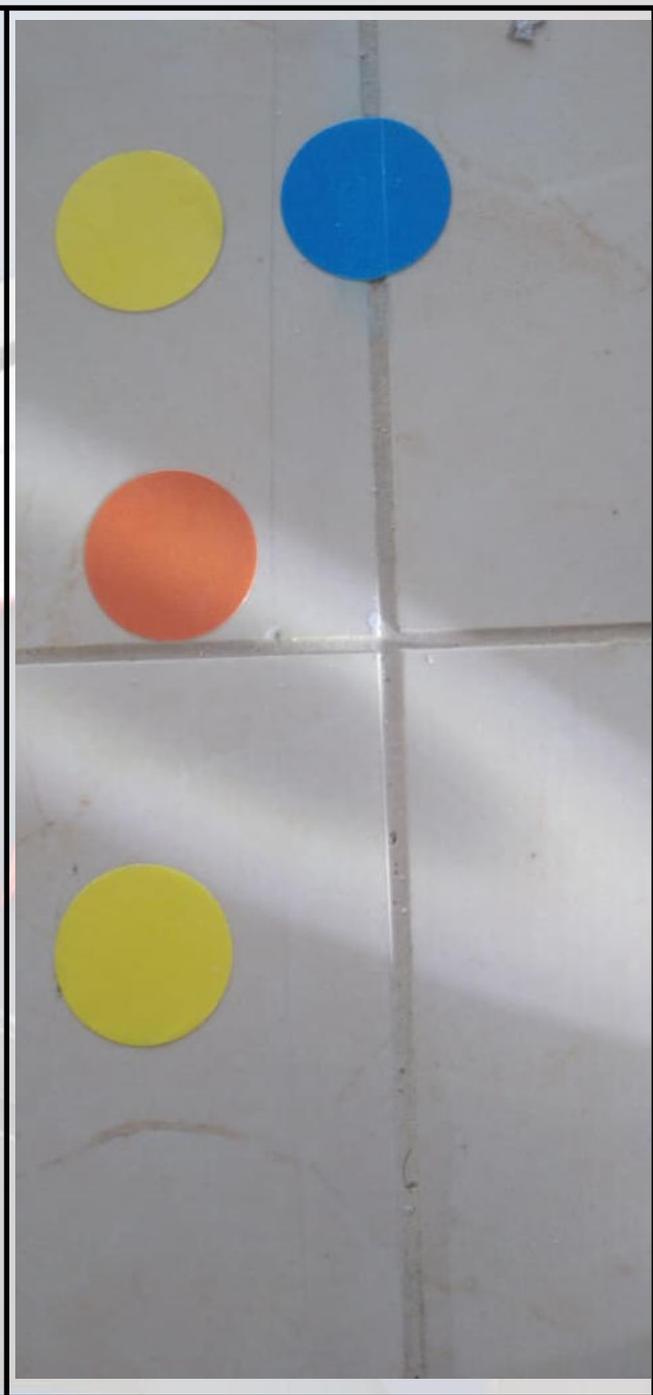
Floor tiles unevenness found - 21

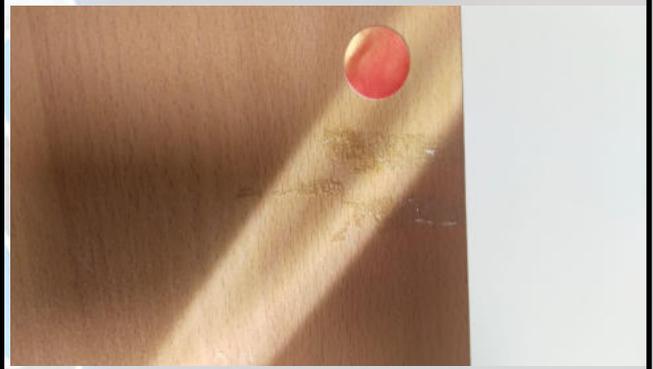
Glue marks found on door

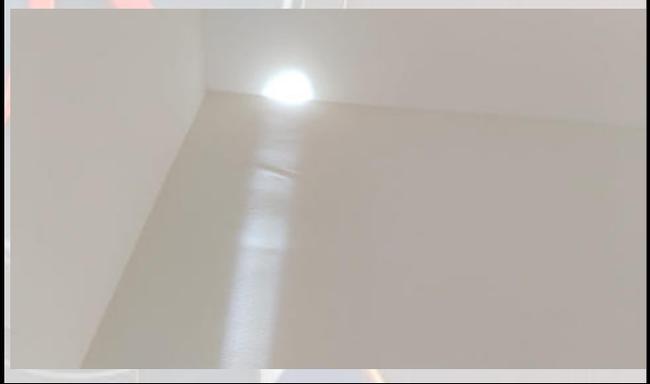
Wall undulations found

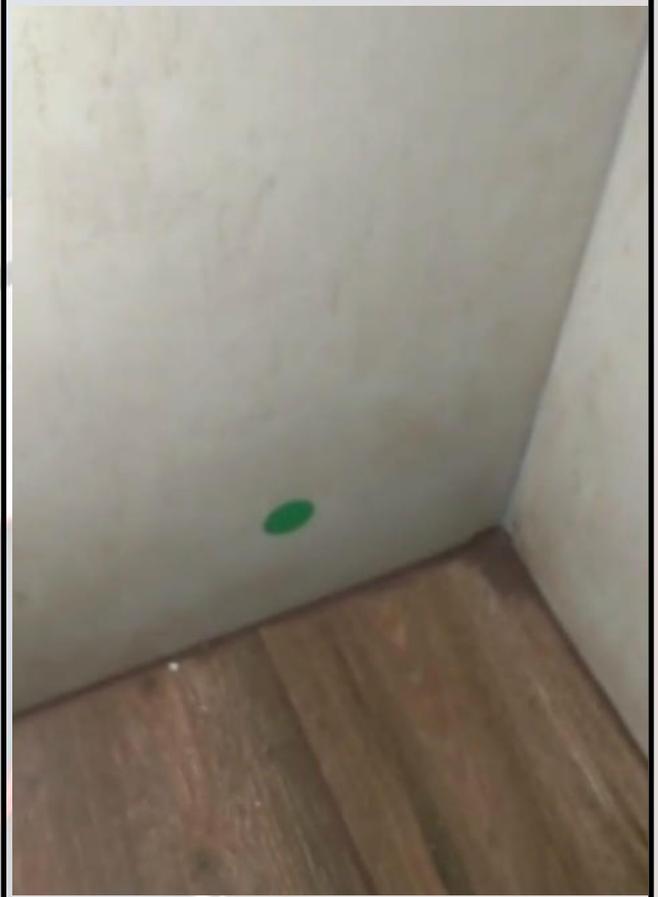
Wall tile hollowness -1

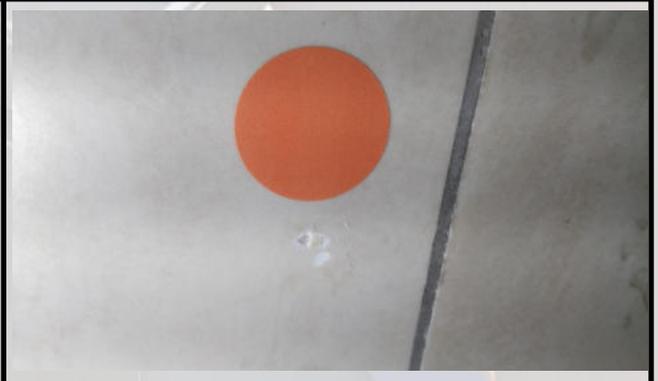
Wall tile minor chipped off -25

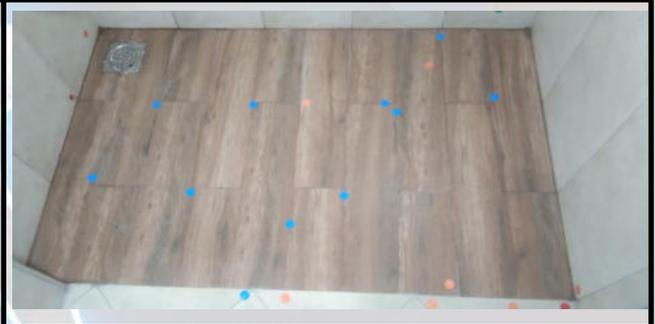
Floor tiles unevenness found - 19

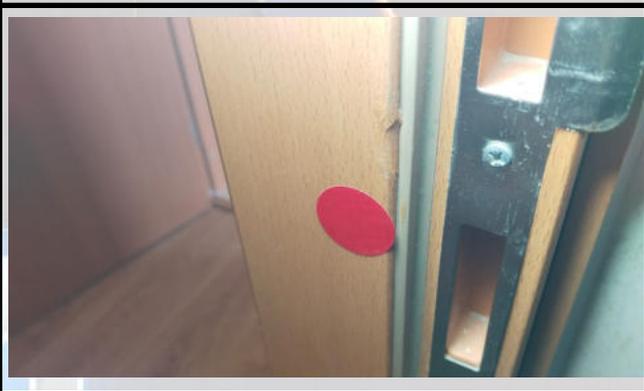
Left side Door frame near lock plate lamination minor damaged

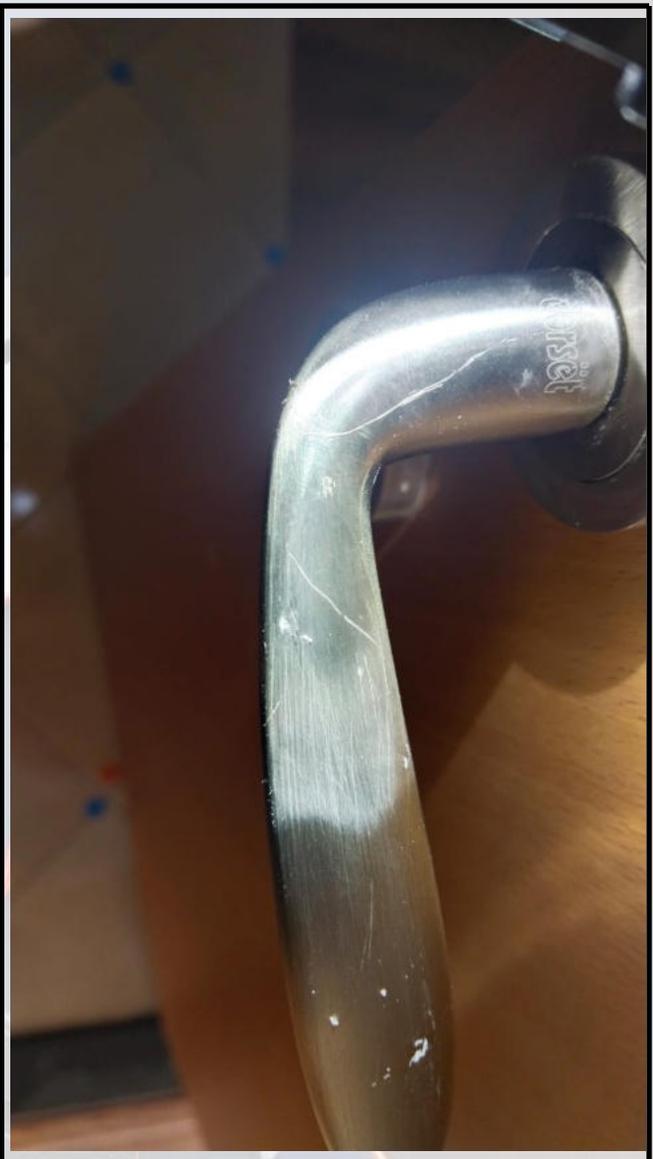
Scratch marks found on the door handle .

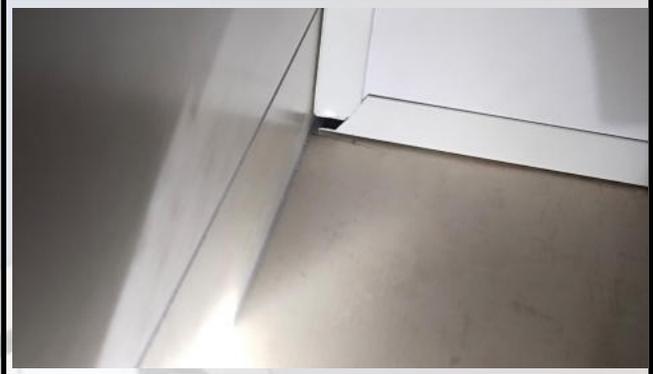
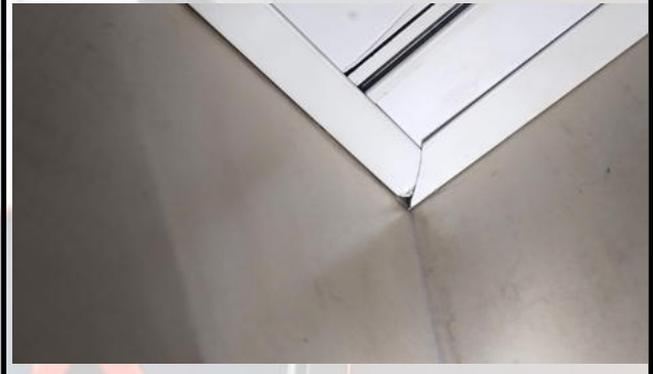
False ceiling channel corner finishing not proper , gap found ..

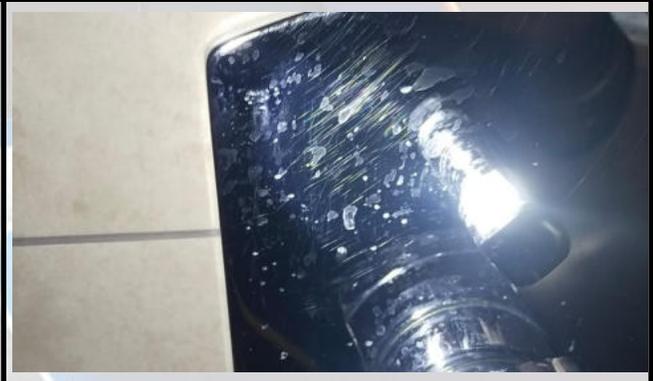
Scratch marks found on wall mixer tap

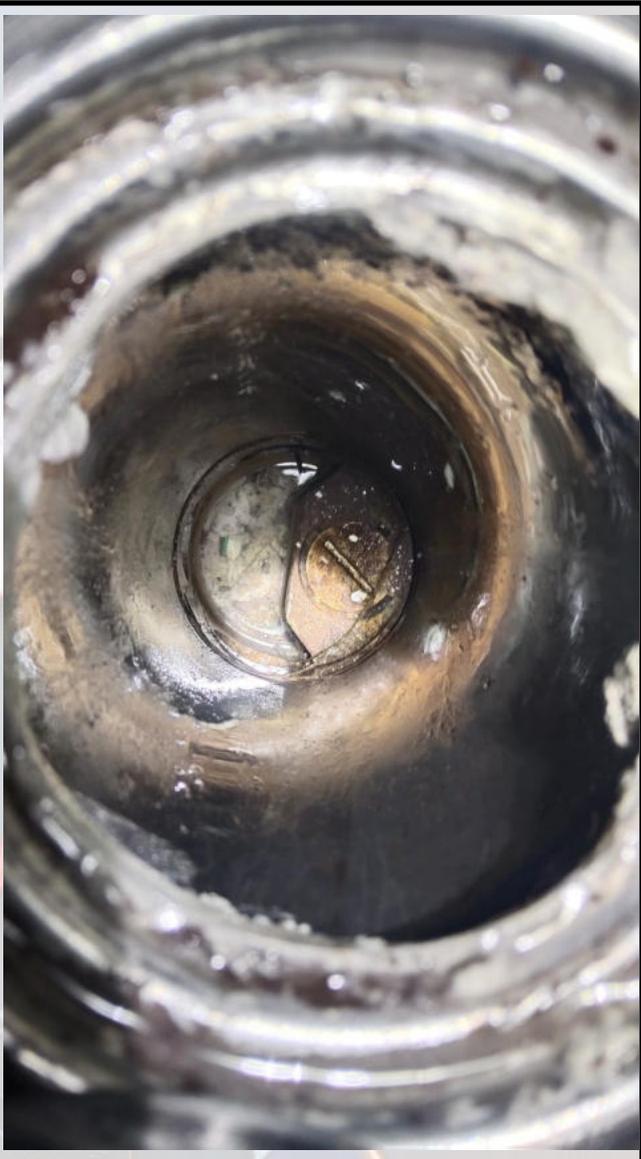
Drainage pipe cleaning required

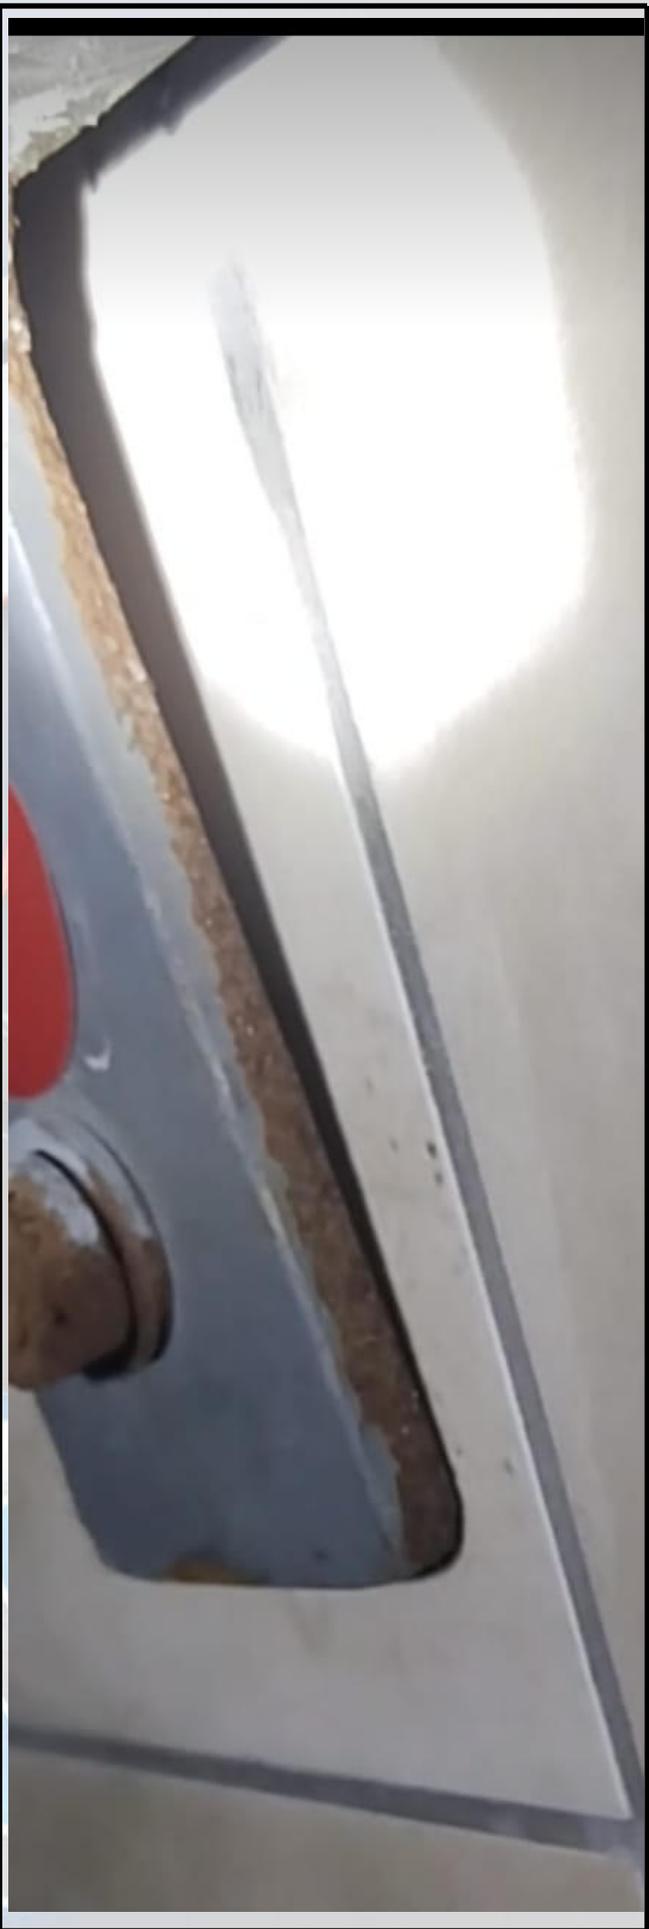
Granite slab metal holder and nut bolt started getting rusty , painting required

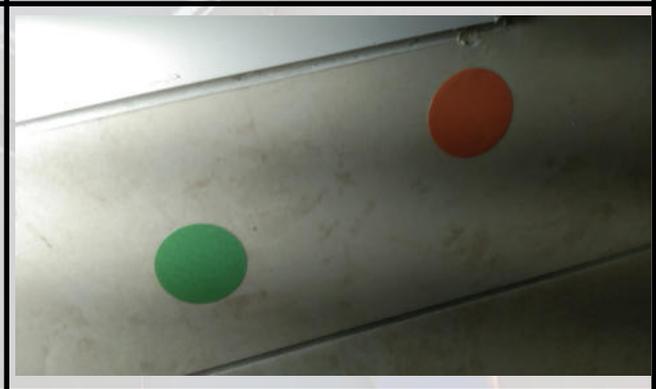
Wall tile hollowness -1

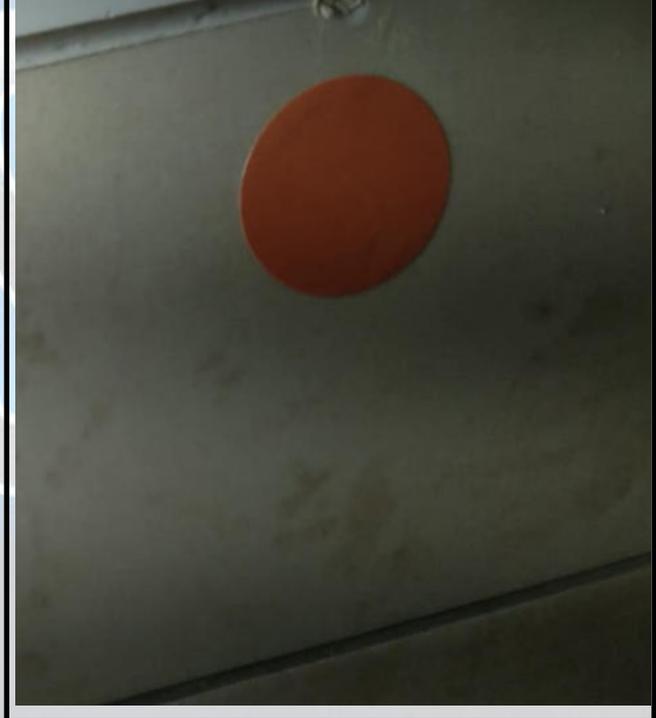
Wall tile minor chipped off -20

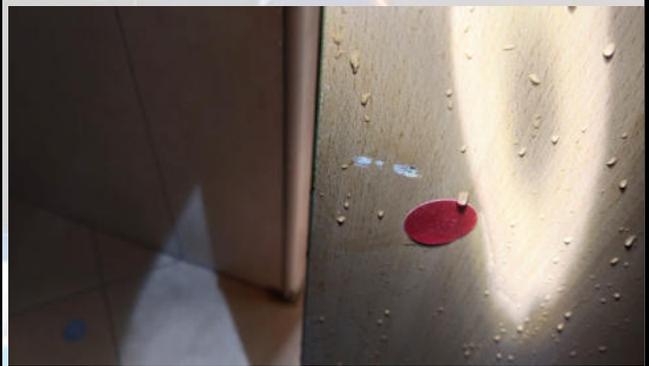
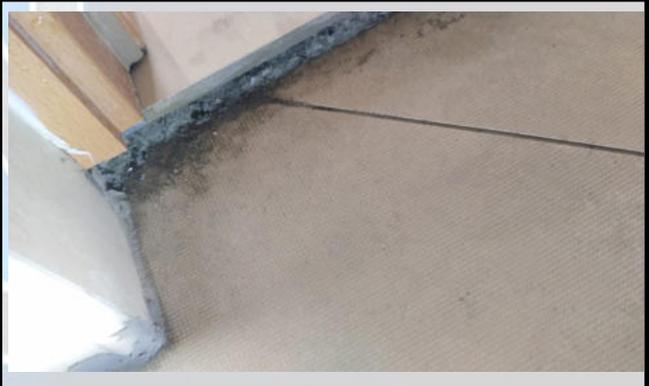
Door entrance tile grouting not done from the  
passage side

Flush tank button and shower head rod loose

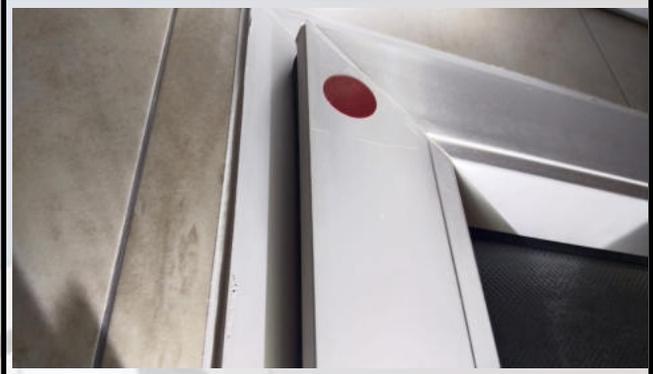
Scratch marks found on window frame

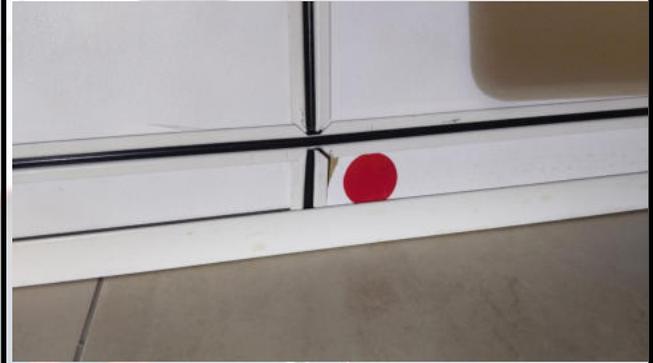
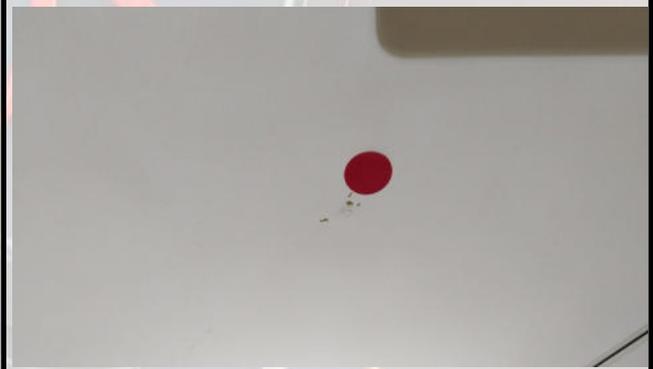
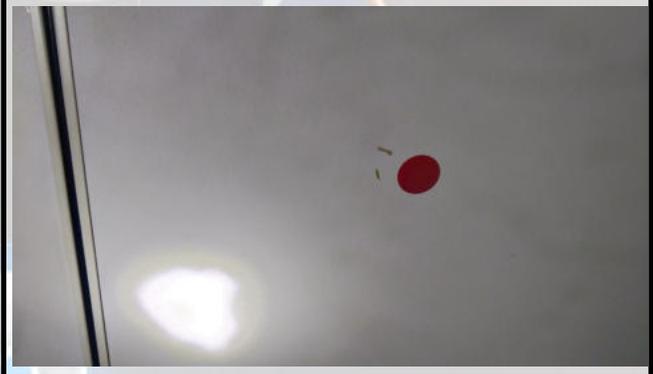
2 false ceiling scratch marks found 1 and damaged

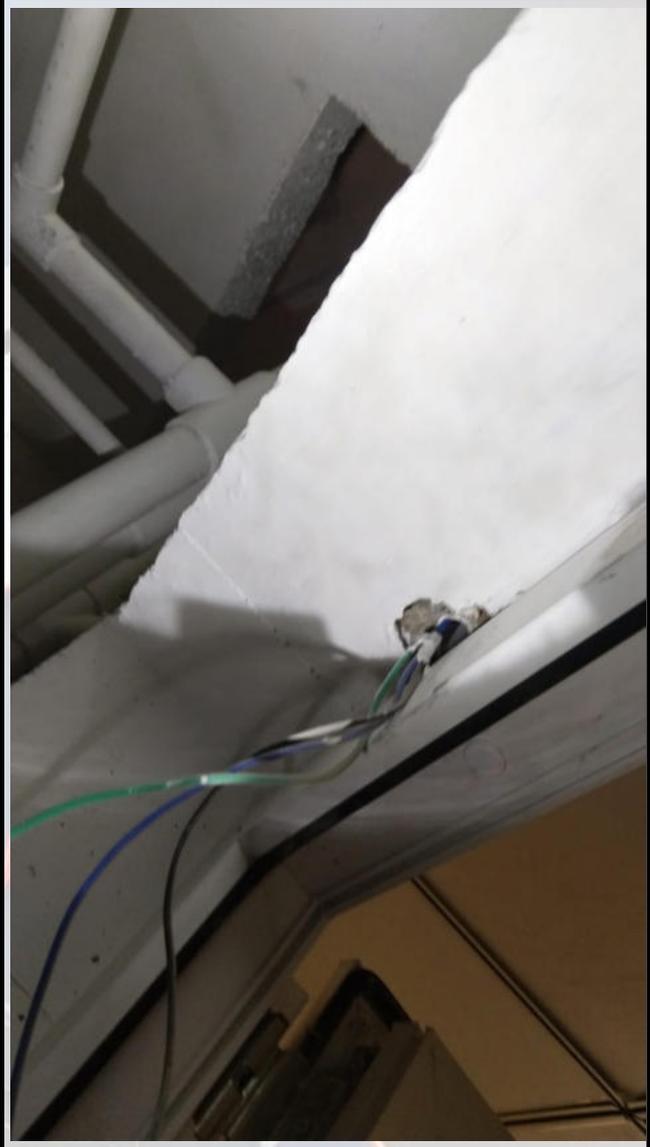
Exhaust fan connection junction cover not provided

Drainage pipe cleaning required .

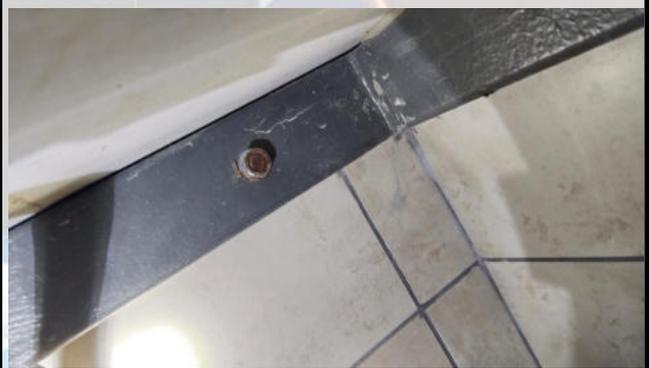
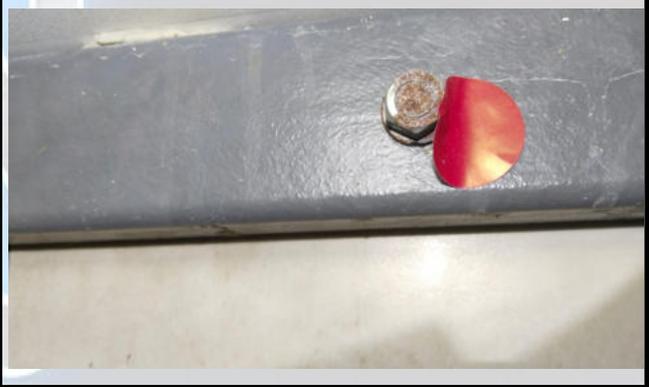
Granite slab nut bolt started getting rusty
