# MAS Home Care Solutions

## Property Inspection Report

### Advanced Inspection

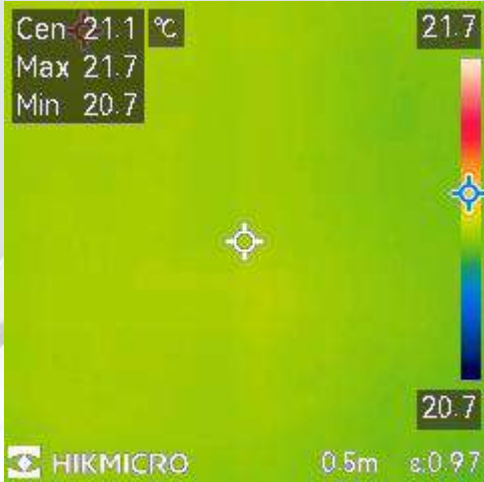
| Dining / Passage area | No Seepage Observed | |

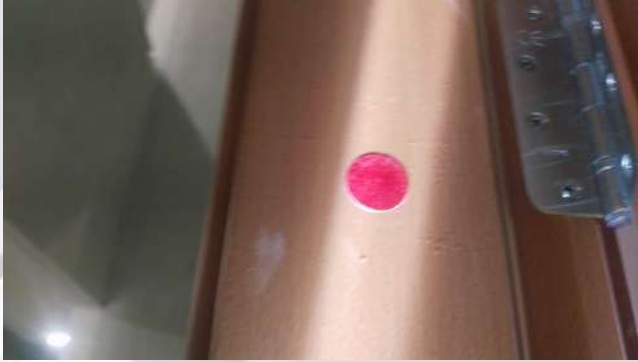
| Exterior | Image Reference |
|---|---|
| <p>Door frame beading got bulged in multiple places .</p> | |

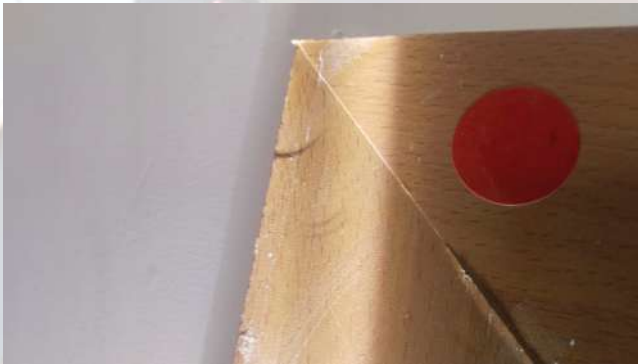
| Exterior | Image Reference |
|---|---|
| <p>Door frame beading top portion minor dent mark found .</p> | |

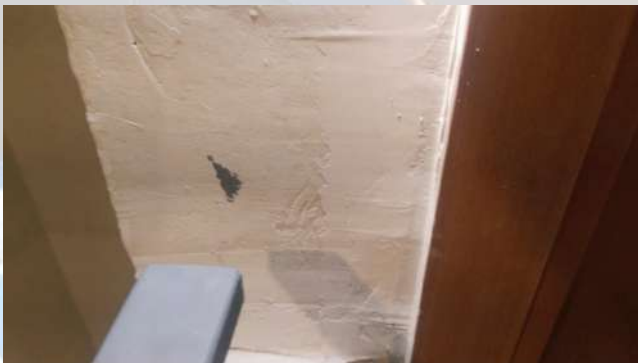
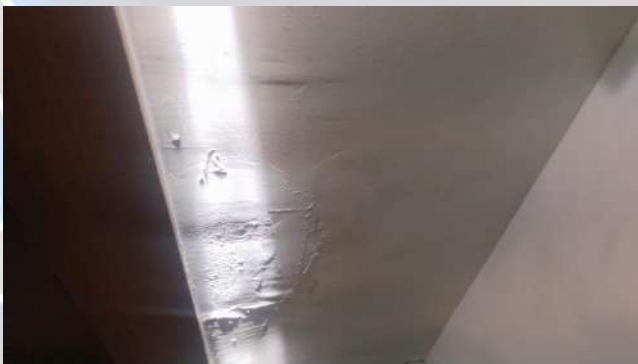
| Exterior | Image Reference |
|---|---|
| <p>Wall putty finishing is not proper on both sides of the door .</p> | |

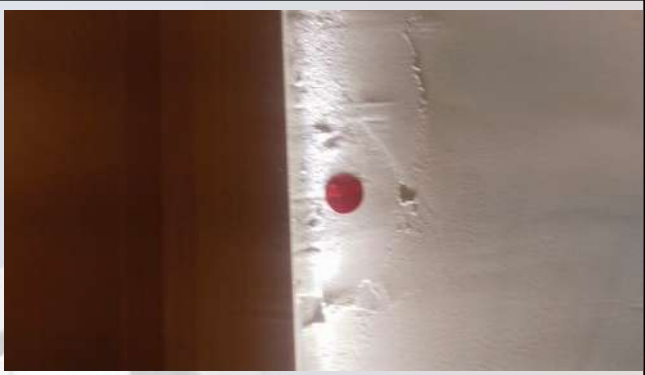
The door is rattling .

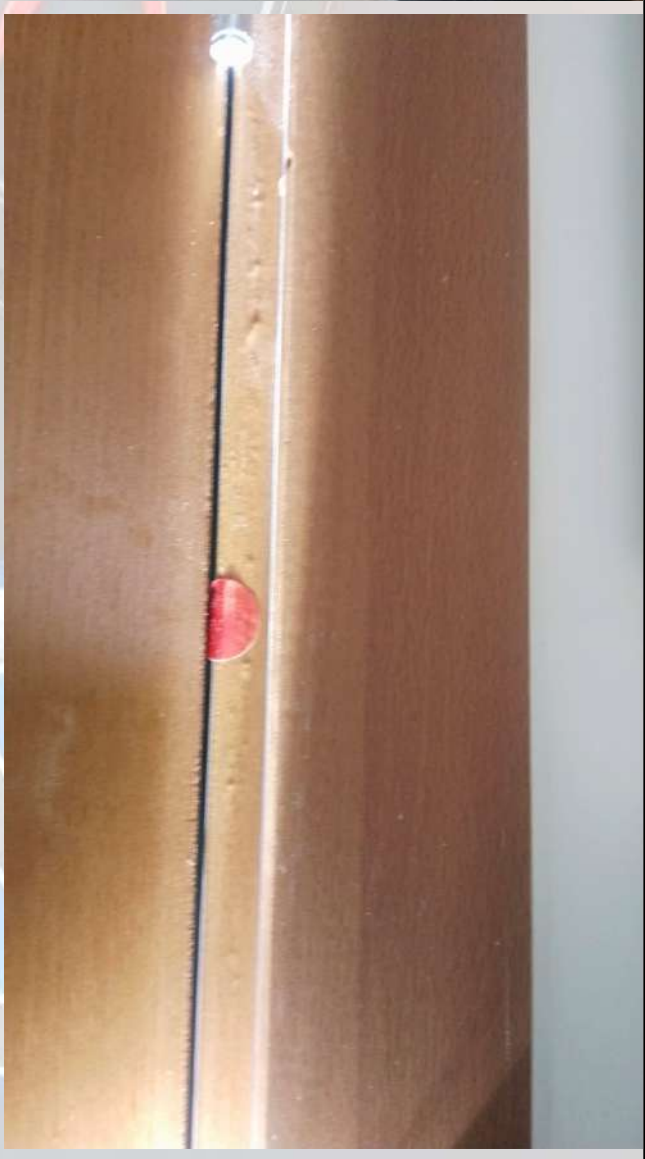
left internal side frame beading and both  
frame bottom packing required .

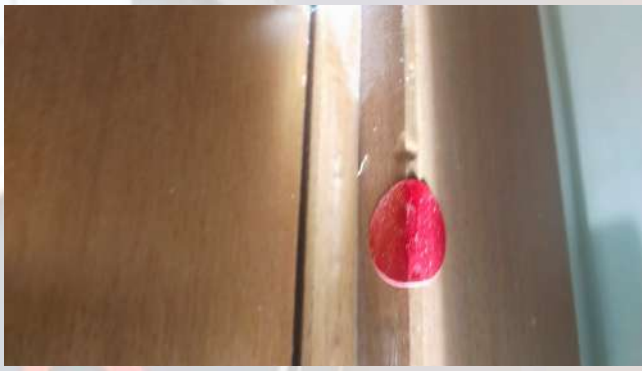
| Left internal side and right internal side top portion beading minor dent mark found . | |

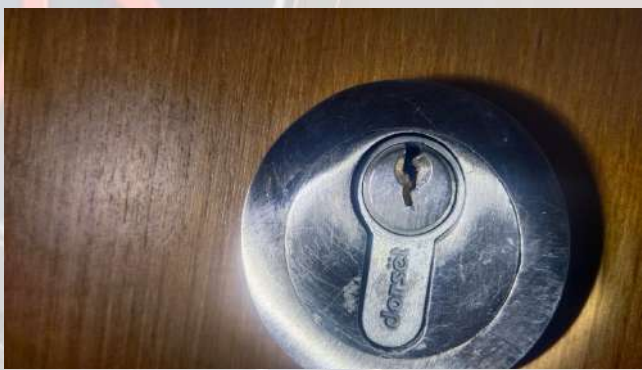
| Scratch marks found on door lock | |

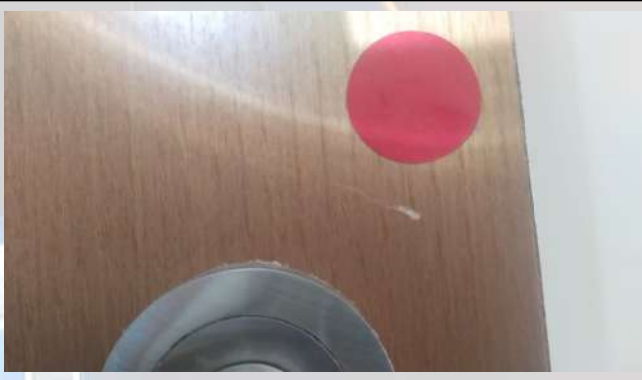
| Scratch marks found on door above lock . | |

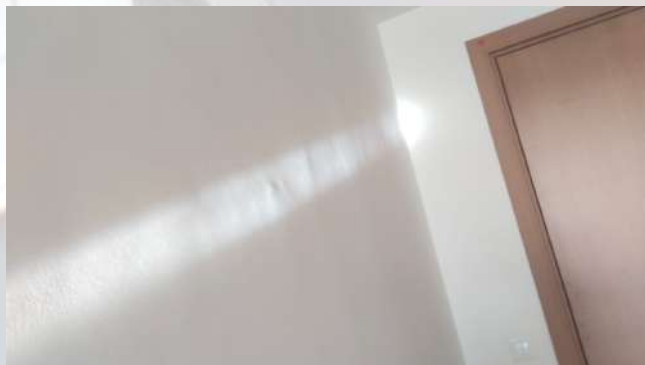
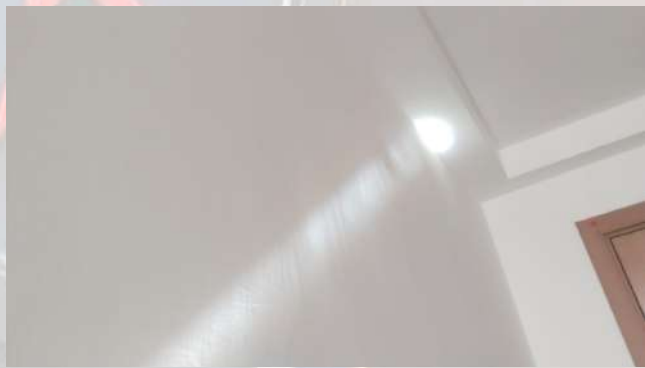
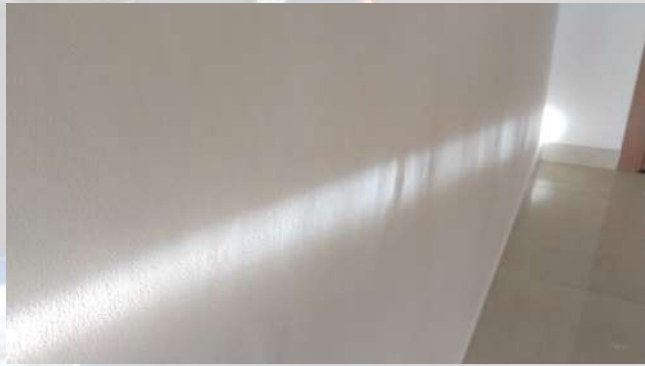
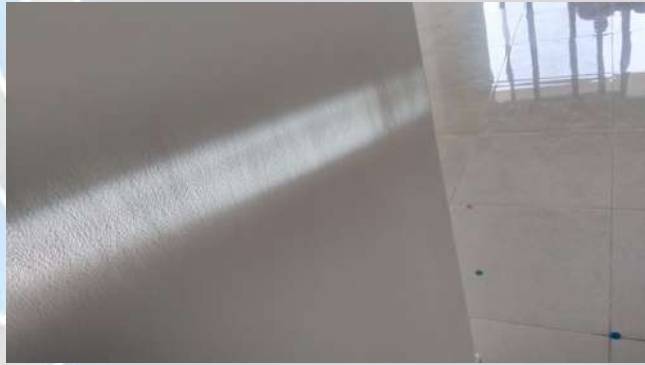
All wall undulations found .

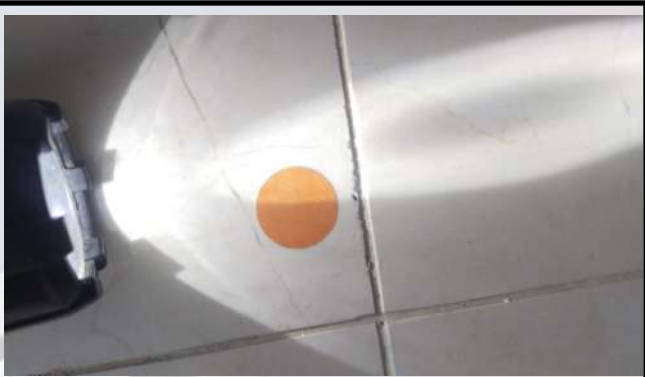
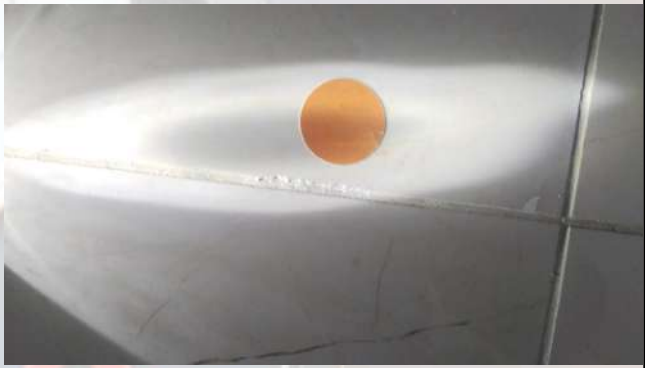
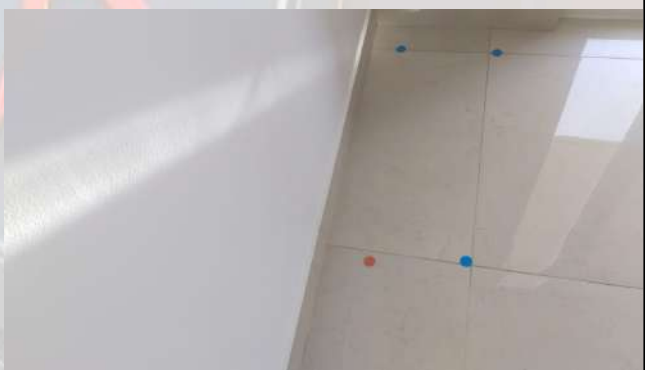
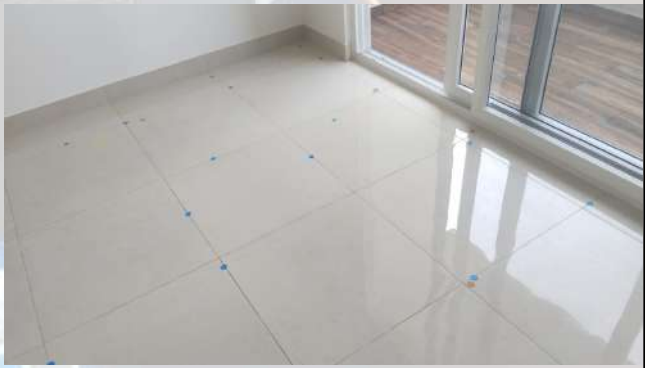
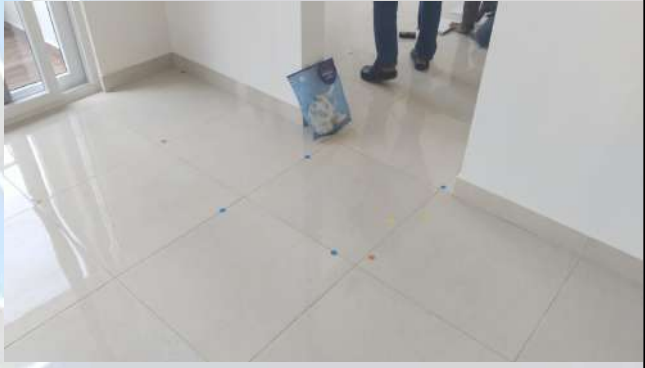
19 floor tiles unevenness found

3 floor tiles scratch marks found

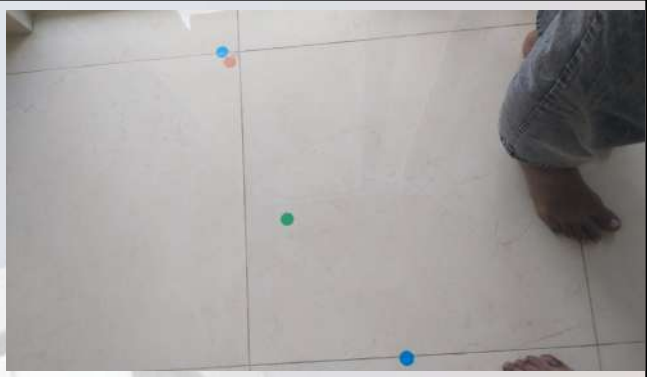
1 floor tile hollowness found

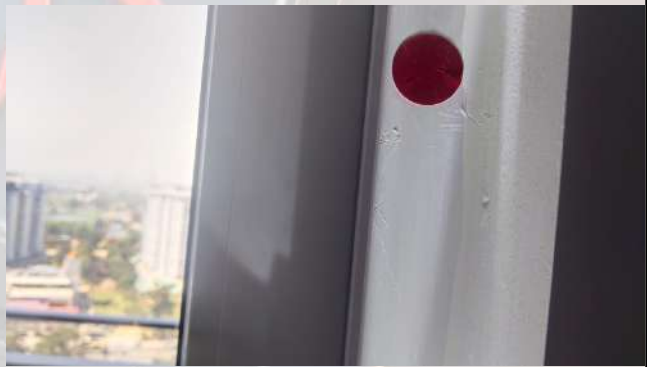
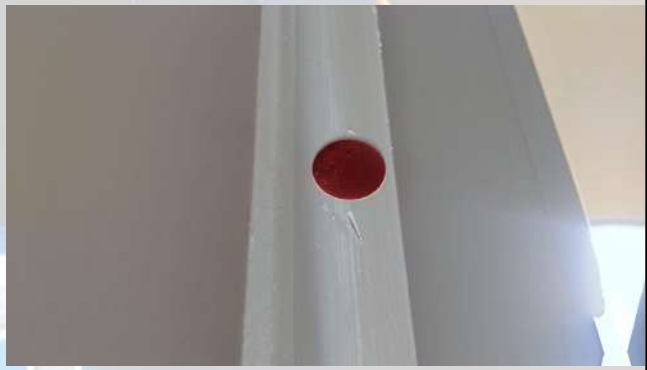
Both side of the sliding door frame scratch marks found

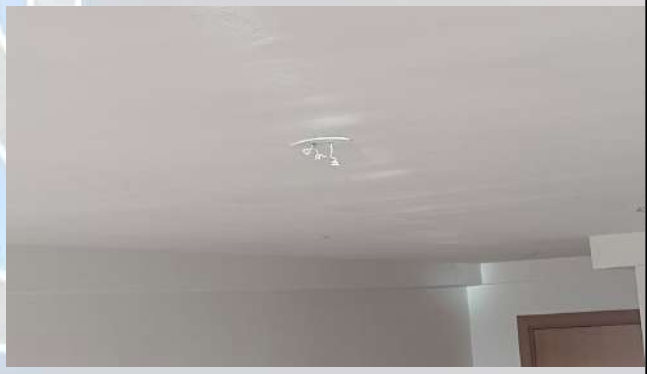
Wall and ceiling undulations found .

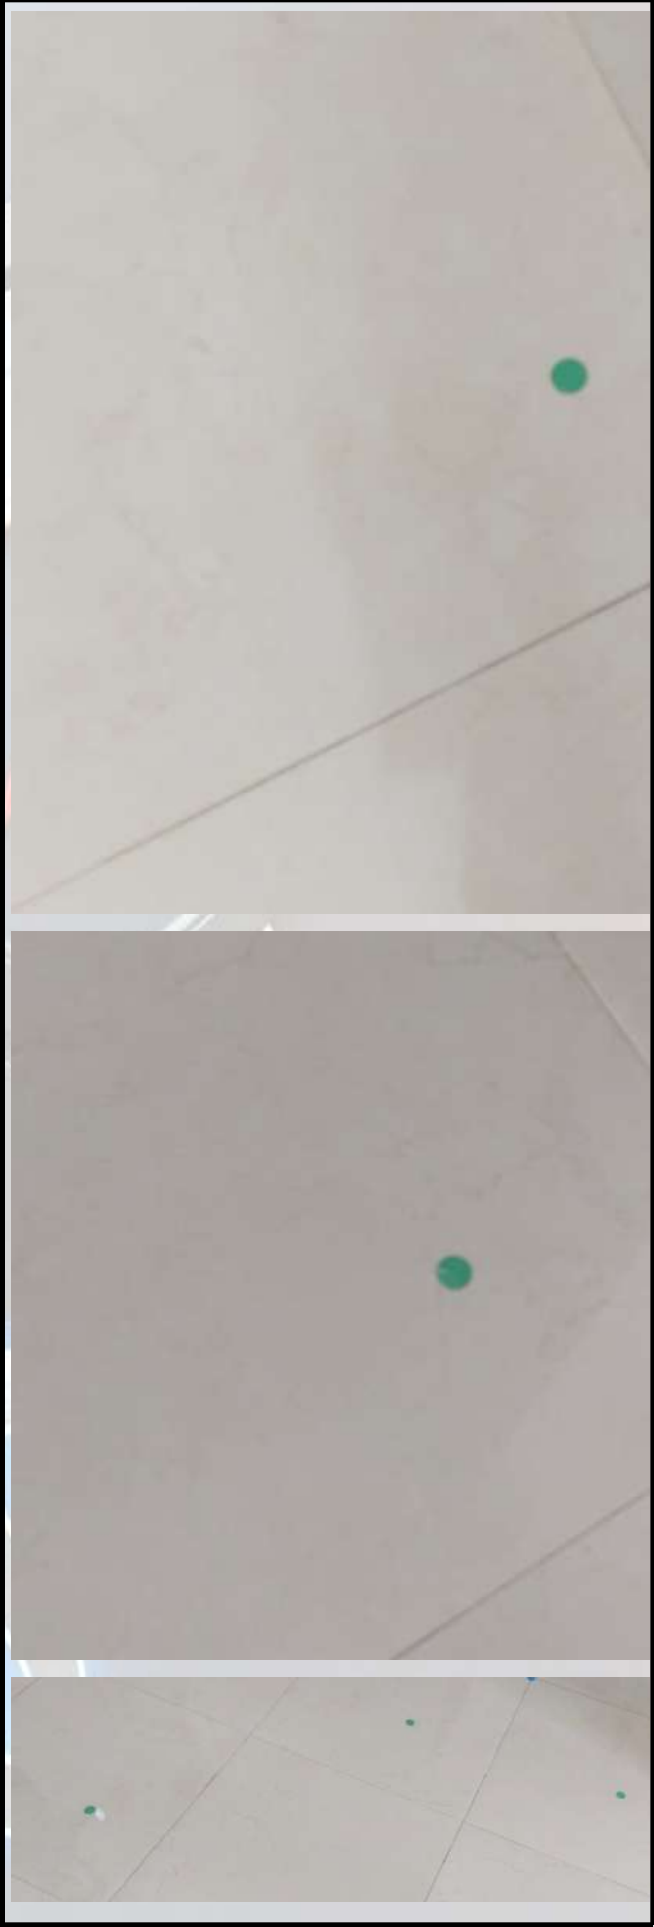
| Dining area | Image Reference |

| Dining area | Image Reference |
|---|---|
| <p data-bbox="186 1943 943 2030">8 floor tiles hollowness found</p> | |

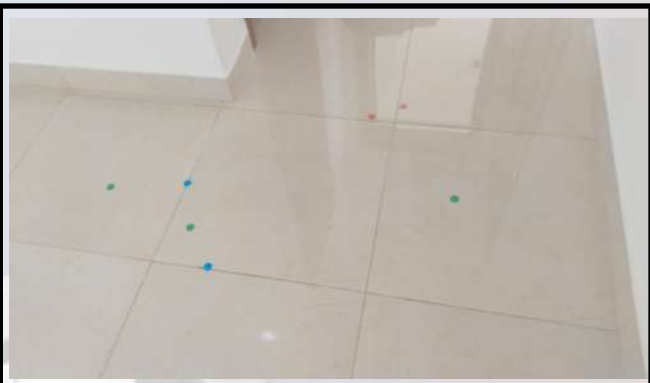
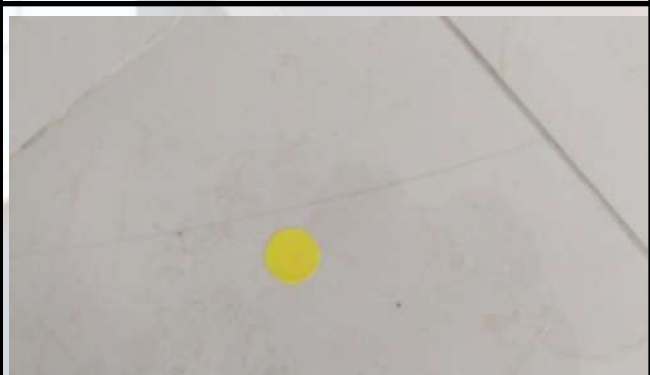
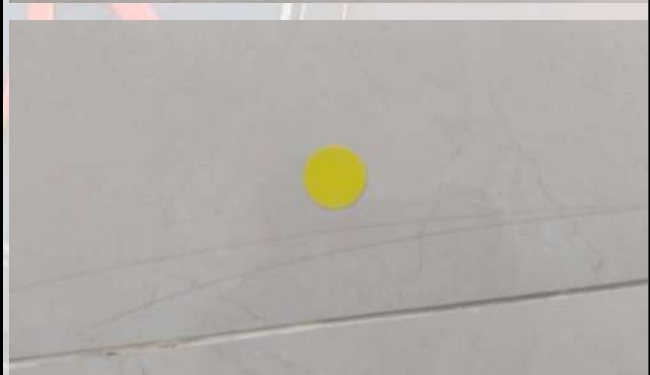
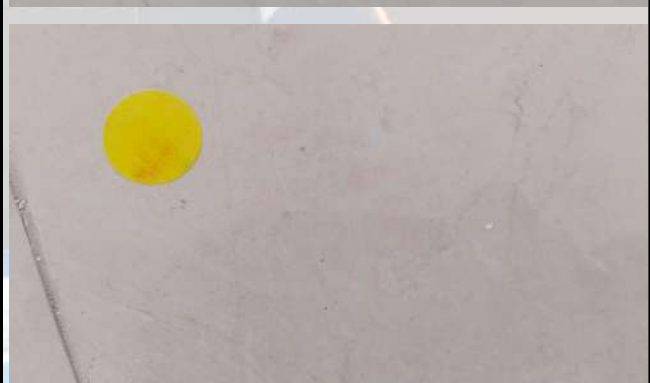
6 floor tiles scratch marks found

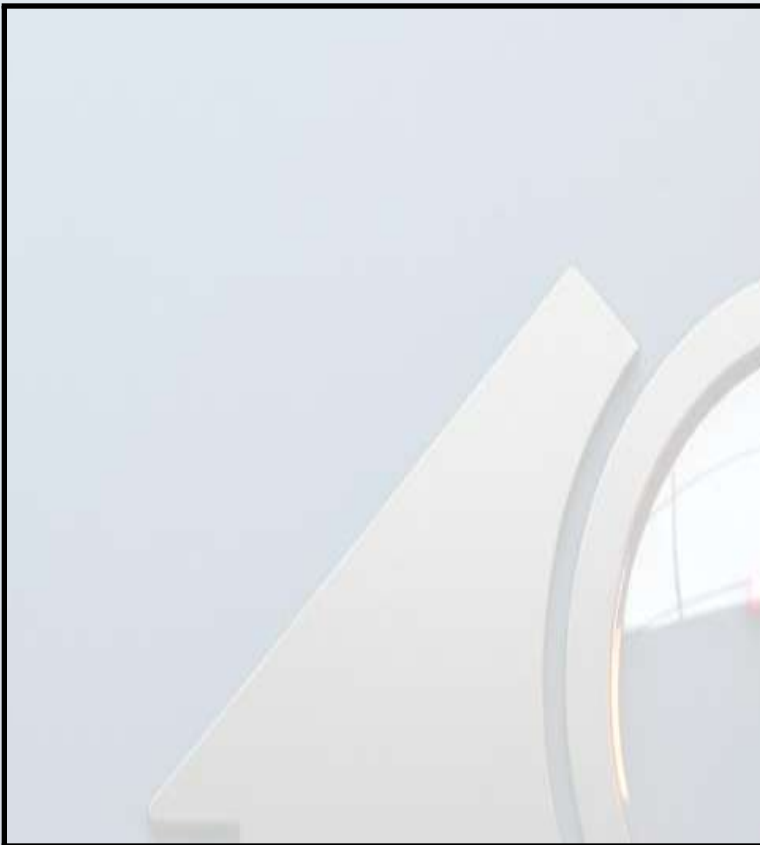
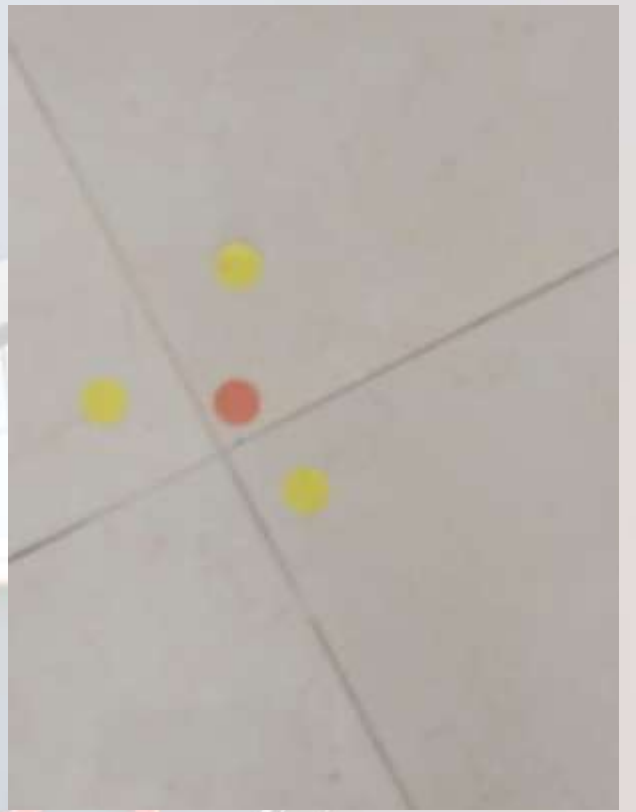
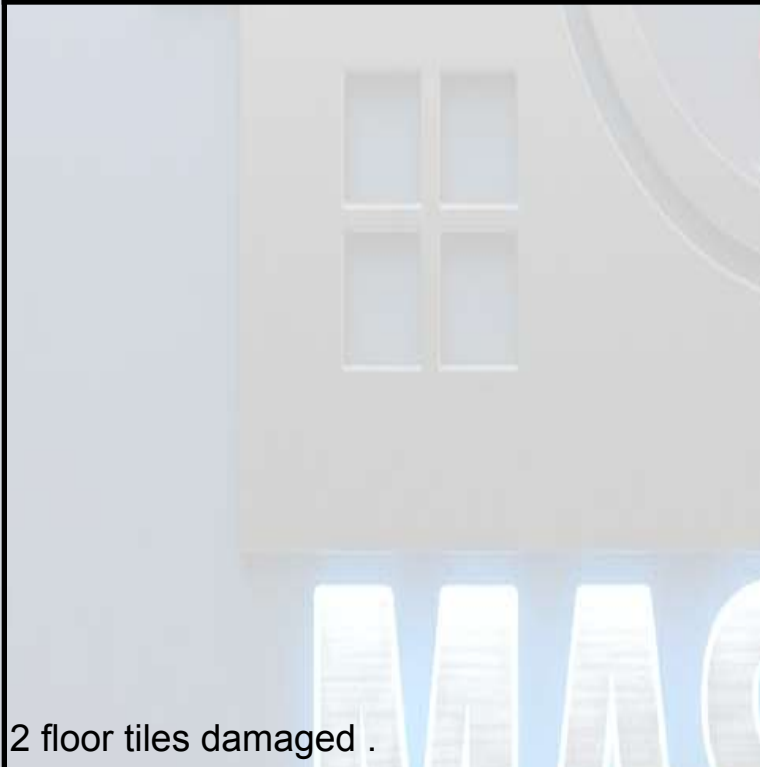
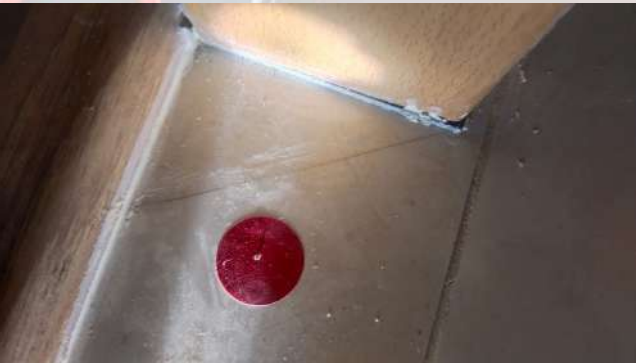
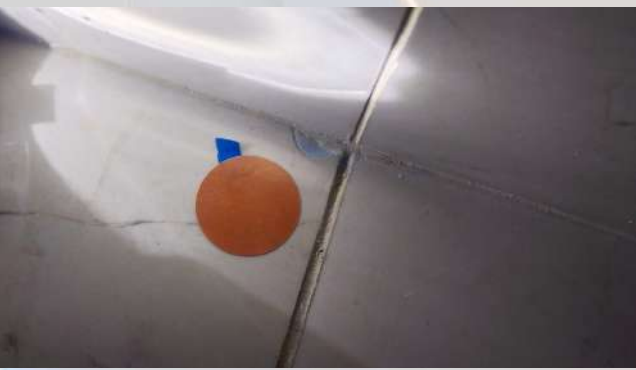
2 floor tiles damaged .

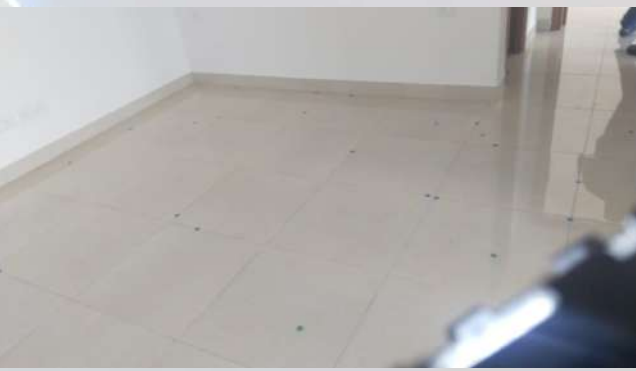
30 floor tiles unevenly found .

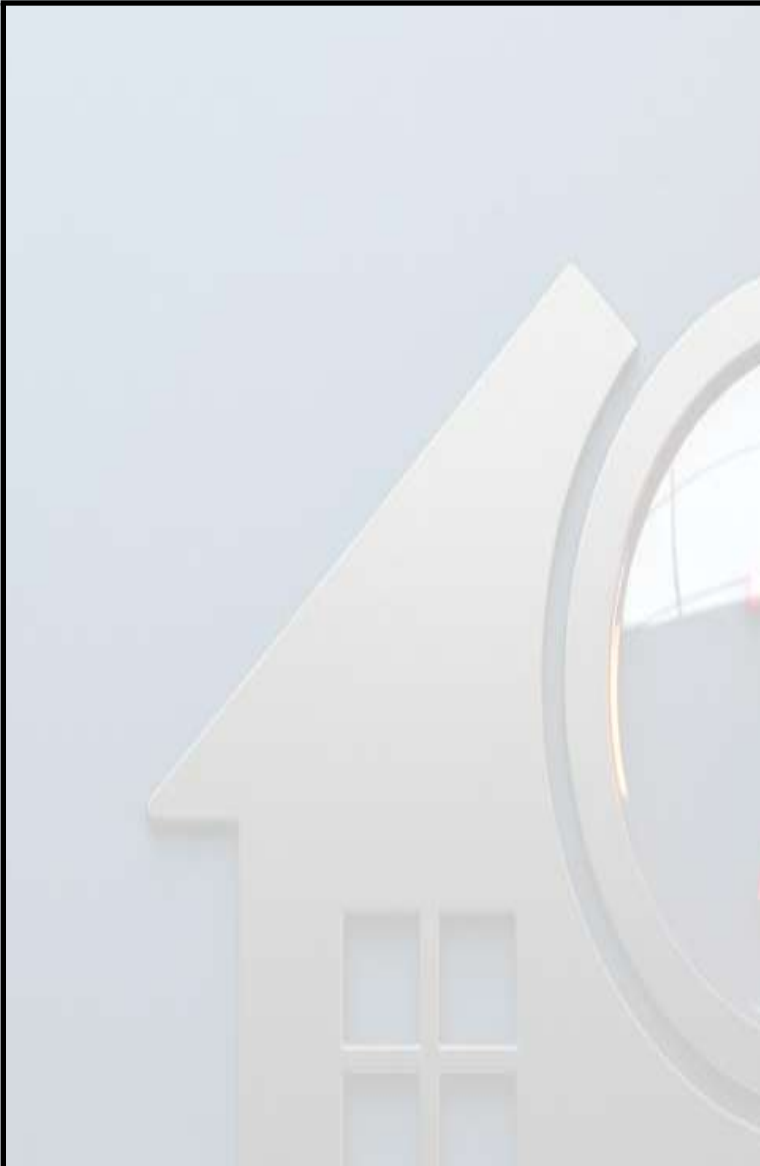
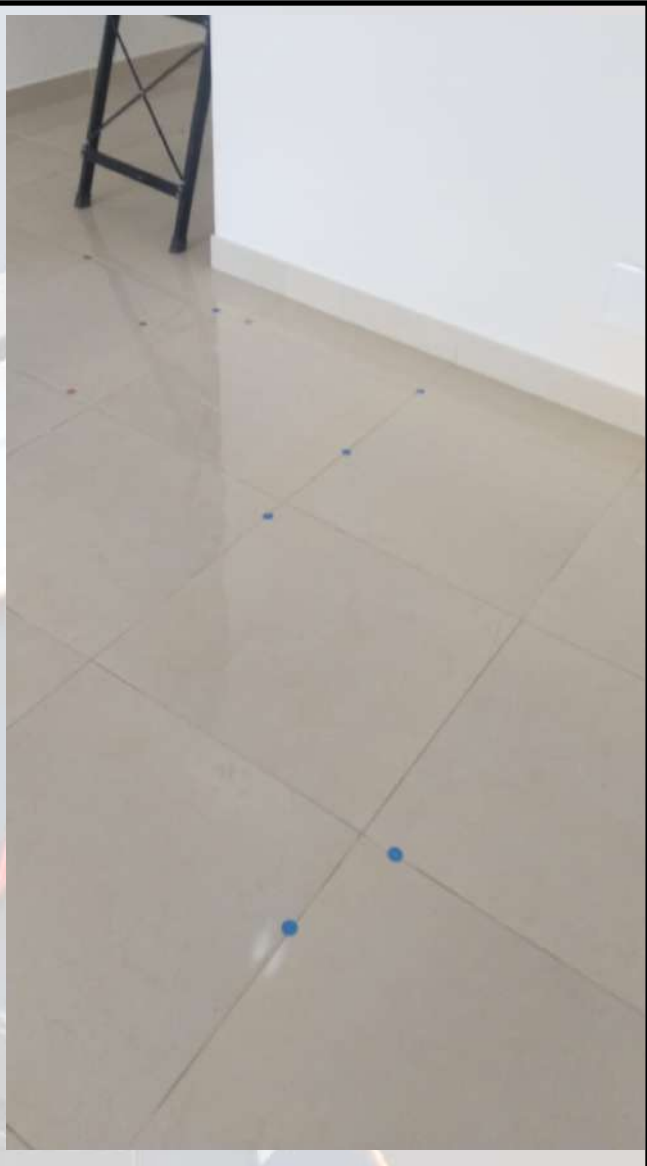
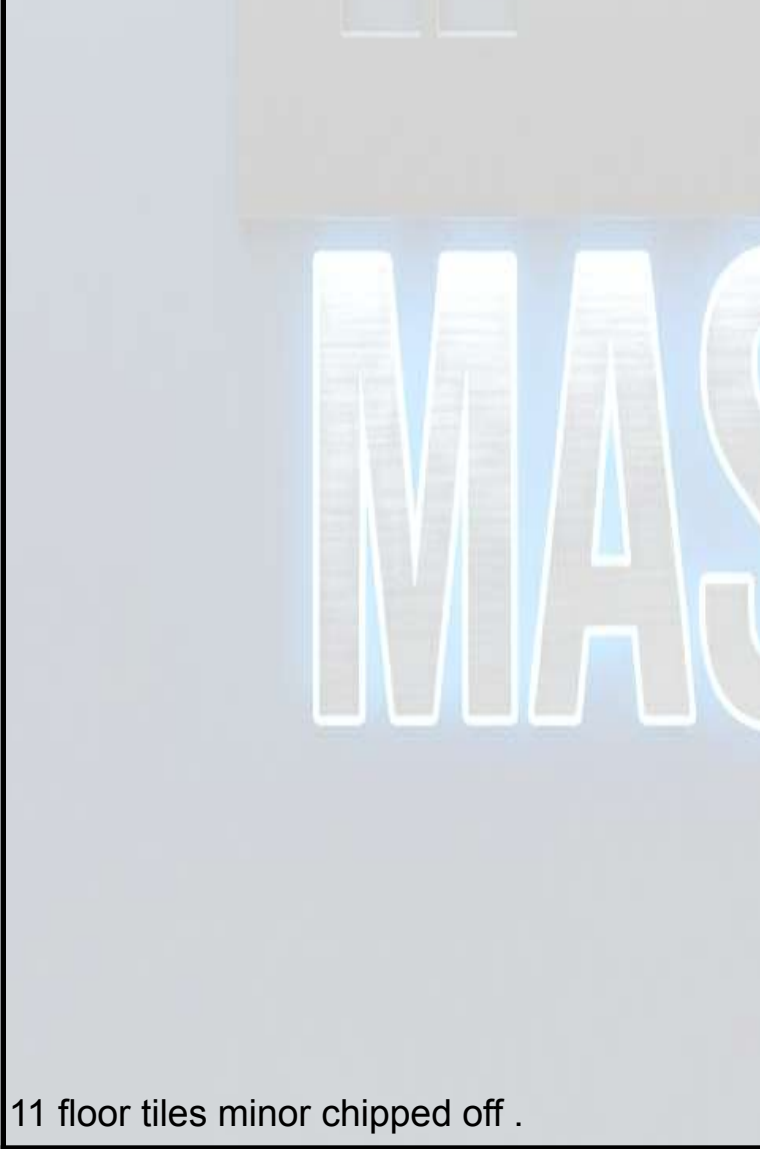
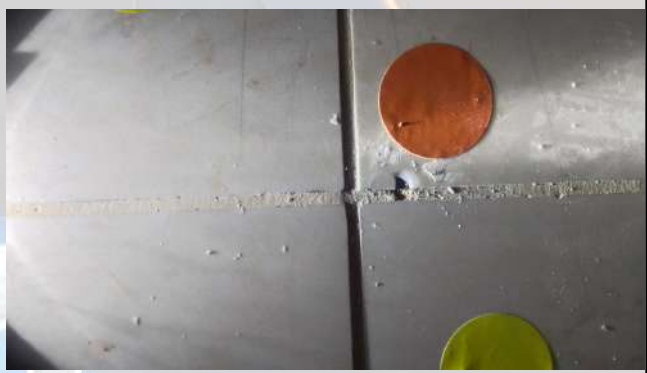
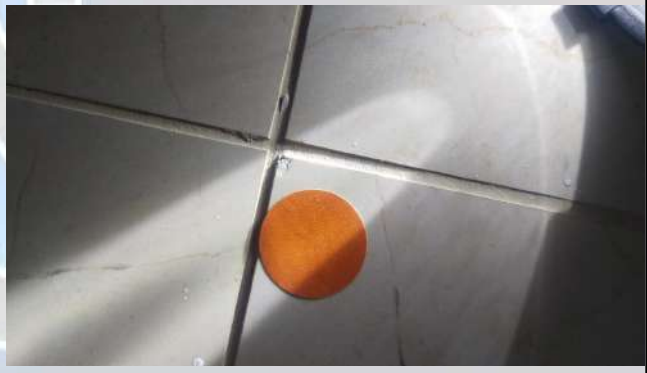
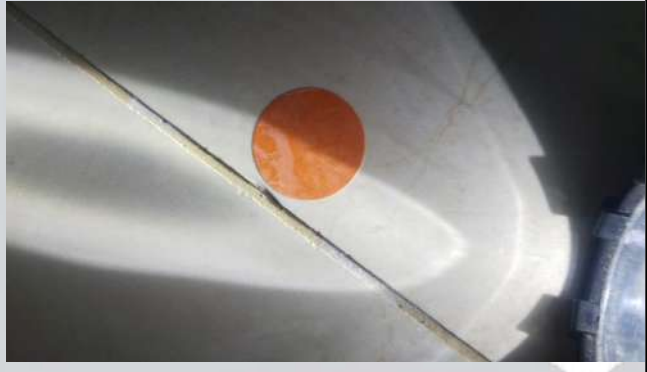
11 floor tiles minor chipped off .

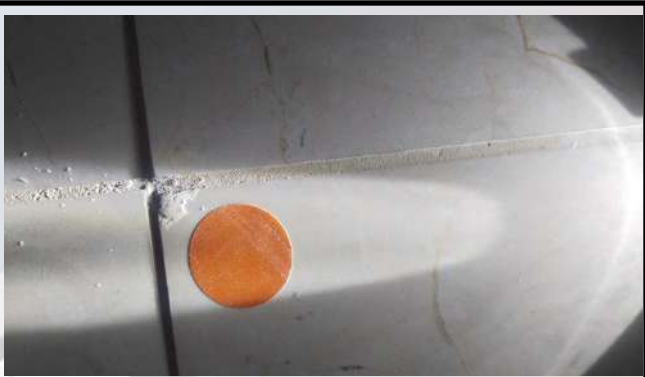
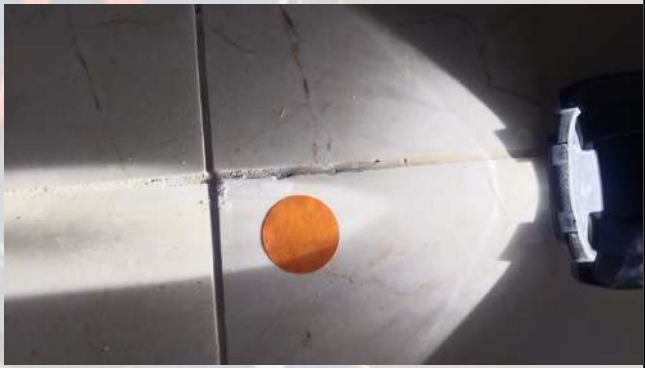
Wall undulations found .

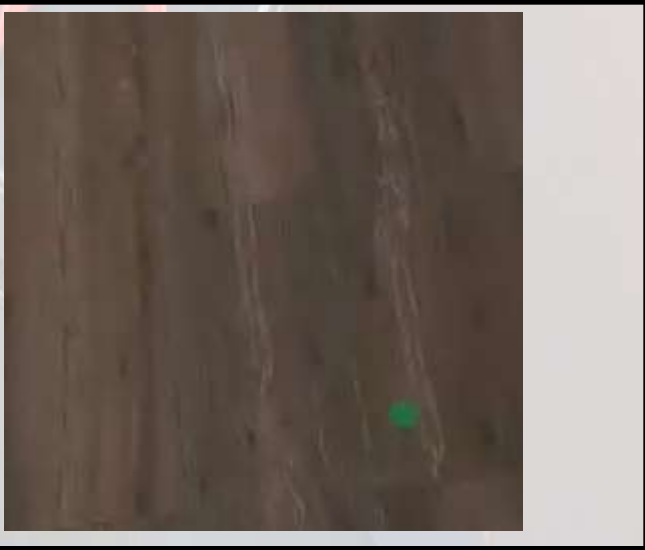
Balcony

Floor tiles hollowness -1

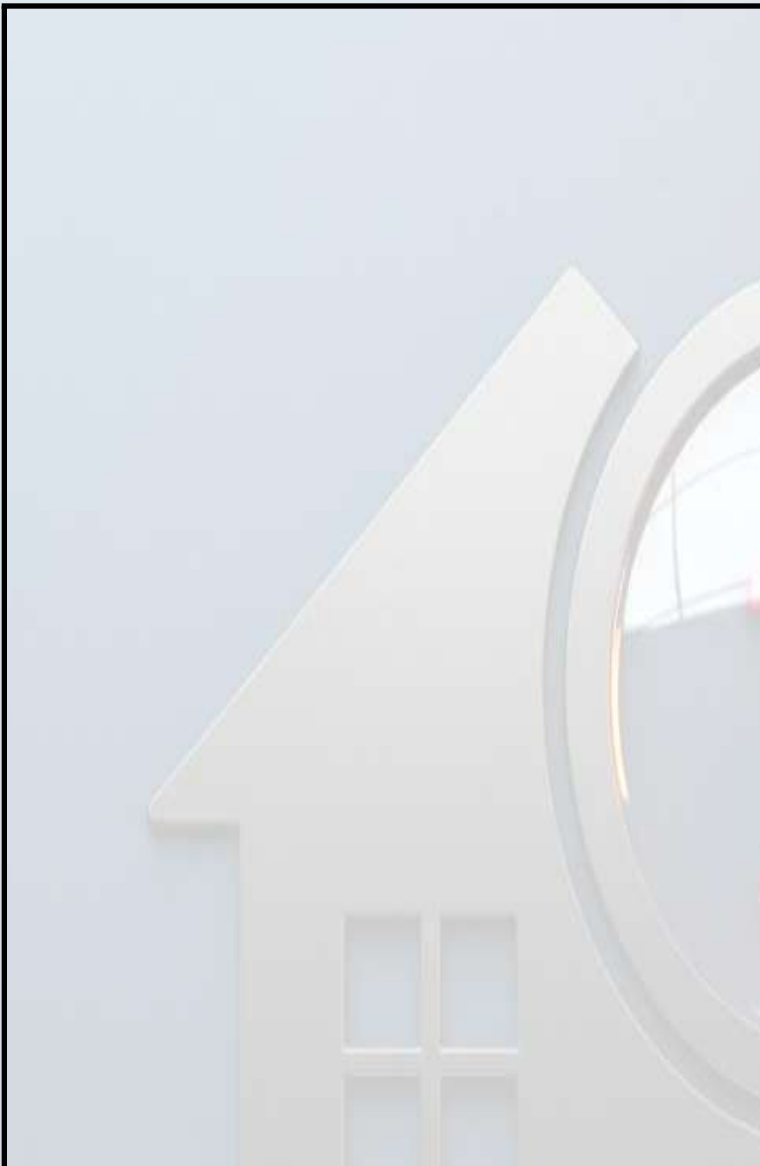
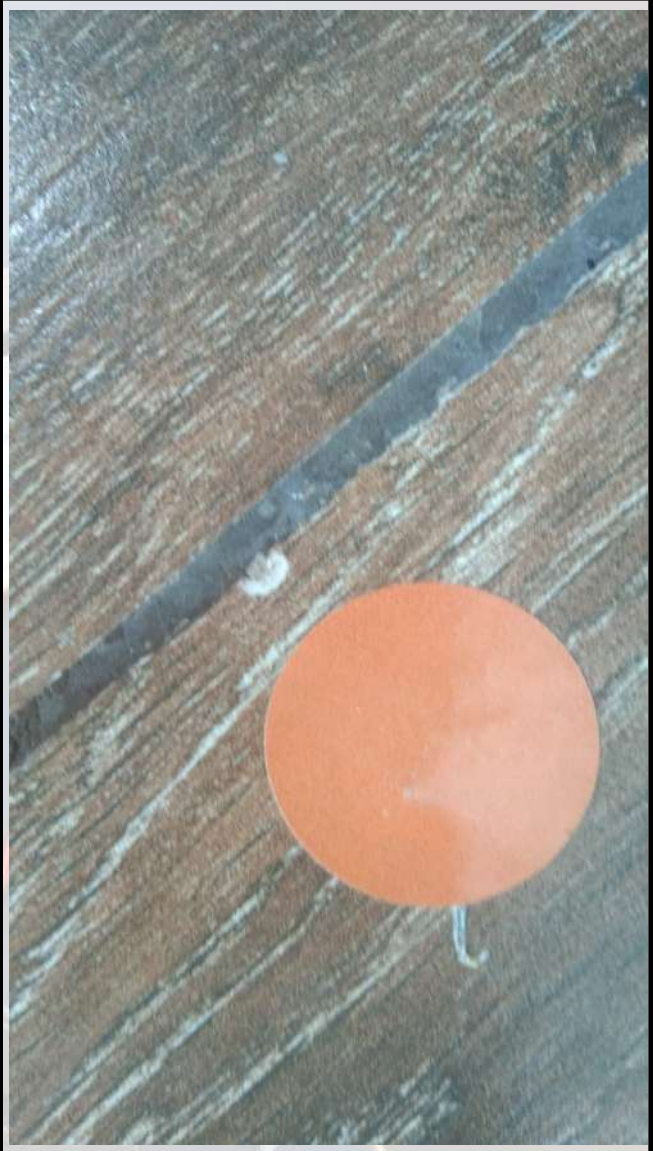
Floor tiles unevenness found - 33.

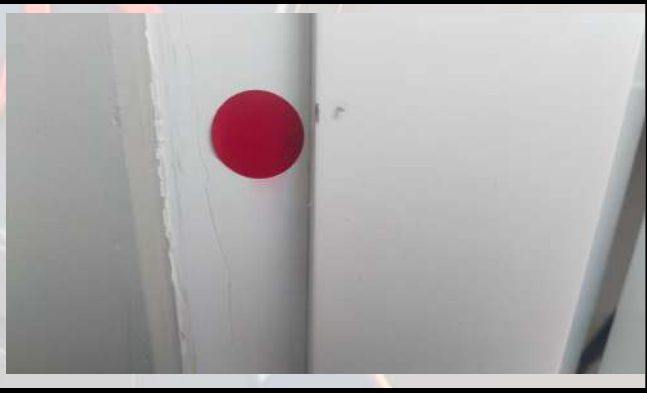
Major scratch marks found on the left side sliding door frame .

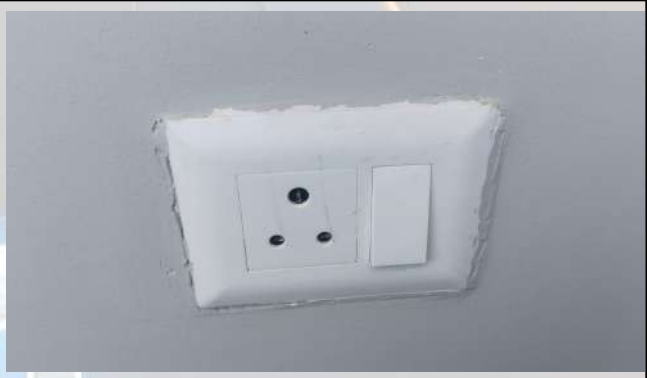
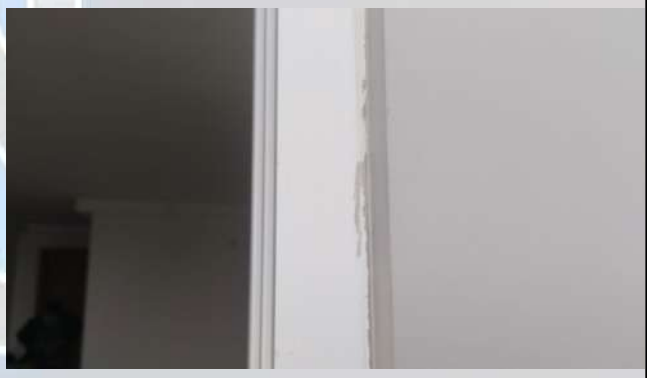
Sliding door frame and switch board packing and cleaning the border area to get proper finishing .

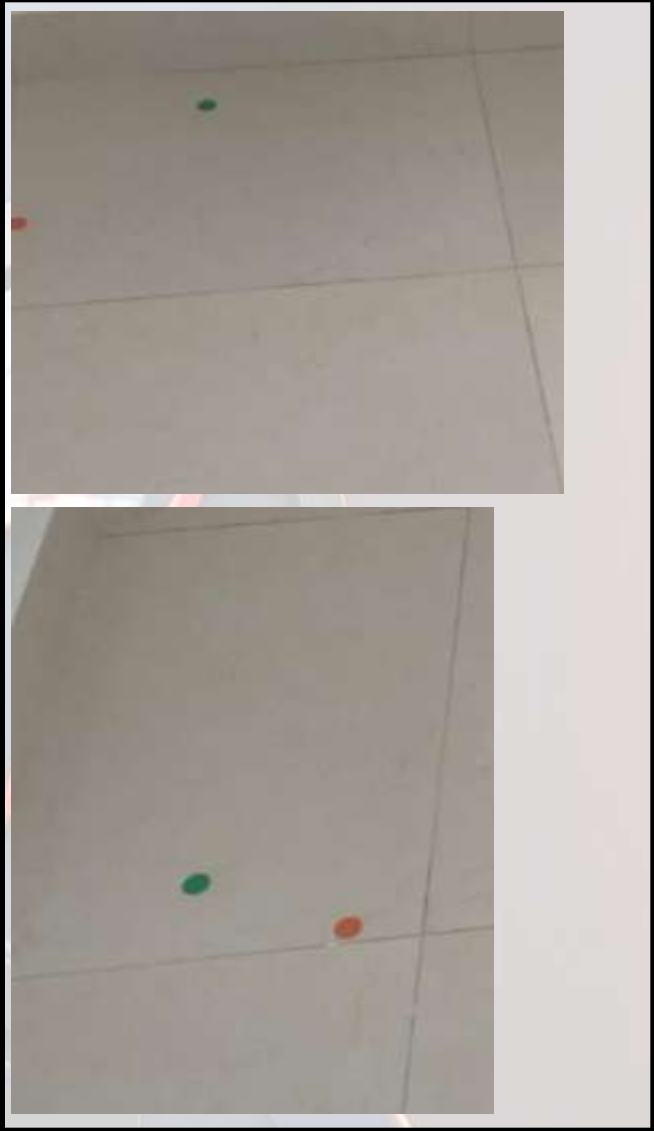
| Kitchen | Image Reference |
|---|---|
| <p data-bbox="185 1178 594 1236">Floor tiles hollowness -2</p> | |

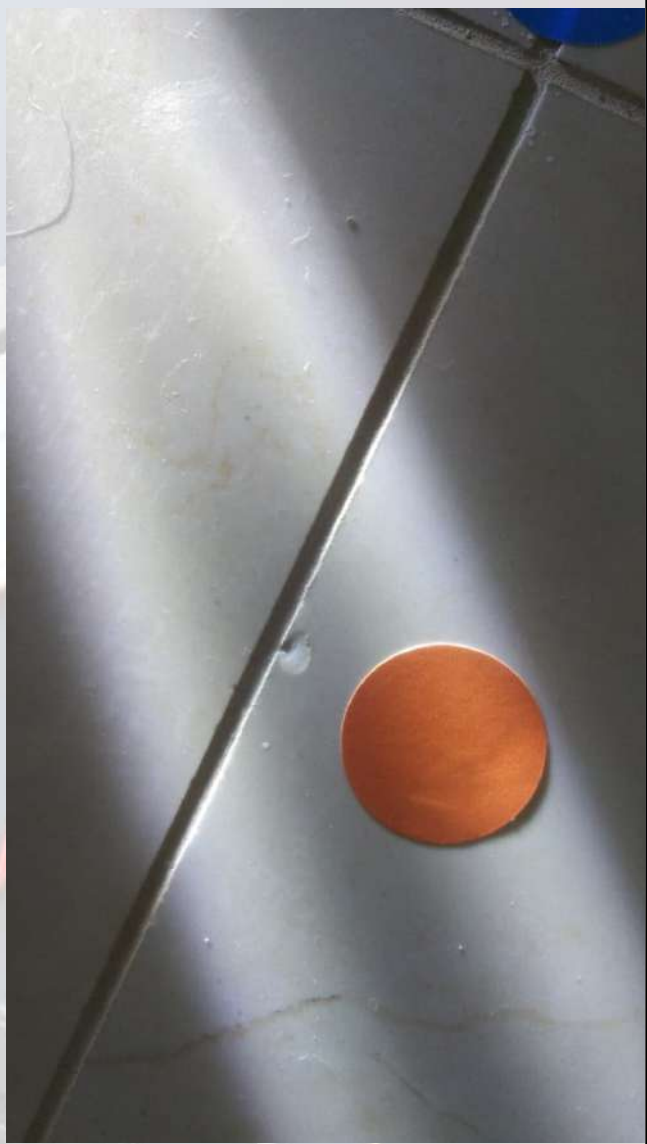
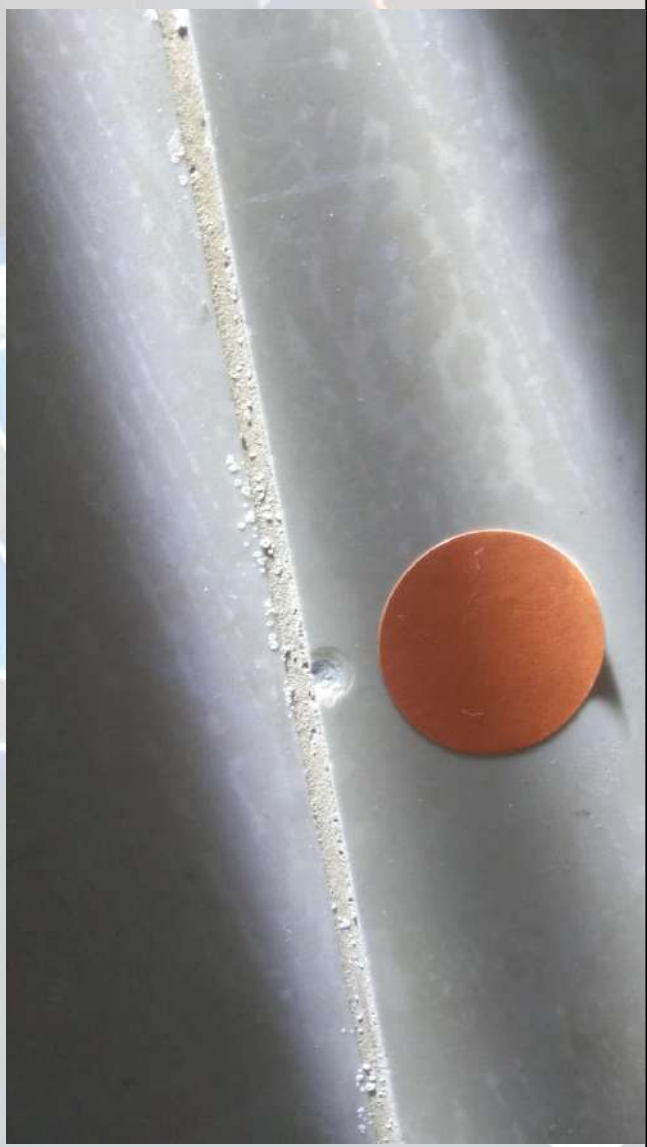
Floor tiles minor chipped off -4

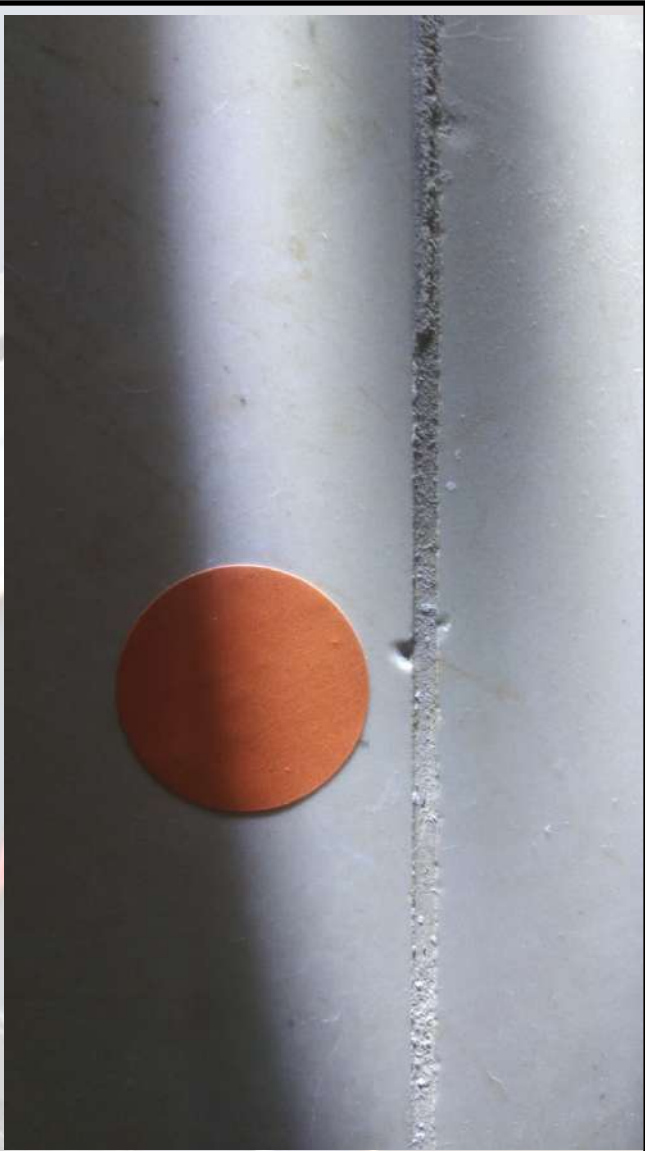
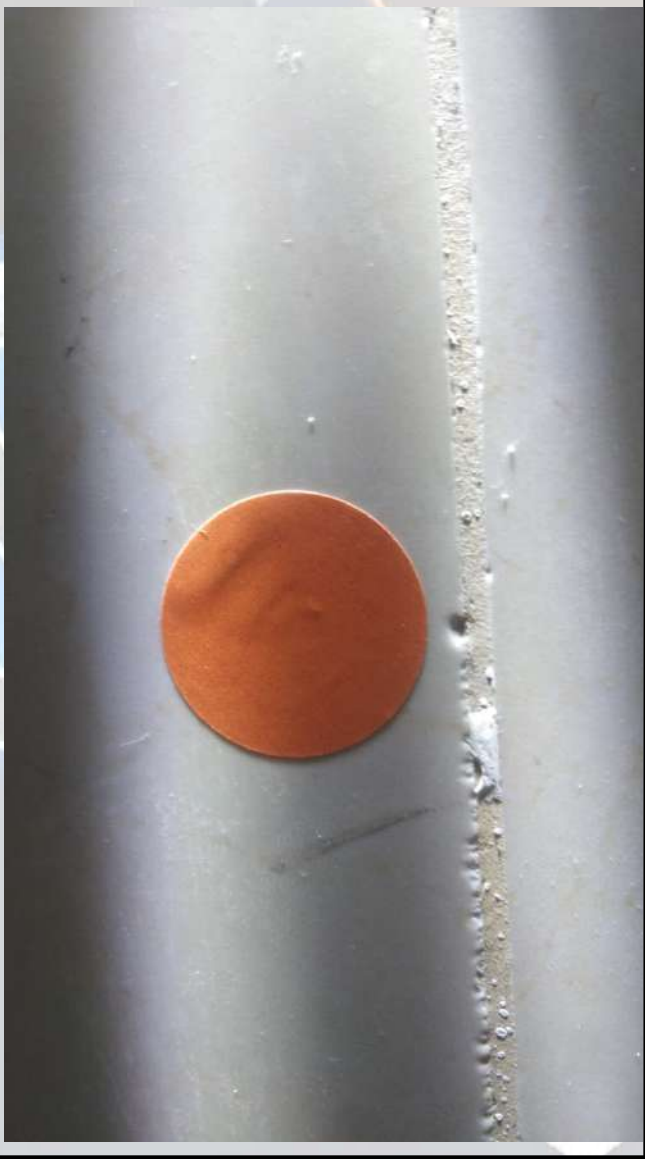
Floor tiles unevenness found - 17

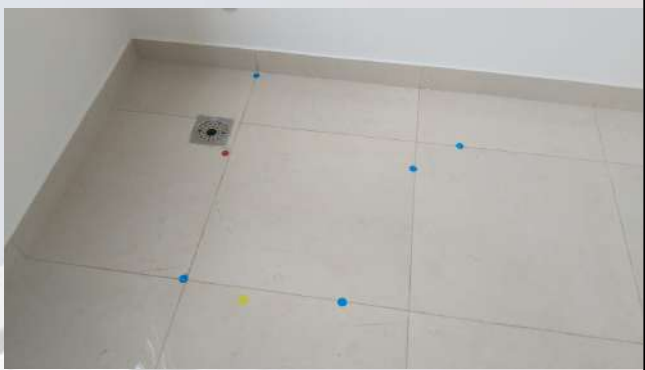
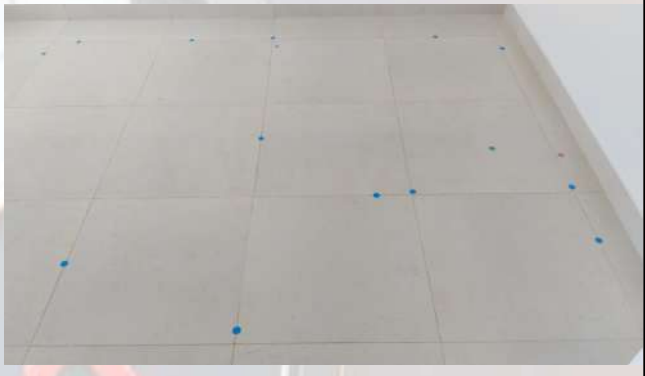
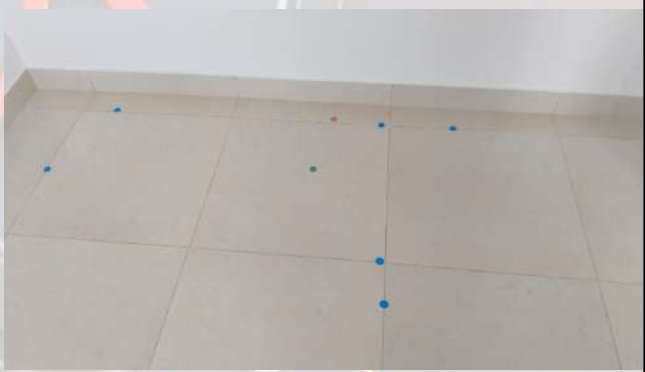
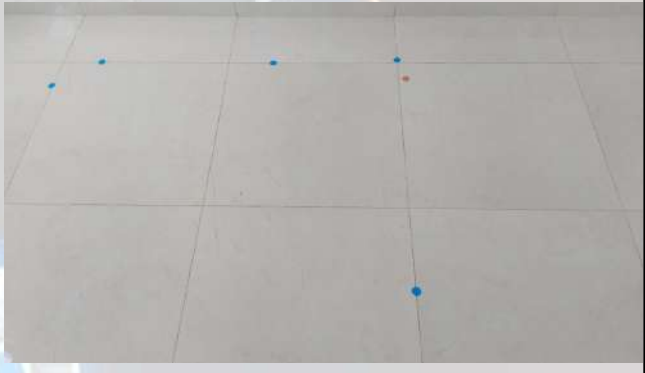
Floor tiles scratch Mark's found -1

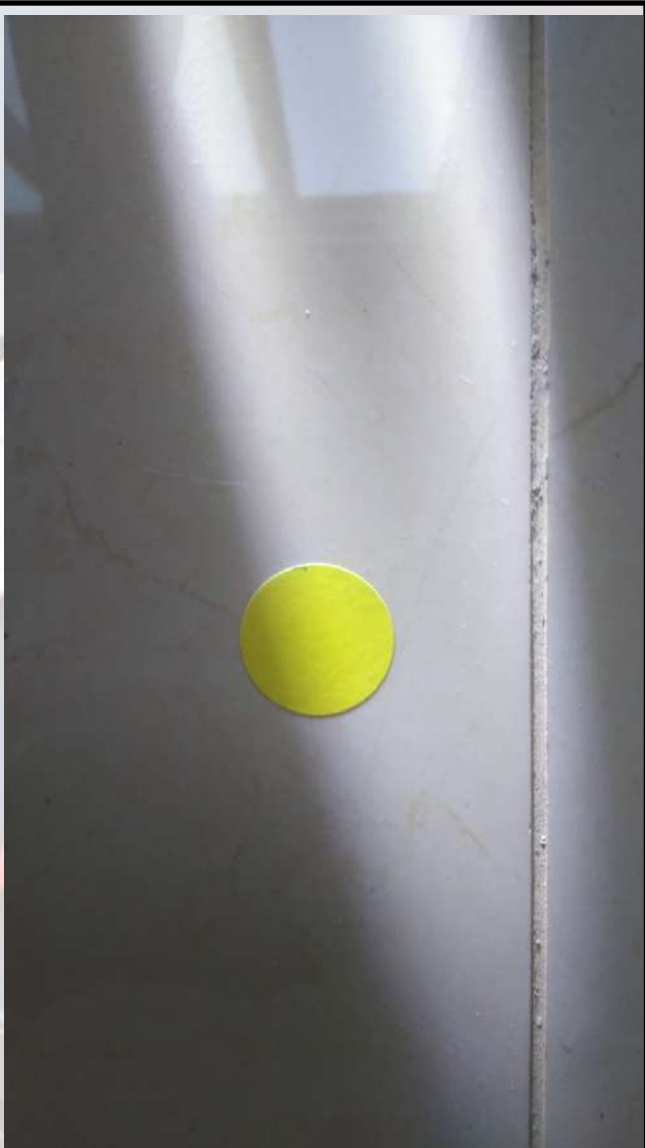
Floor tiles damage found -1
