# MAS Home Care Solutions

## Property Inspection Report

### Advanced Inspection

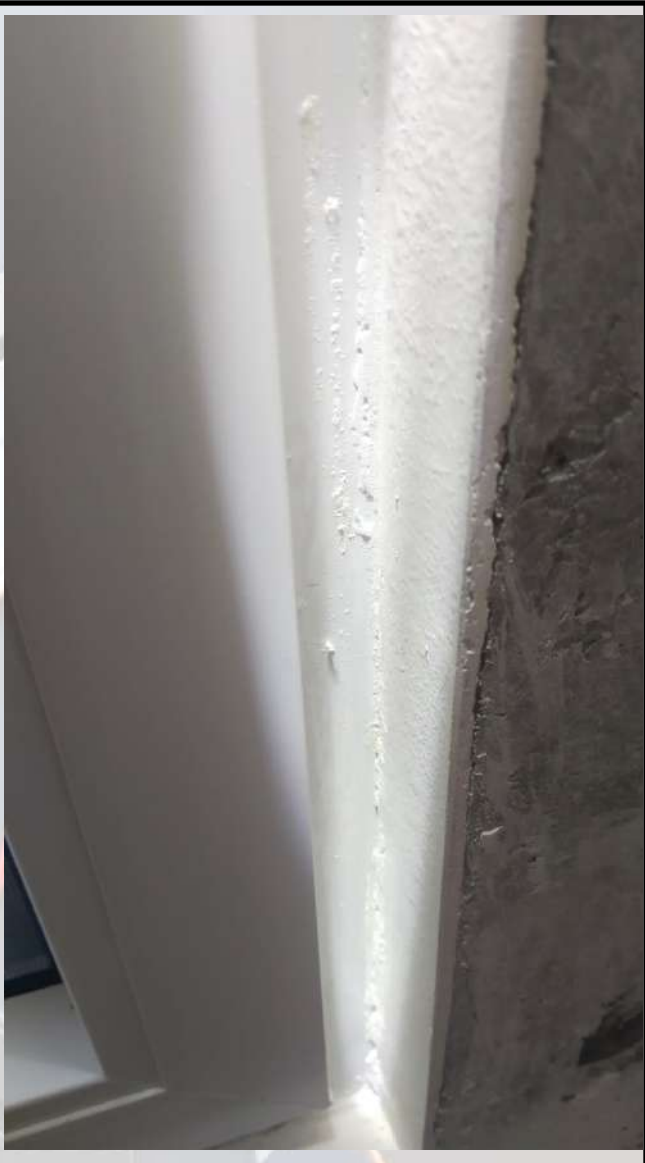
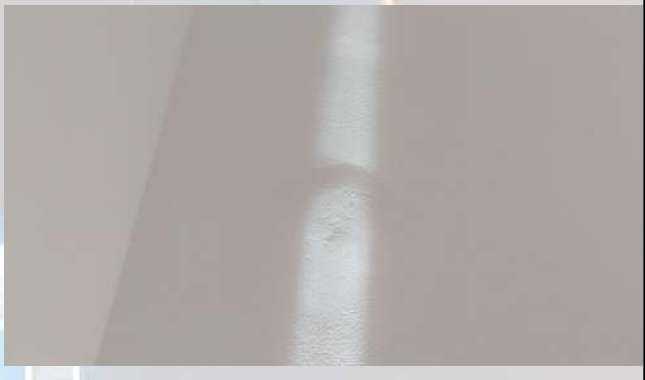
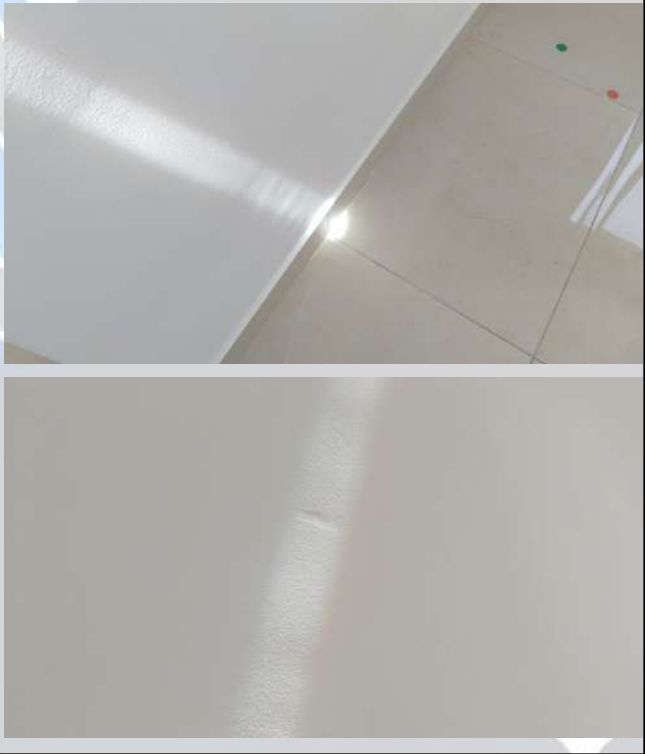
Wall undulations found .

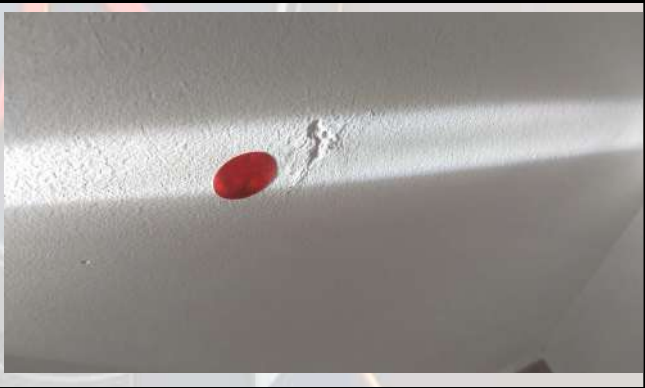
Wall putty chipped out

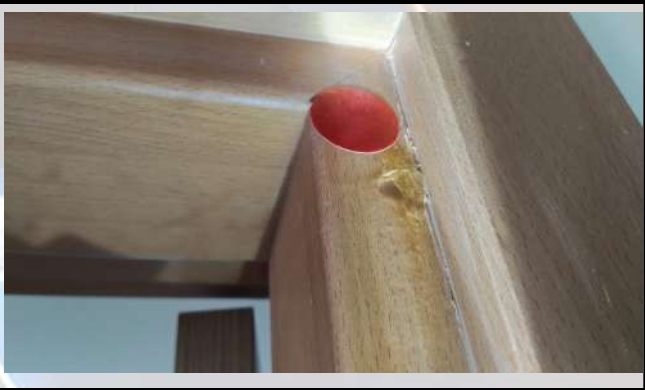
Door frame right top portion lamination chipped off .

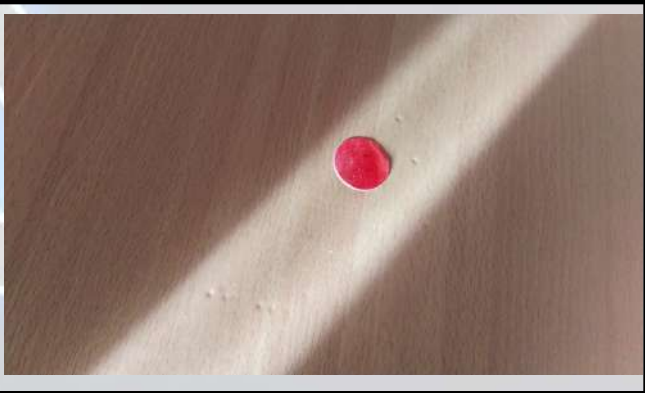
Multiple dent marks found on the door front portion .

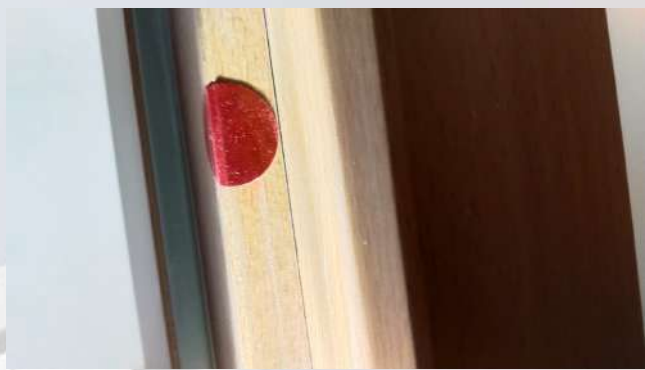
Major scratch mark found on door front bottom side .

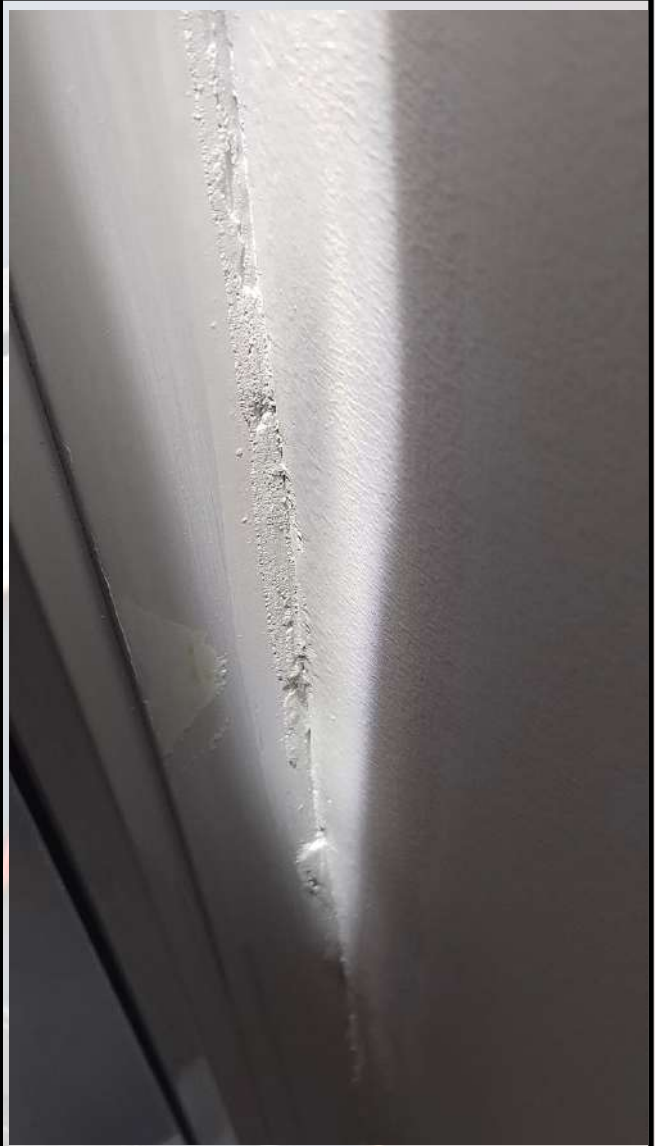
Window frame right bottom side packing damaged .

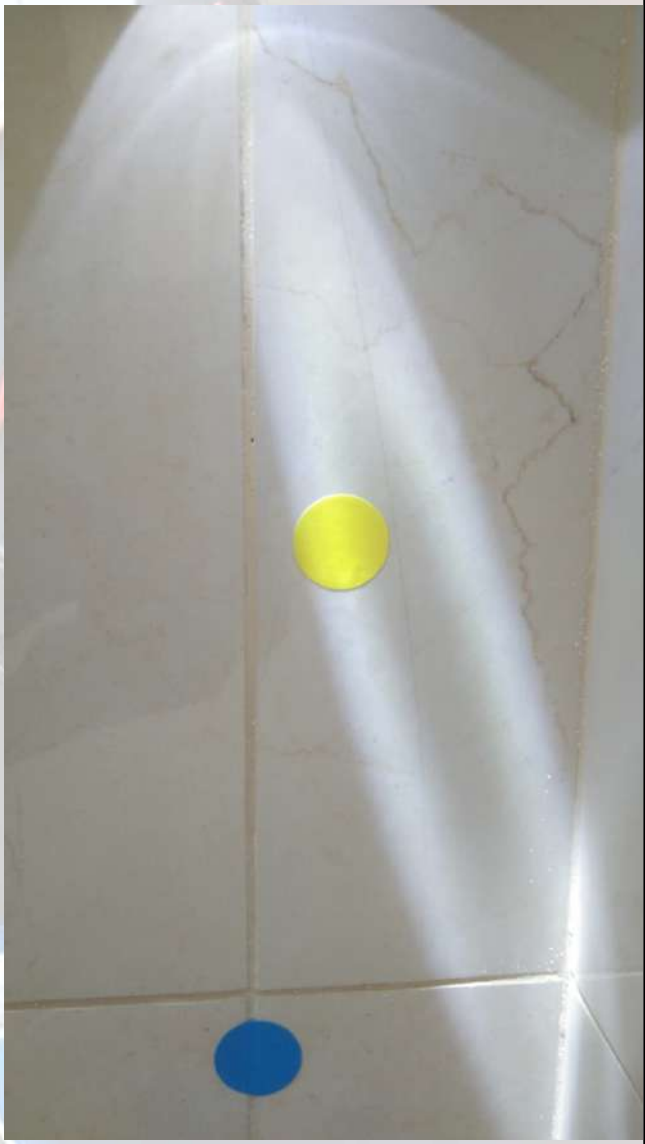
Floor tiles scratch Mark's -2

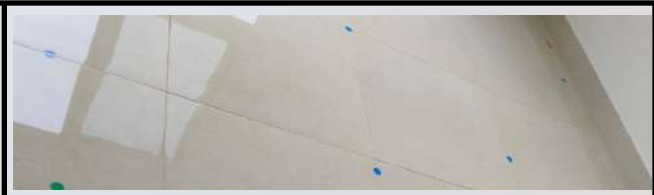
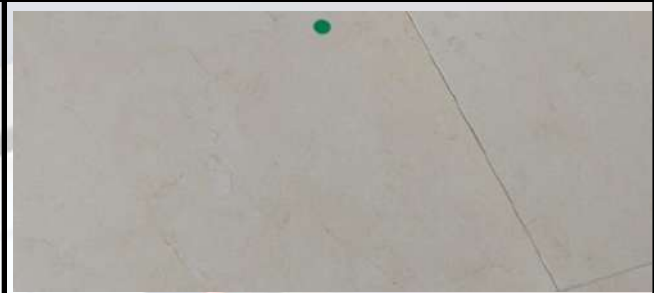
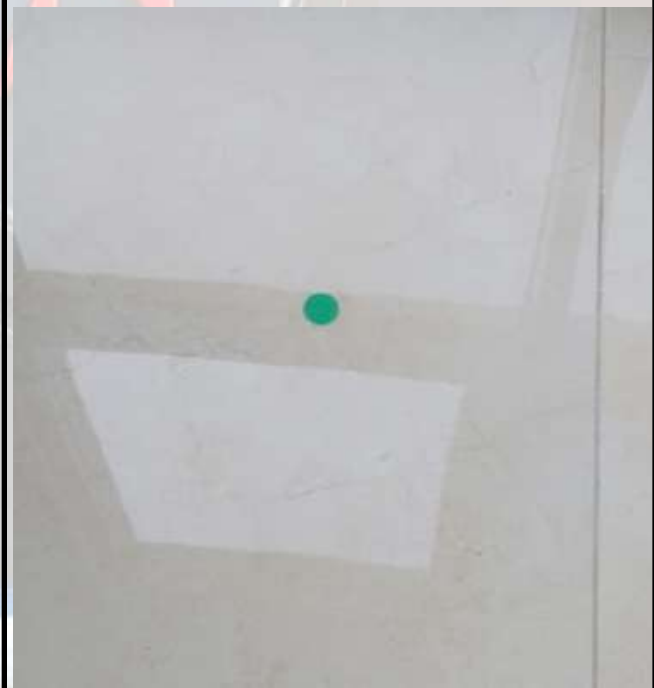
Floor tiles hollow found -7

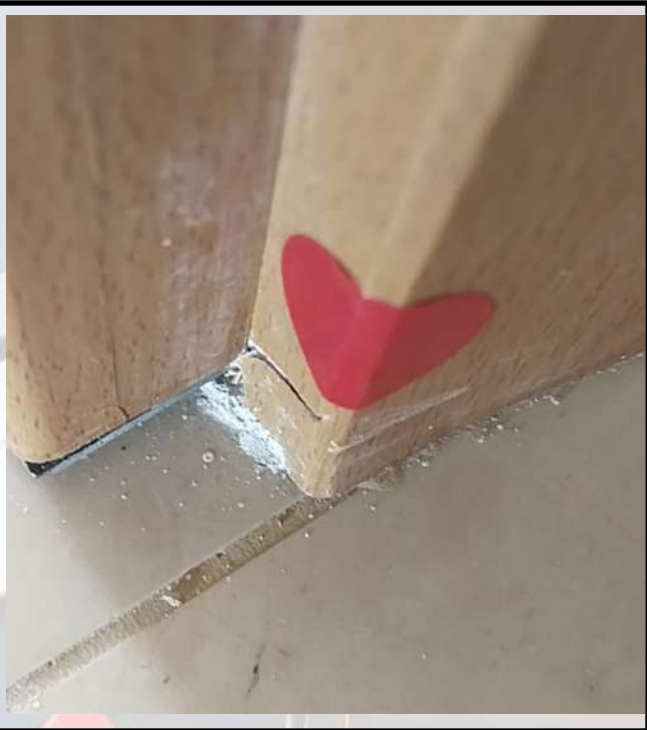
Right side door frame beading lamination  
bottom side minor damage .

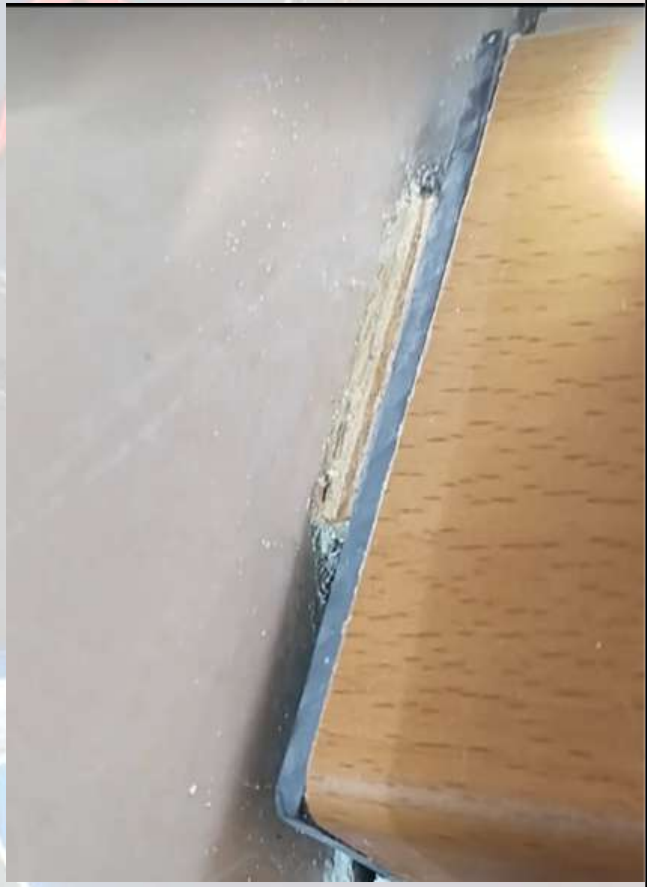
The door is rattling .

Door Frame bottom packing required

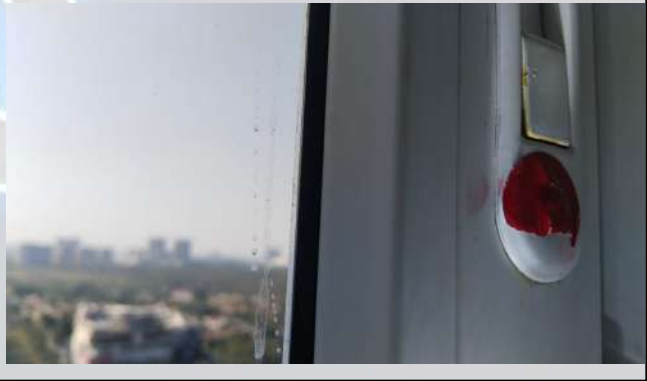
The right side window lock started getting  
rusty .

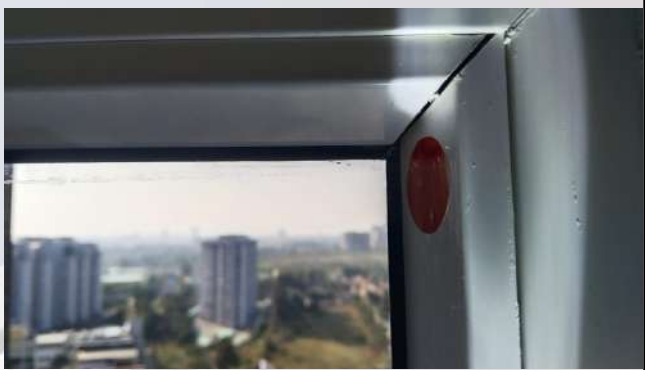
Right side Glass frame centre portion finishing not proper , gap visible .

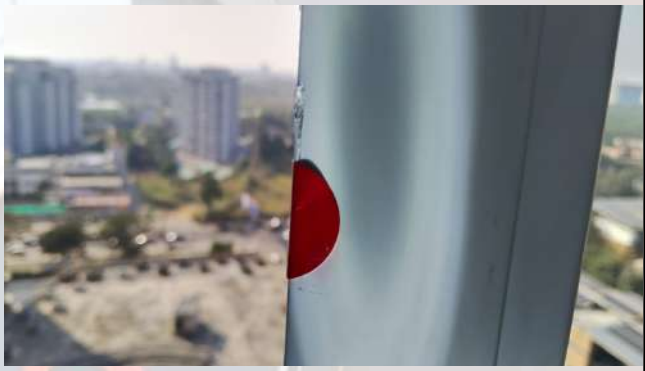
Left side glass frame minor chipped off .

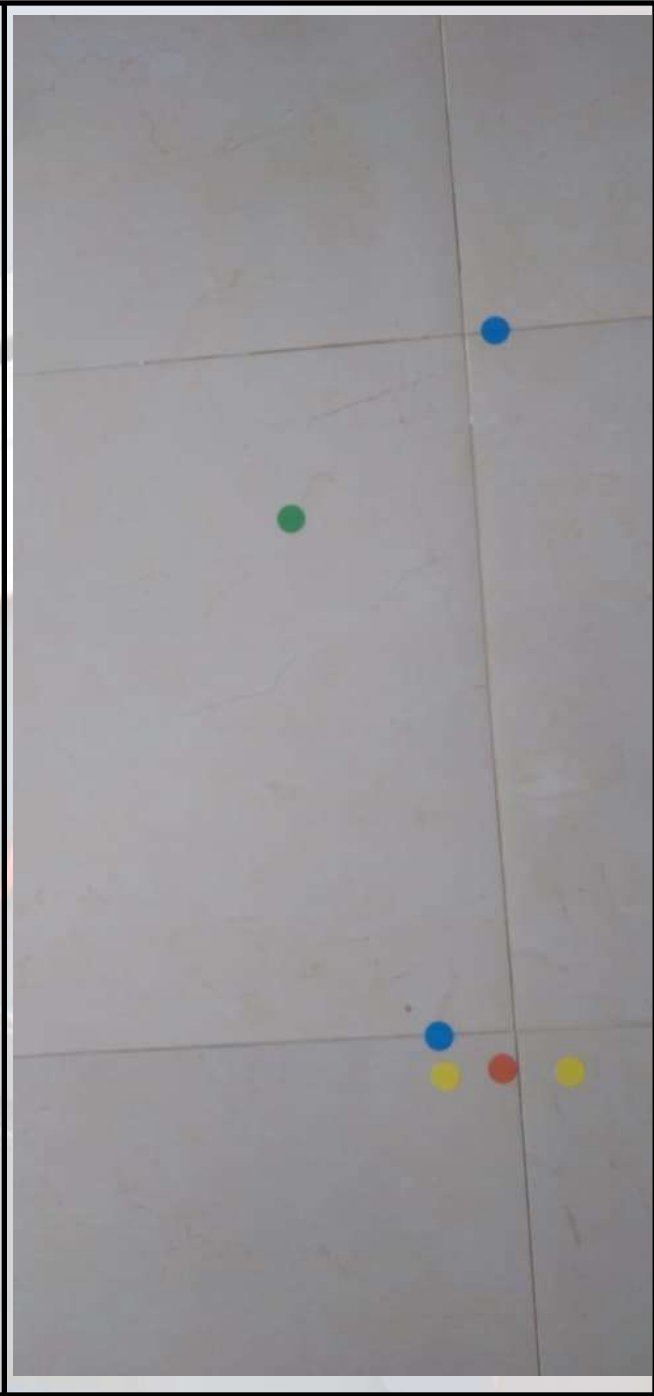
Floor tiles hollowness -6

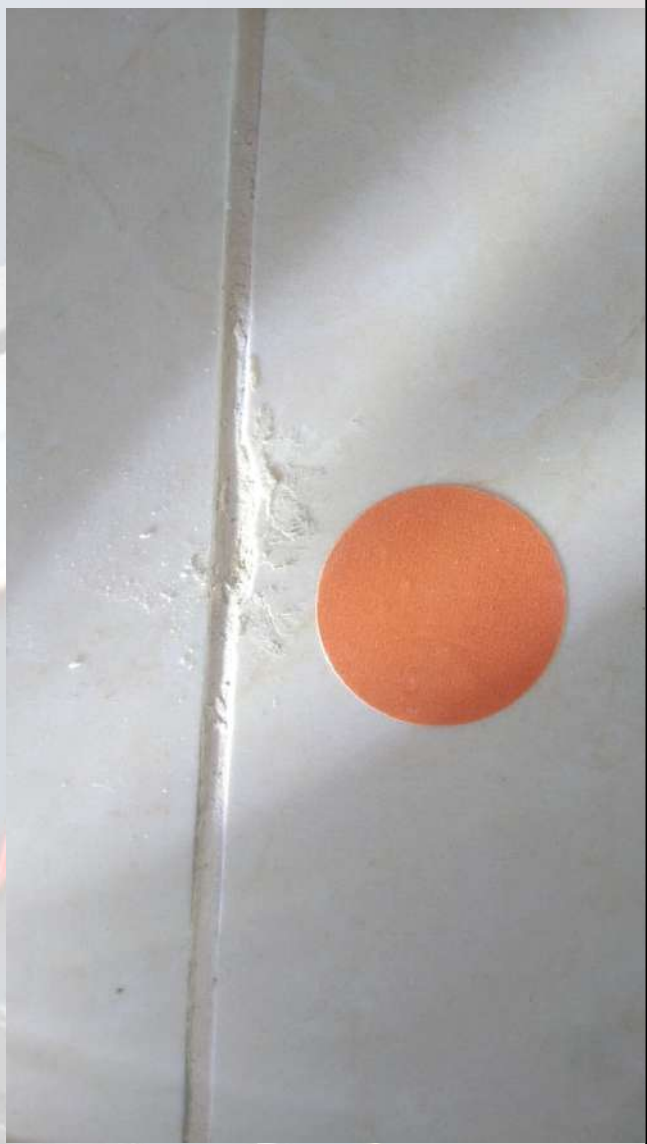
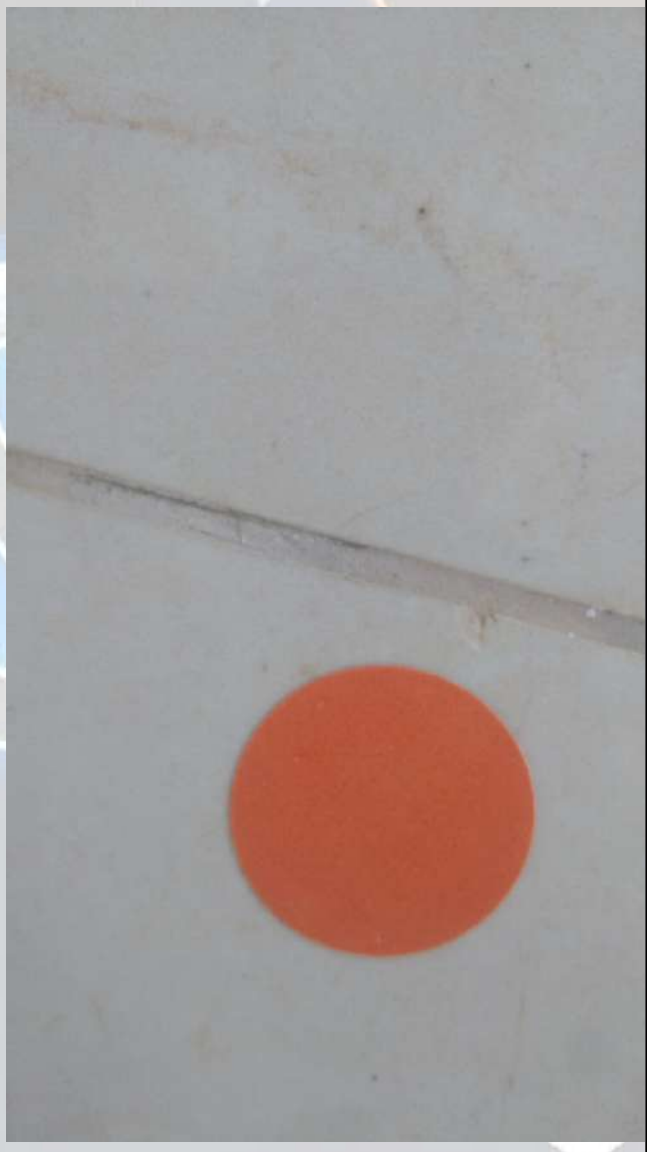
Floor tiles minor chipped off -11

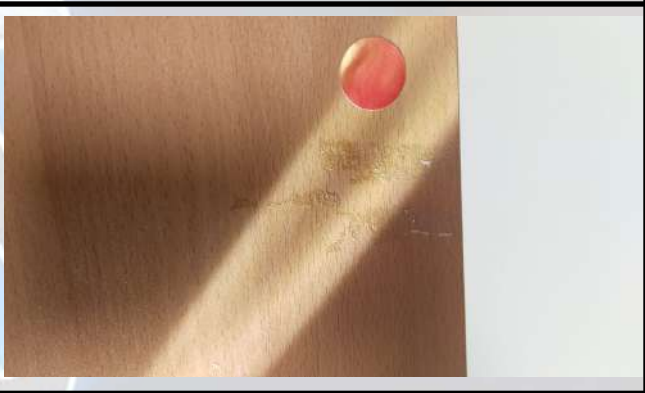
Glue marks found on door

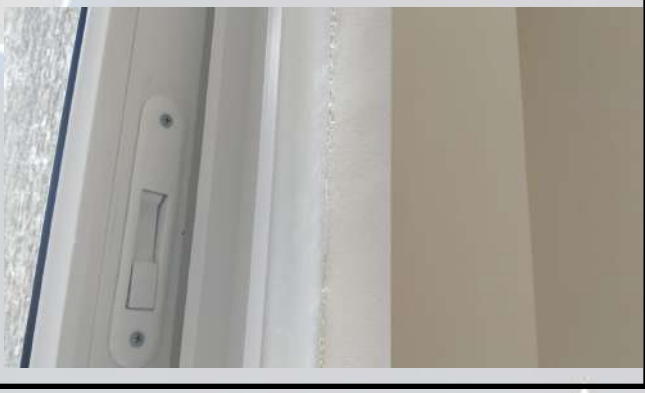
Window frame packing finishing not proper , proper finishing required .

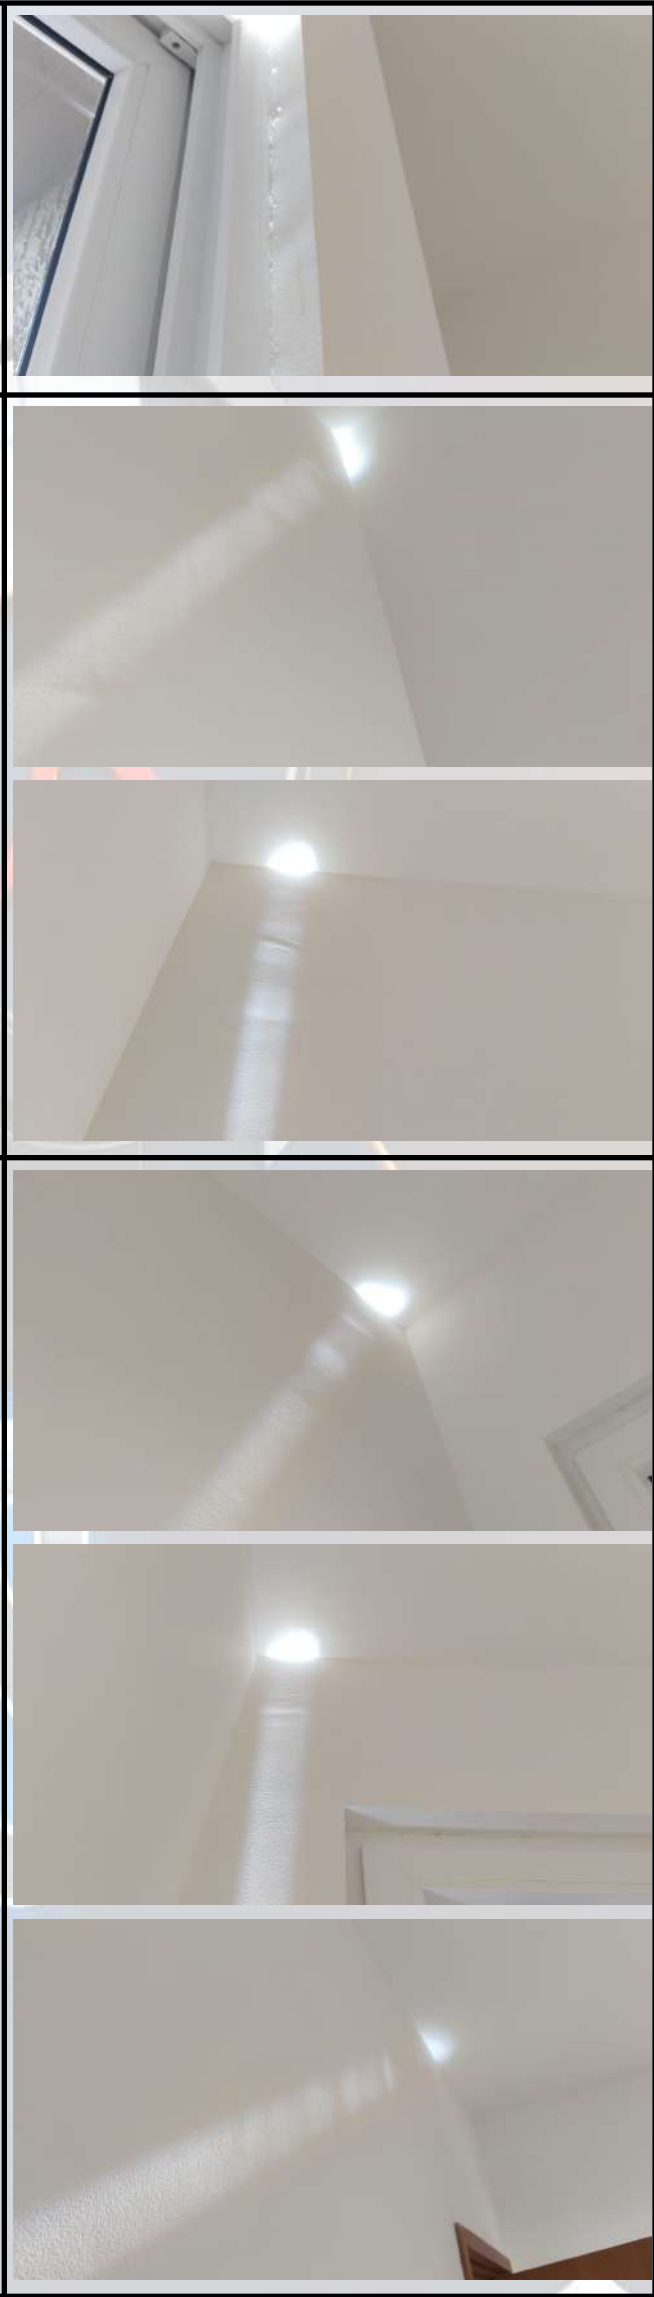
Wall undulations found

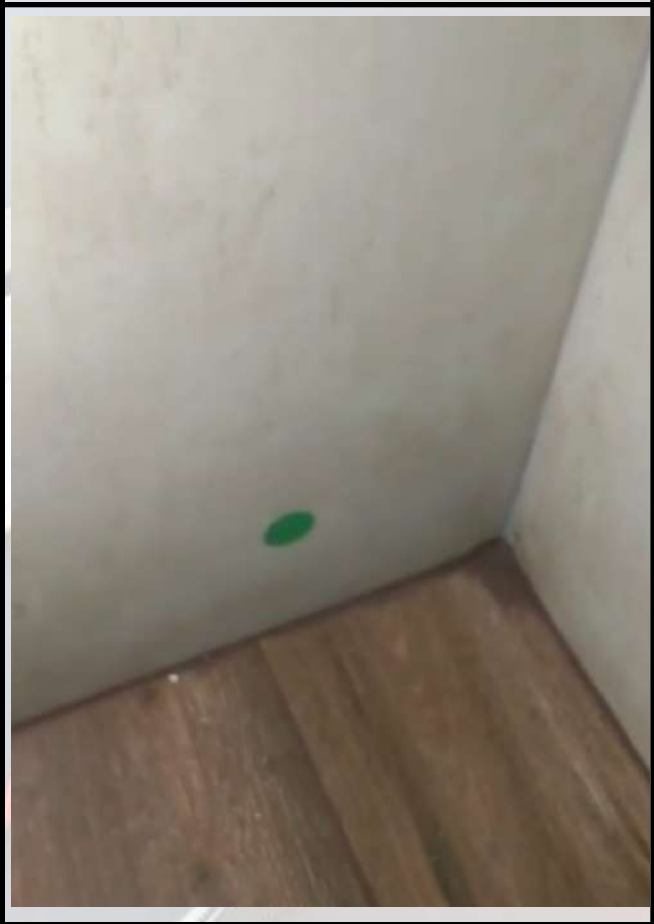
| Bathroom 1 attached to master bedroom | Image Reference |
|---|---|
| <p data-bbox="185 966 558 1011">Wall tile hollowness -1</p> | |

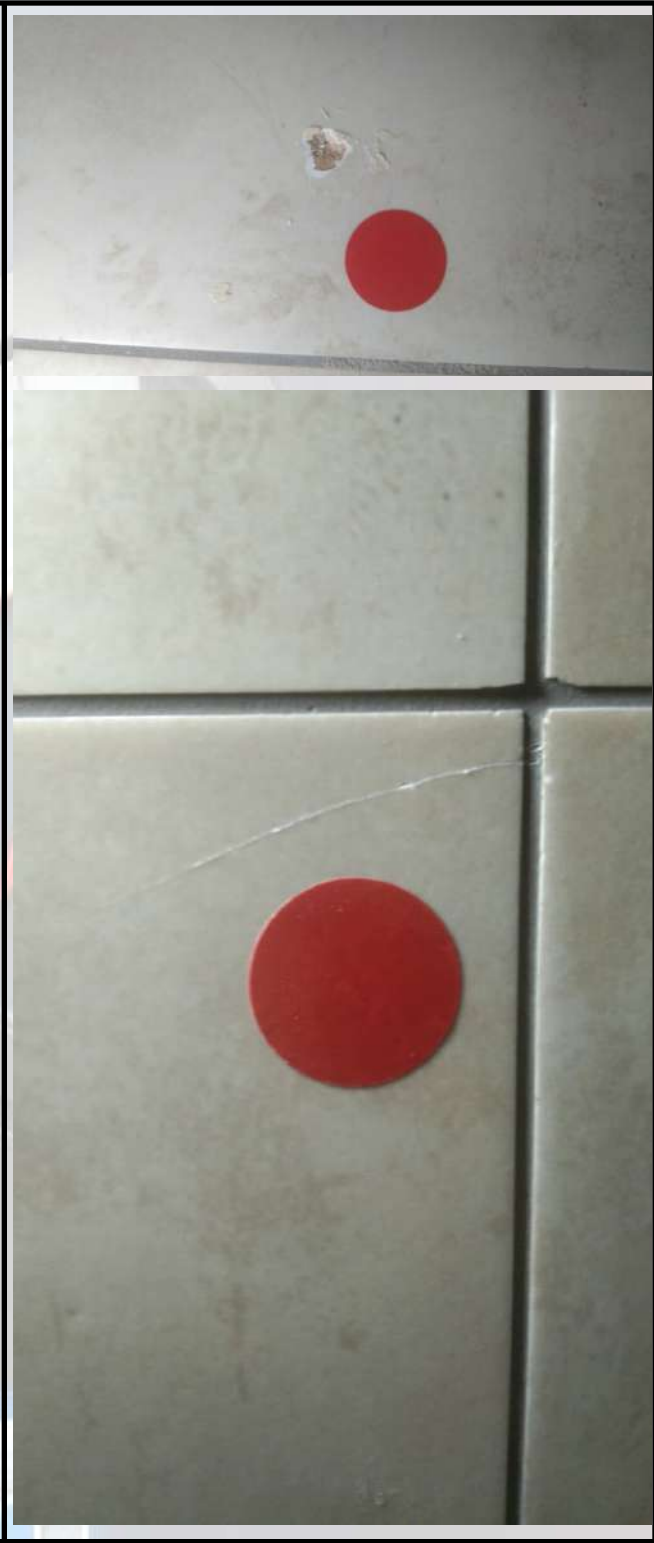
Wall tile damaged-7

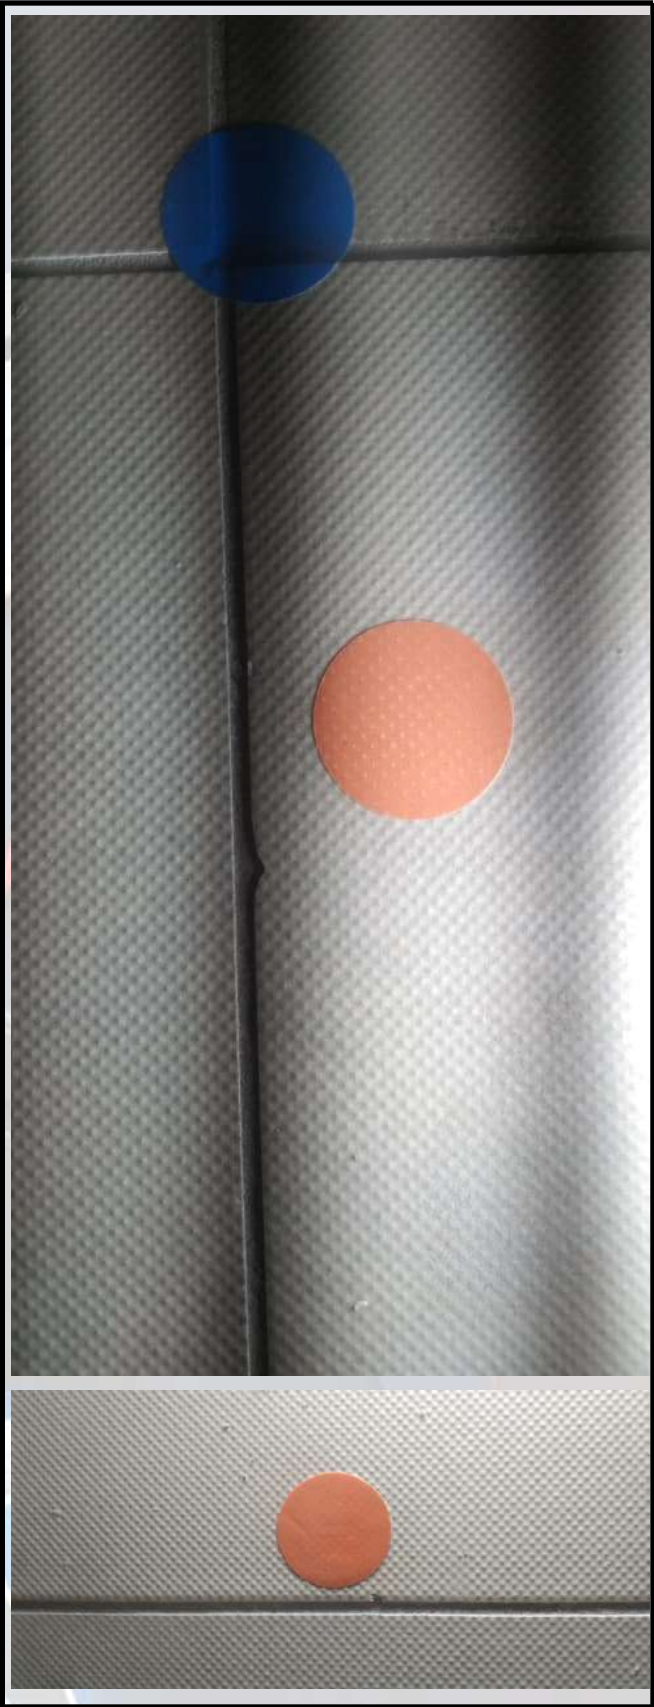
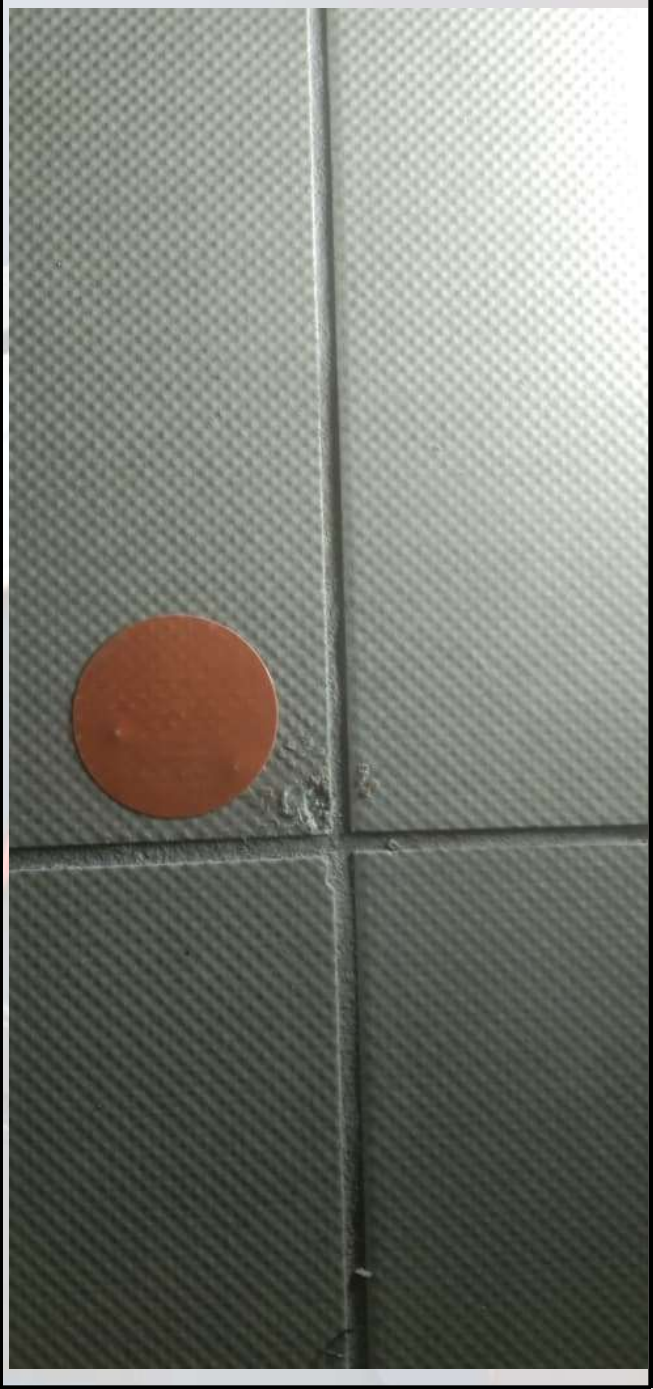
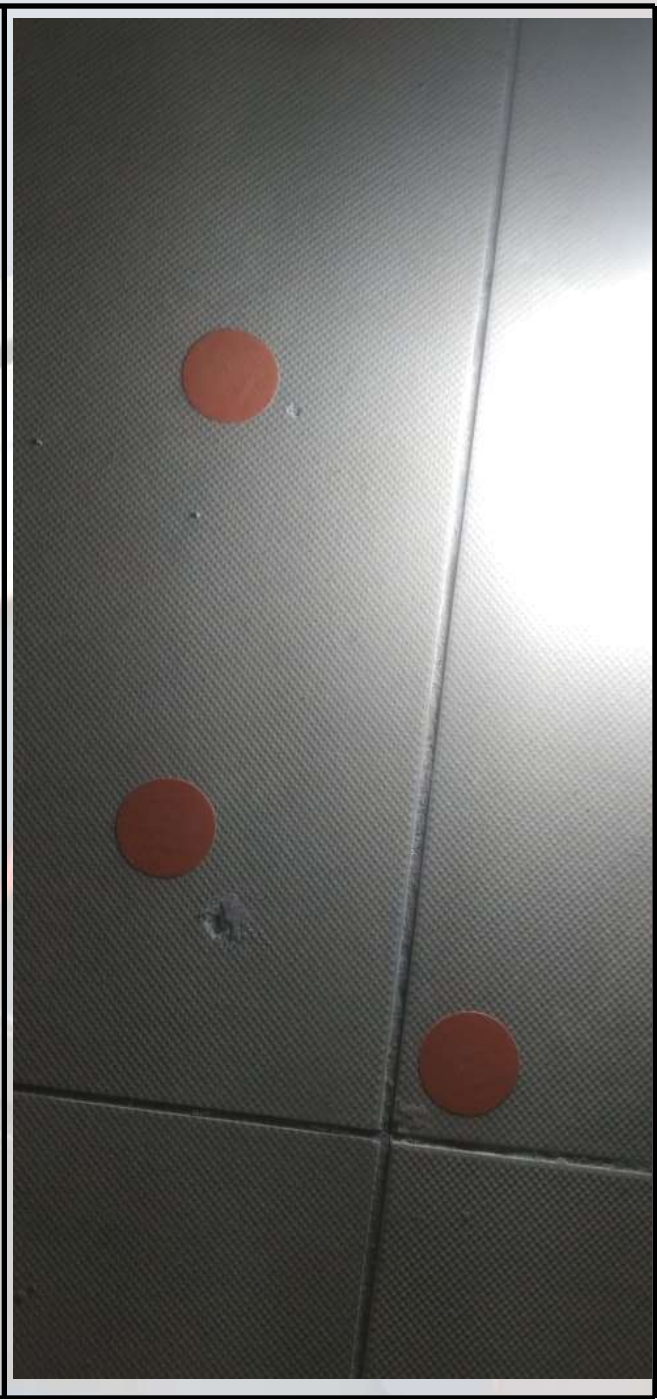
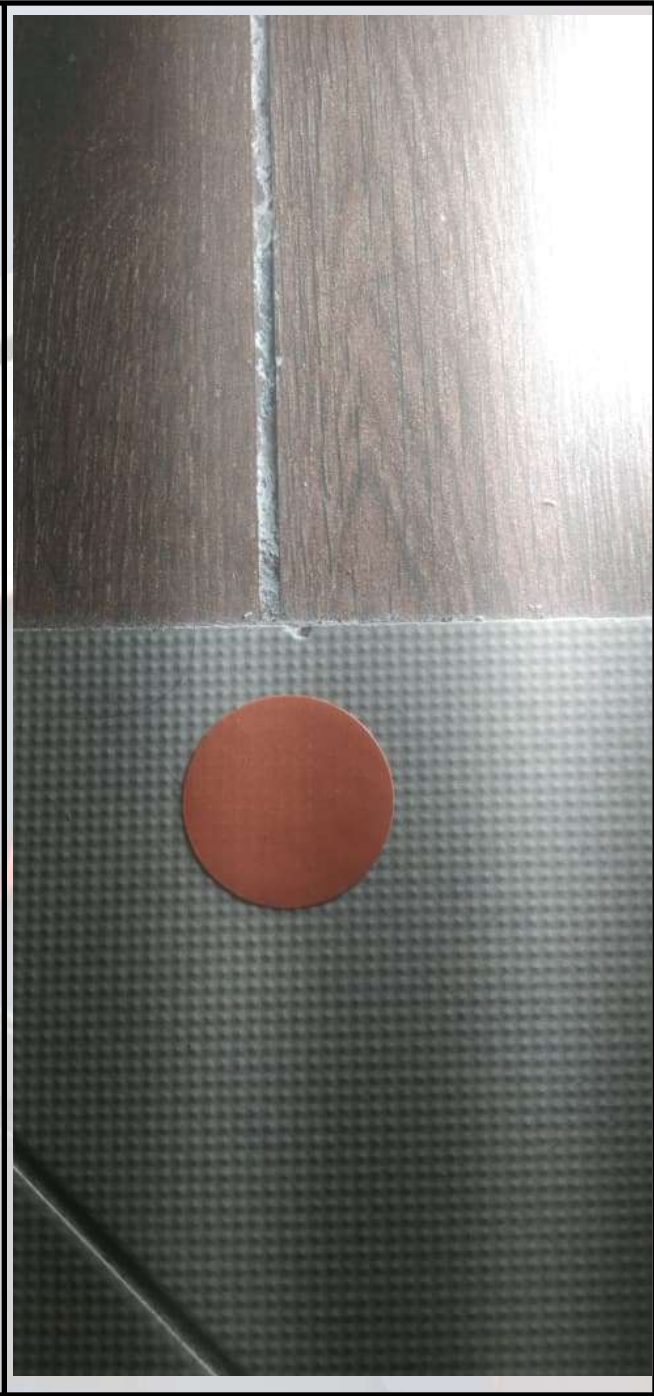
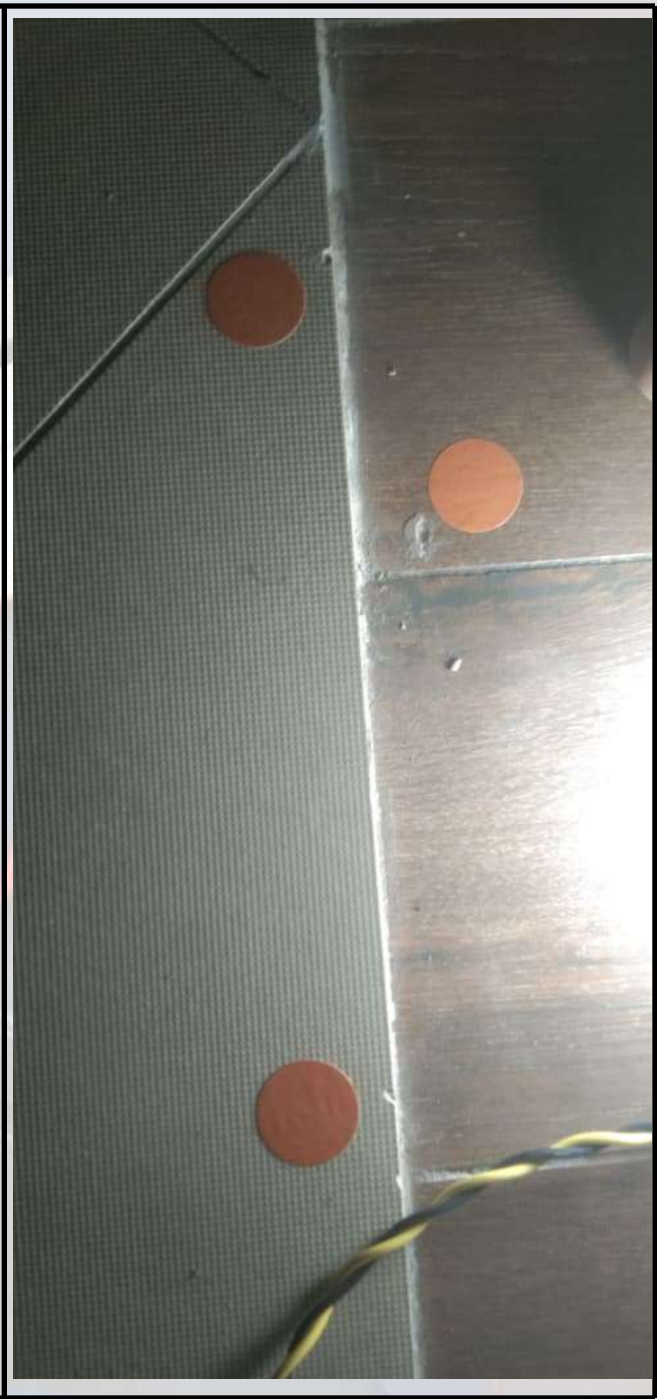
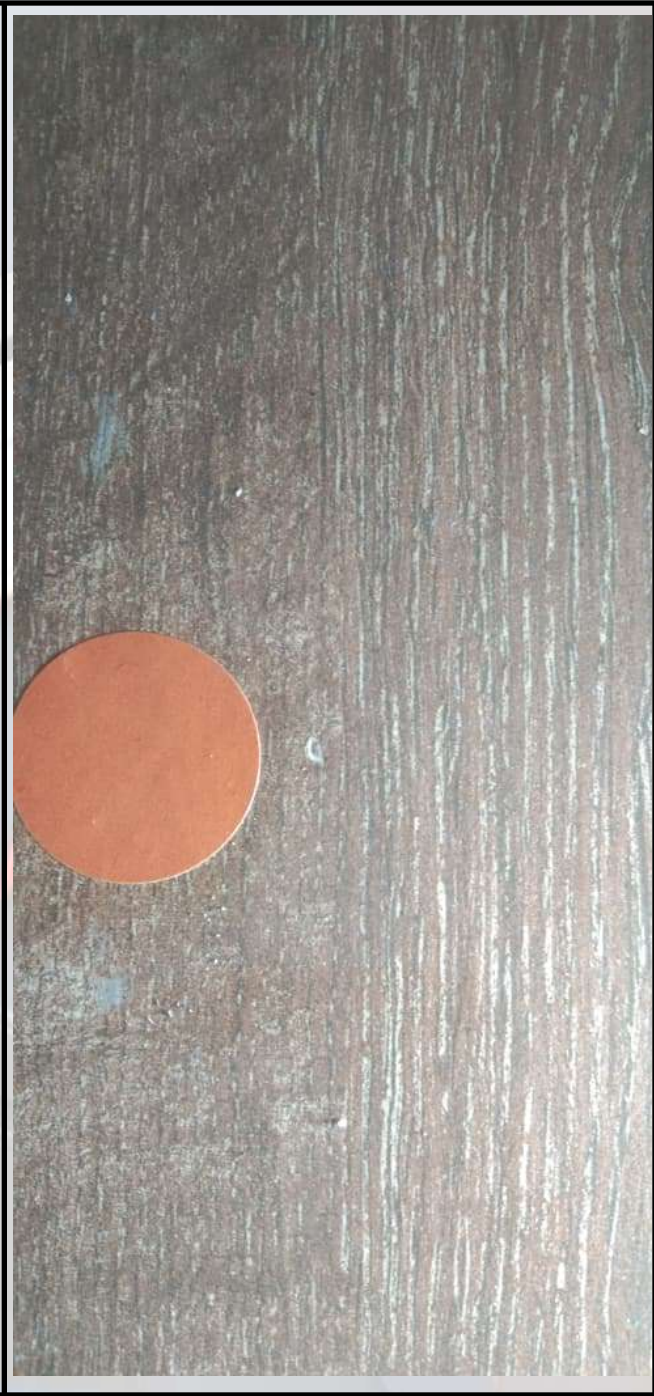
Floor tiles minor chipped off -21

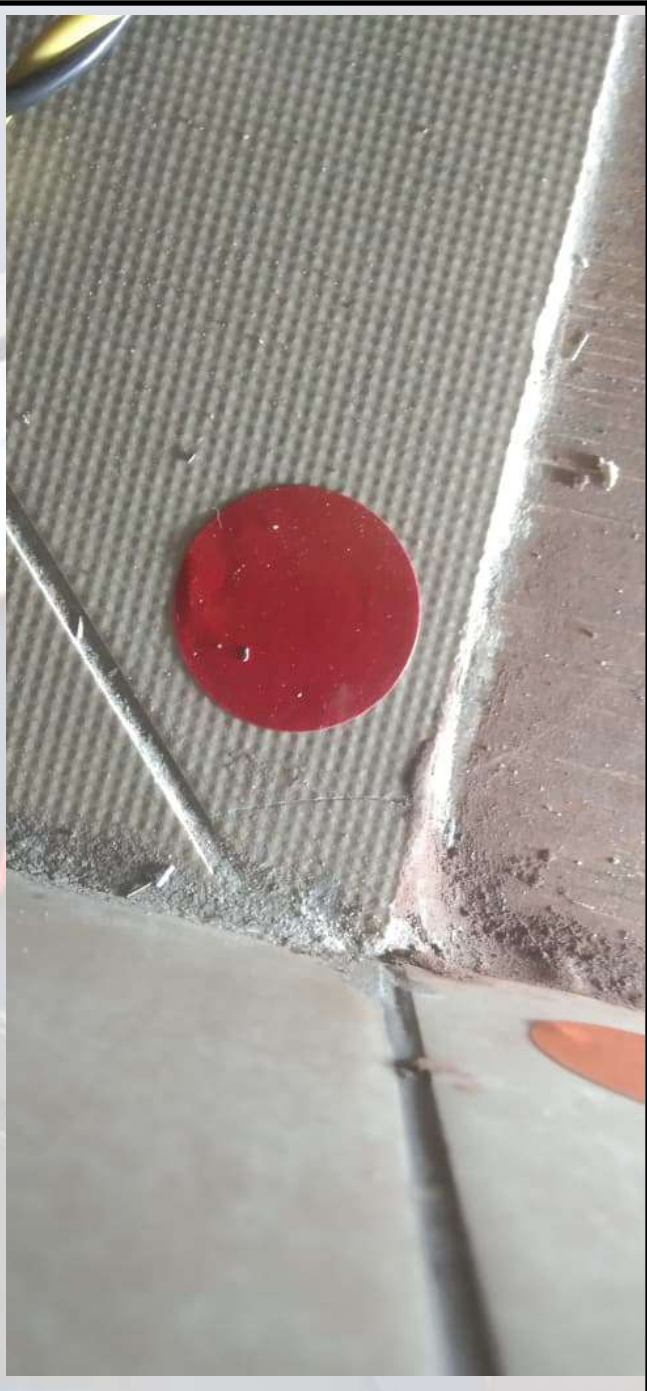
Floor tiles damaged - 1

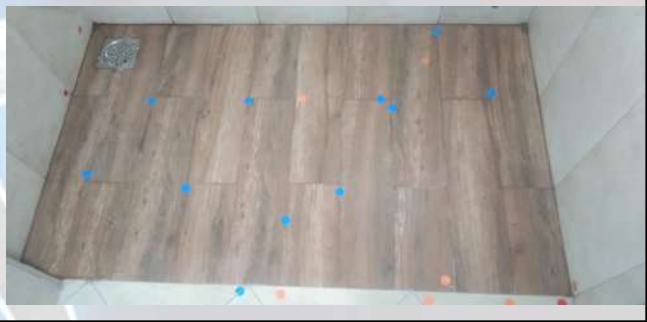
Floor tiles unevenness found - 19

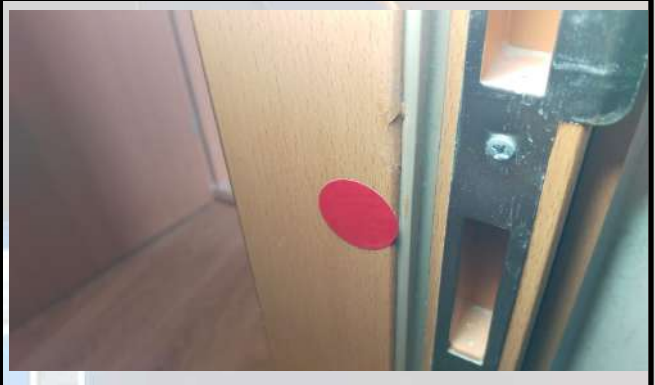
Left side Door frame near lock plate lamination minor damaged

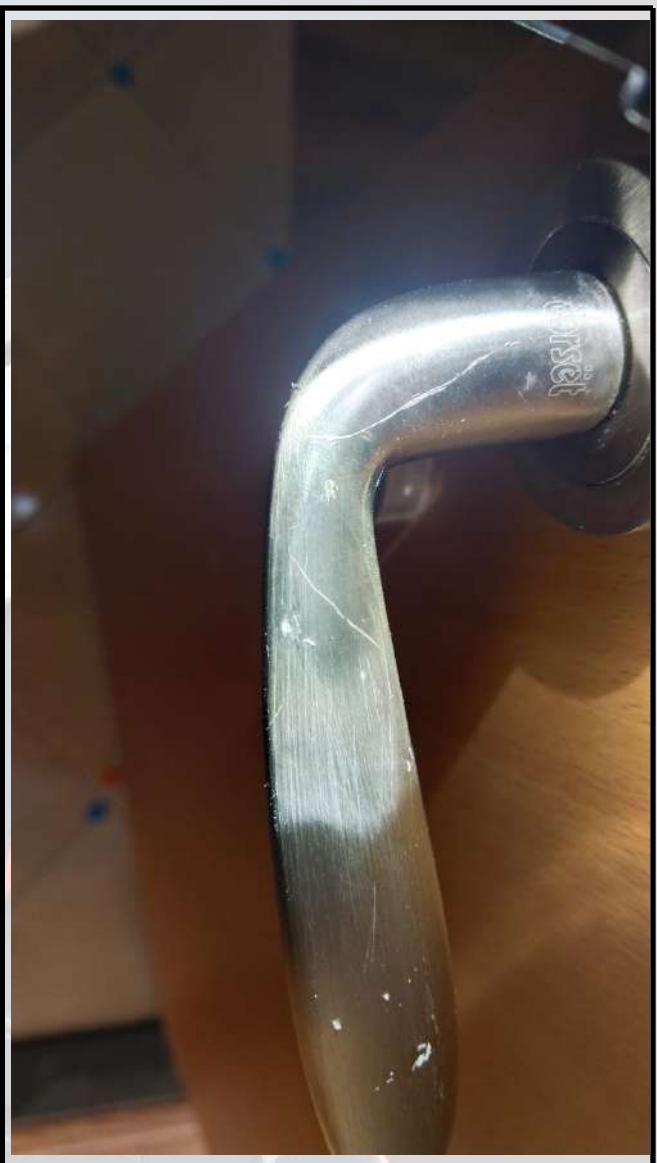
Scratch marks found on the door handle .

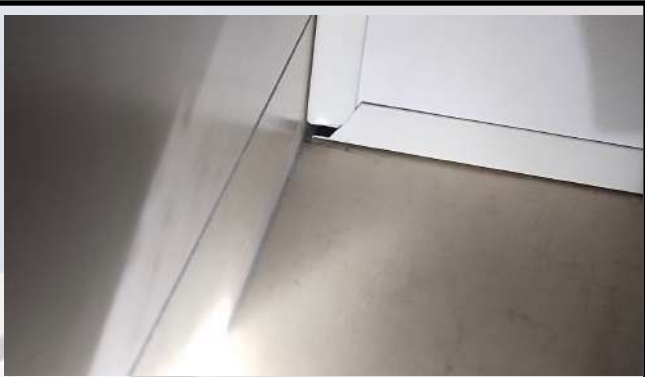
Shower head rod and flush tank button loose

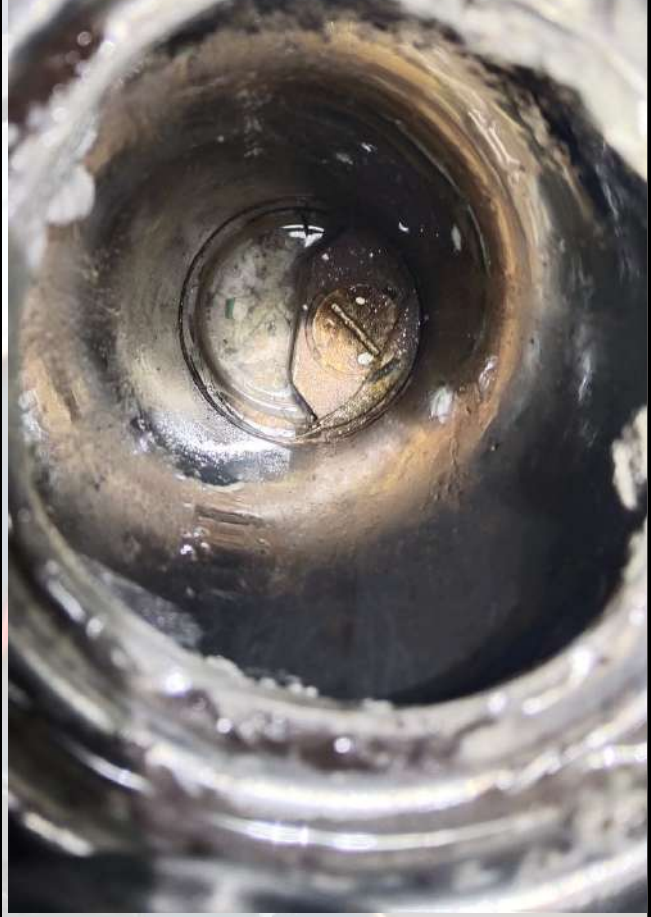
Drainage pipe cleaning required
