# MAS Home Care Solutions

## Property Inspection Report

### Advanced Inspection

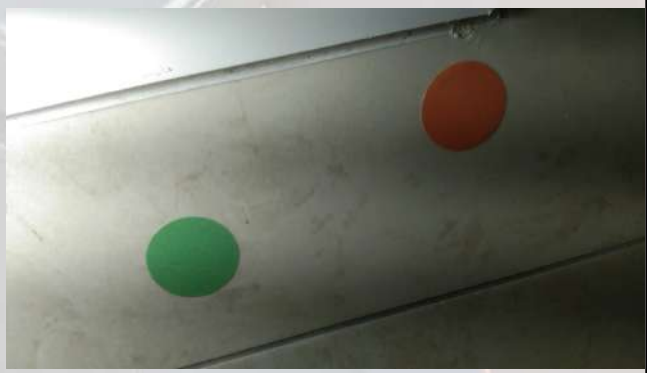
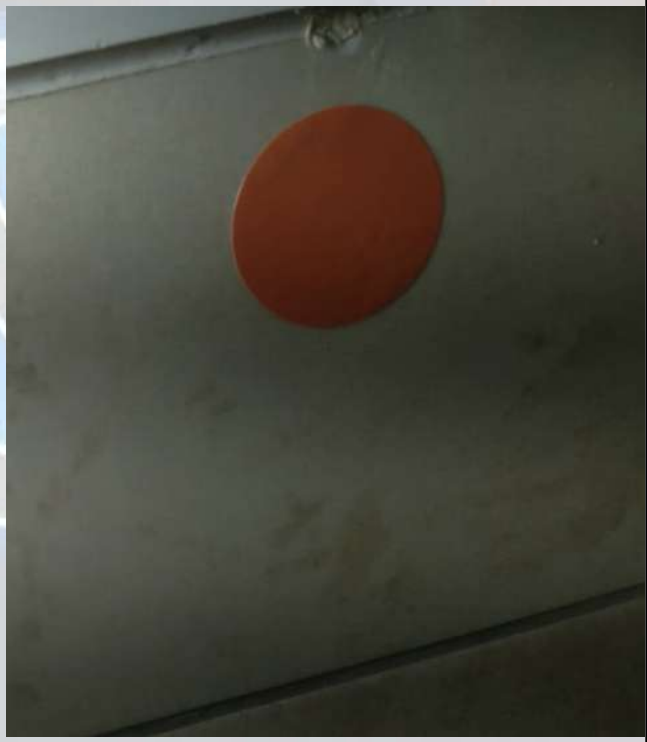
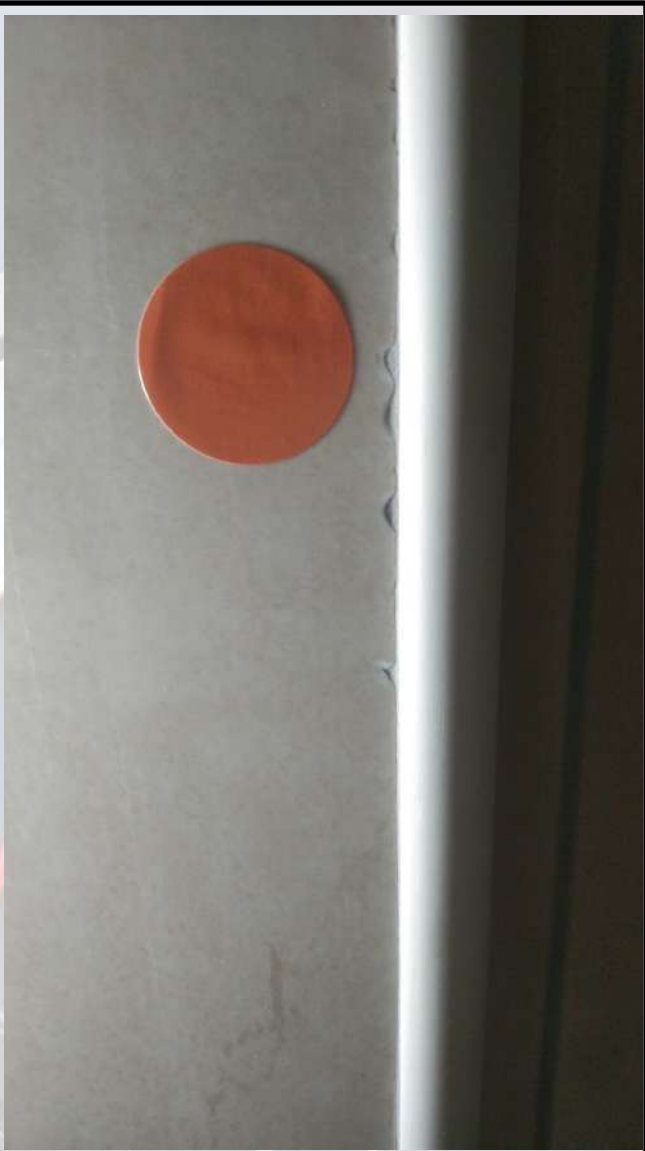
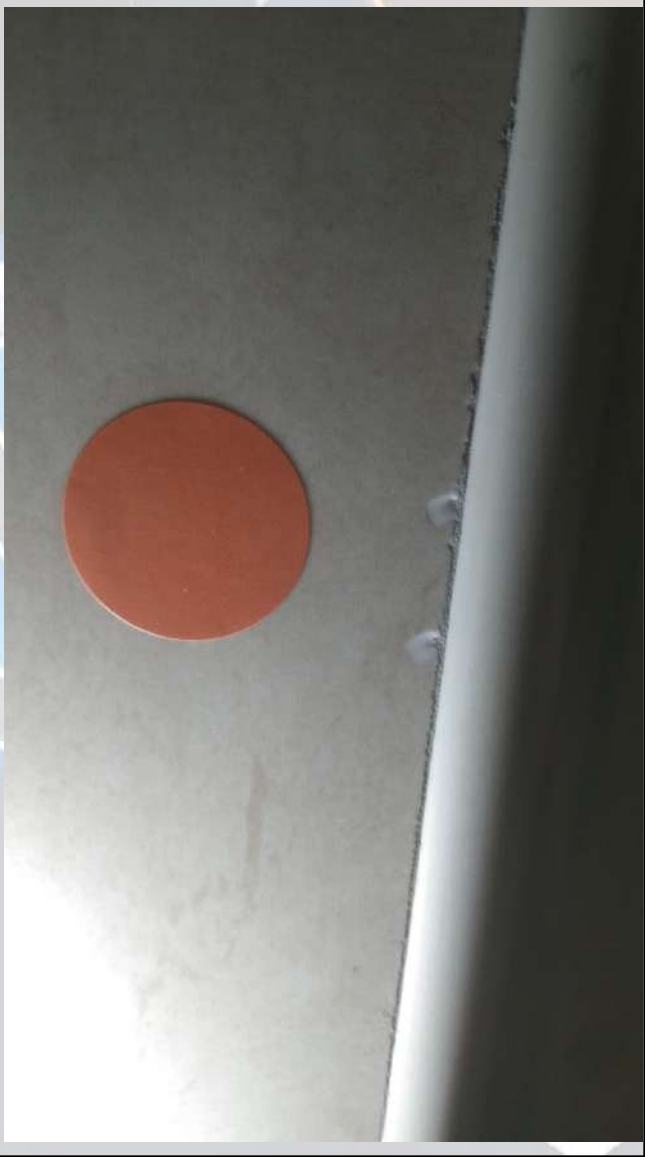
Wall tile minor chipped off -20

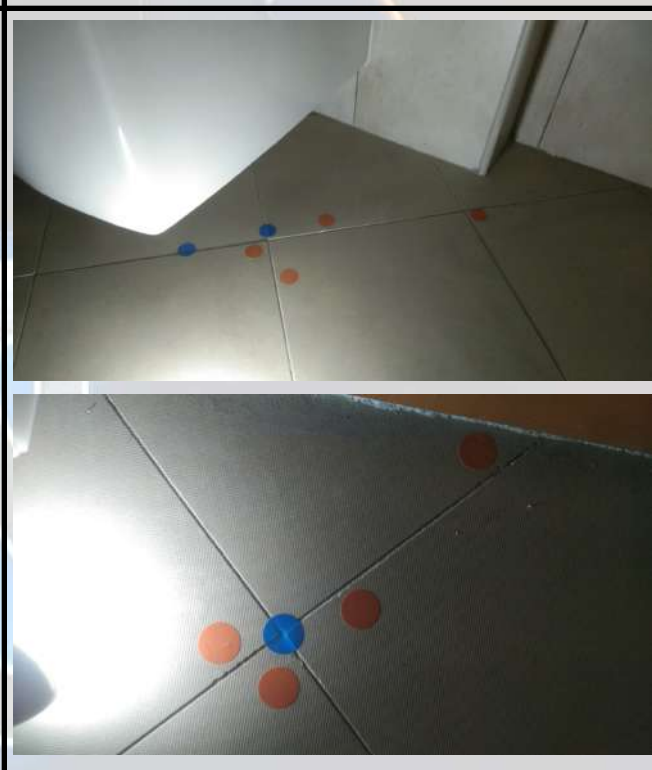
Floor tiles minor chipped off -14

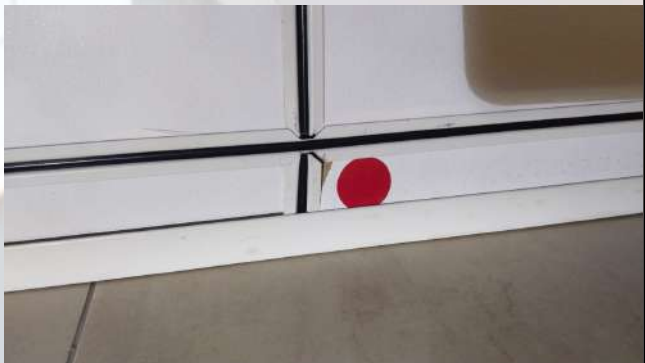
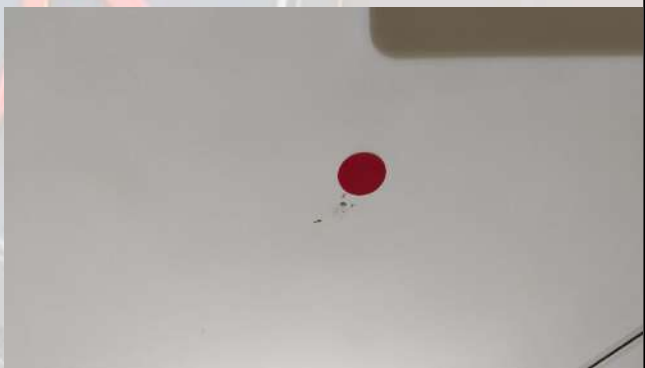
2 false ceiling scratch marks found 1 and damaged

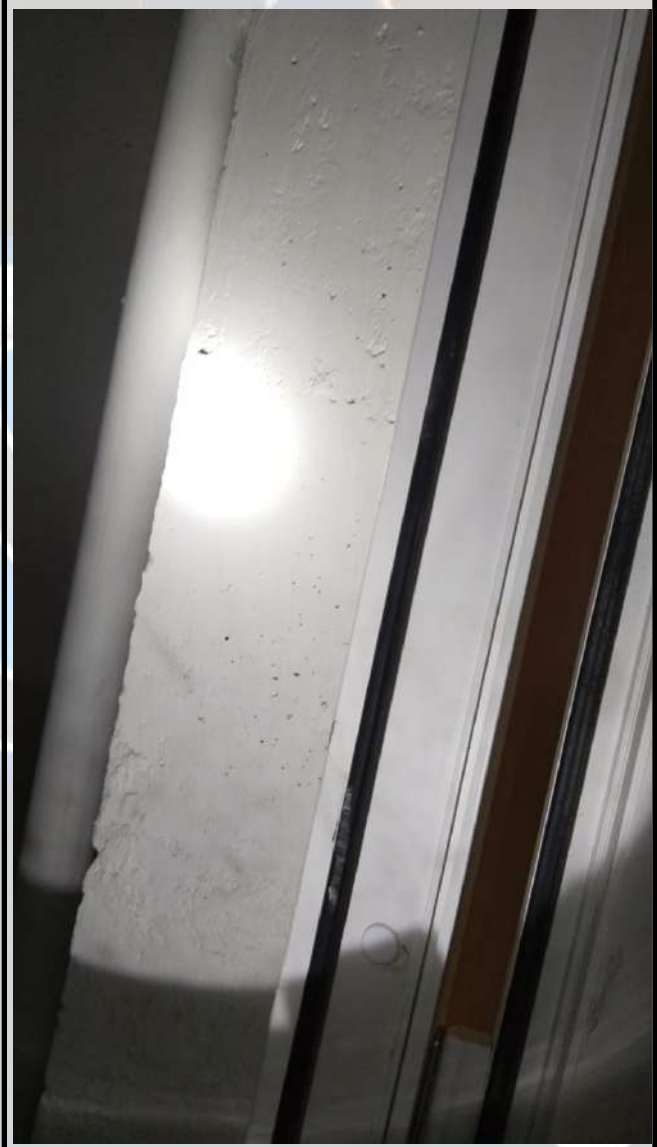
Window external side plaster finishing not proper and cleaning required

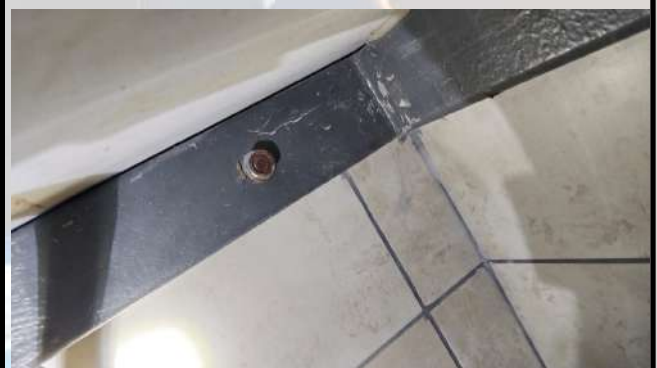
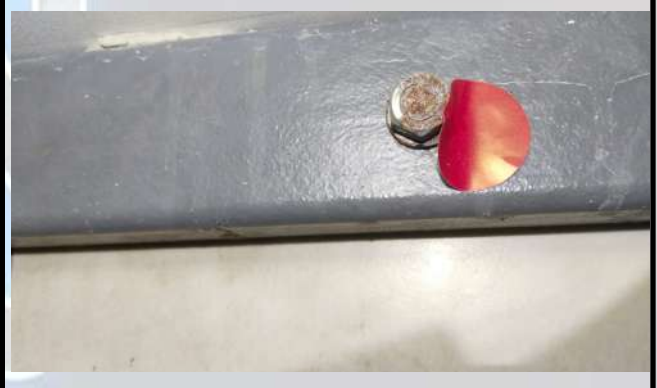
Granite slab nut bolt started getting rusty
